GOLD FIELDS

KDC East No.1 Gold Plant

Conveyor Belt No.17 Frame Support

CONCRETE BEAM FAILURE

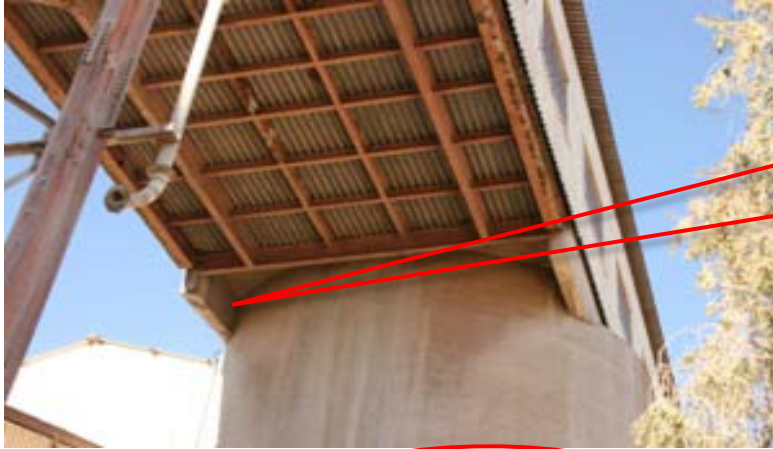
Underside of silo floor with failed concrete beam on the far left

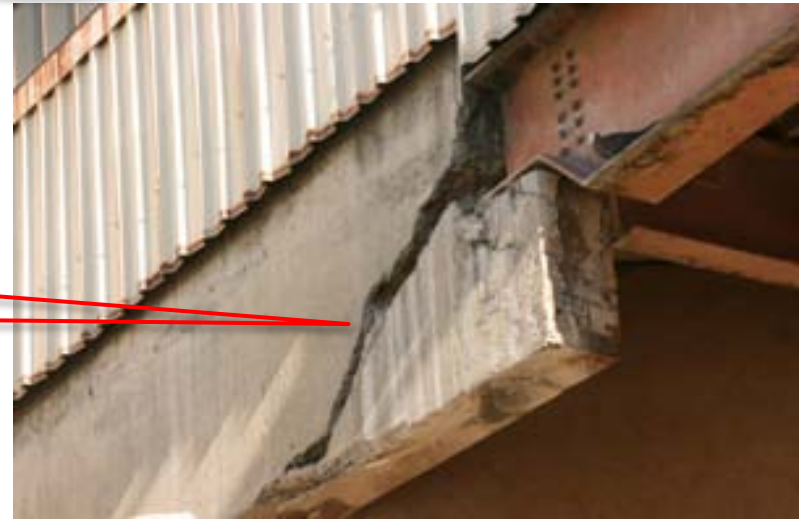
Large crack in cantilever beam supporting the floor

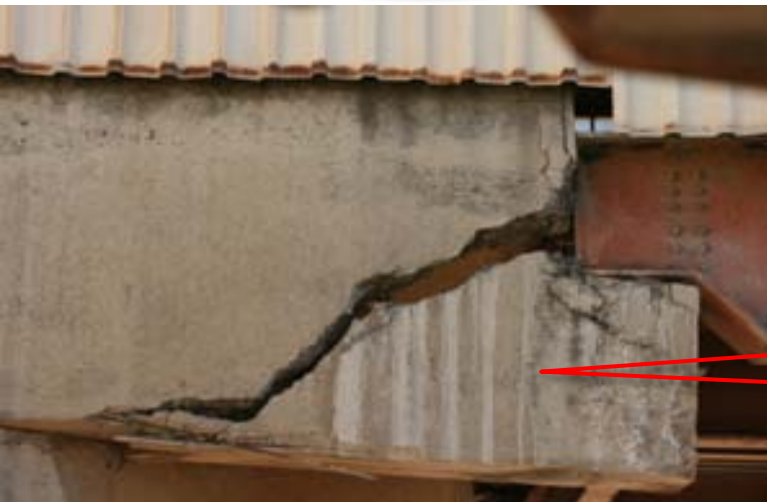
The steel floor girder has slipped down approx. 160mm
