**KDC**

**K4 Sub Vertical Rock Winder  
Overwind occurred 17 Jan 2010**

Presented to AMRE Safety Seminar on 19 April 2011

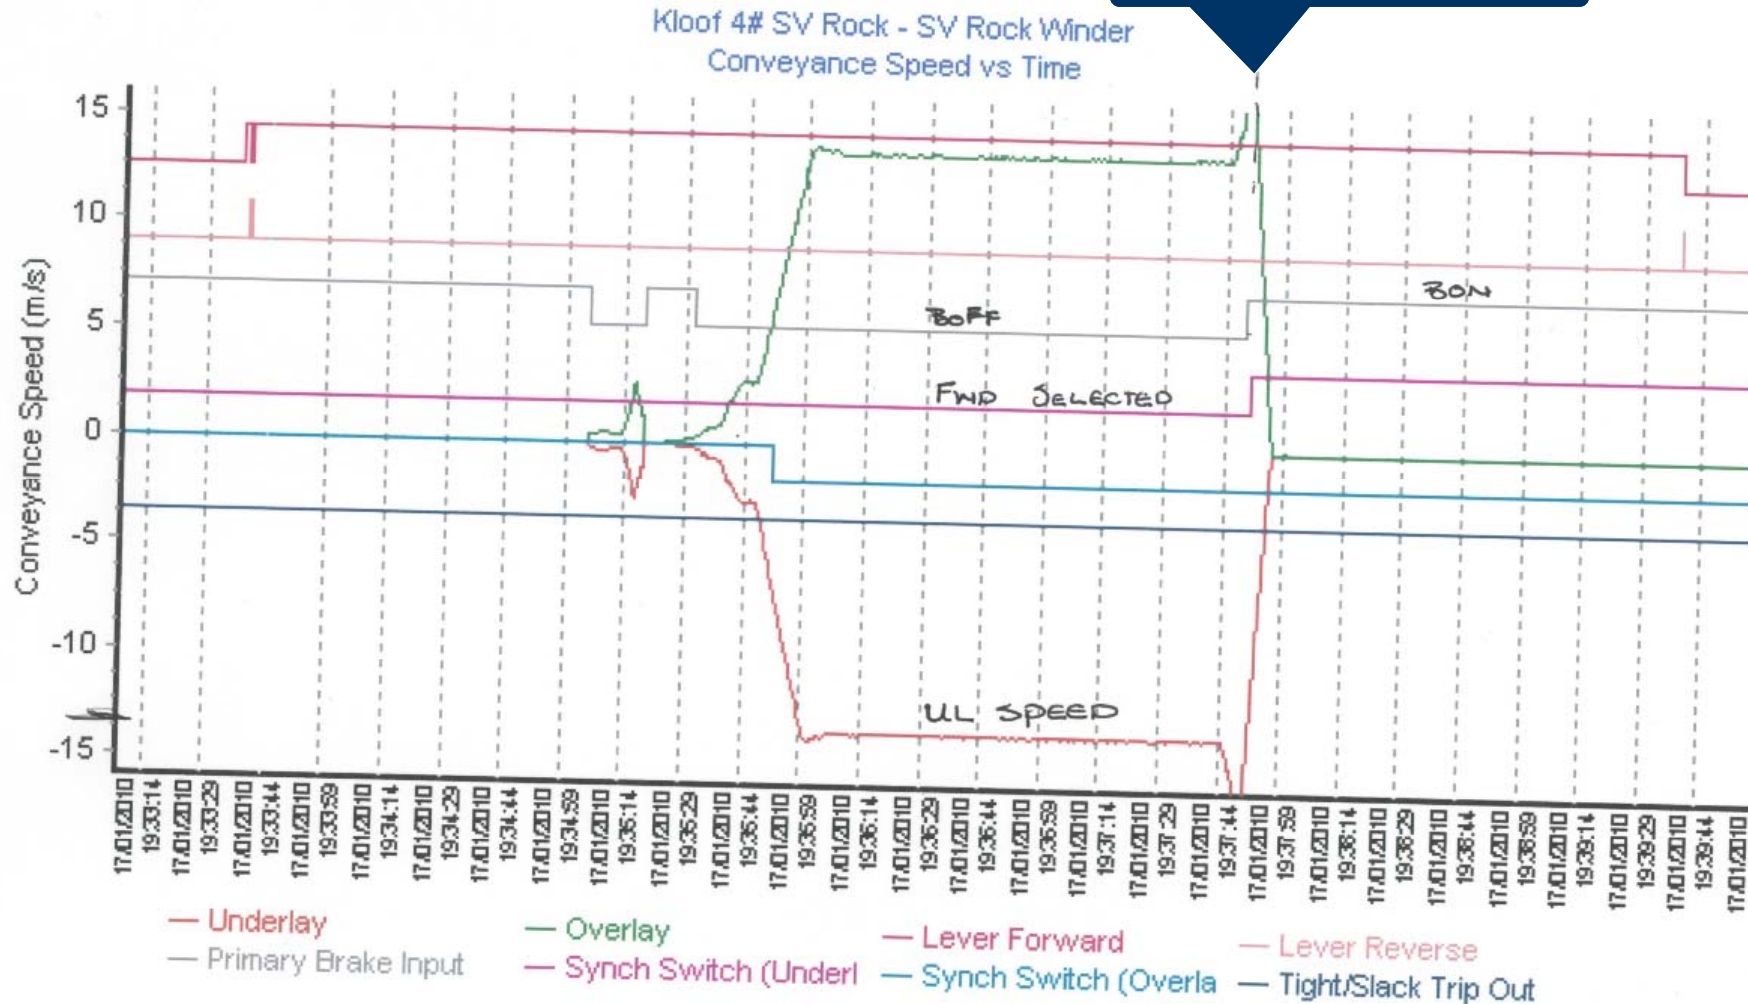
Ultimate overwind

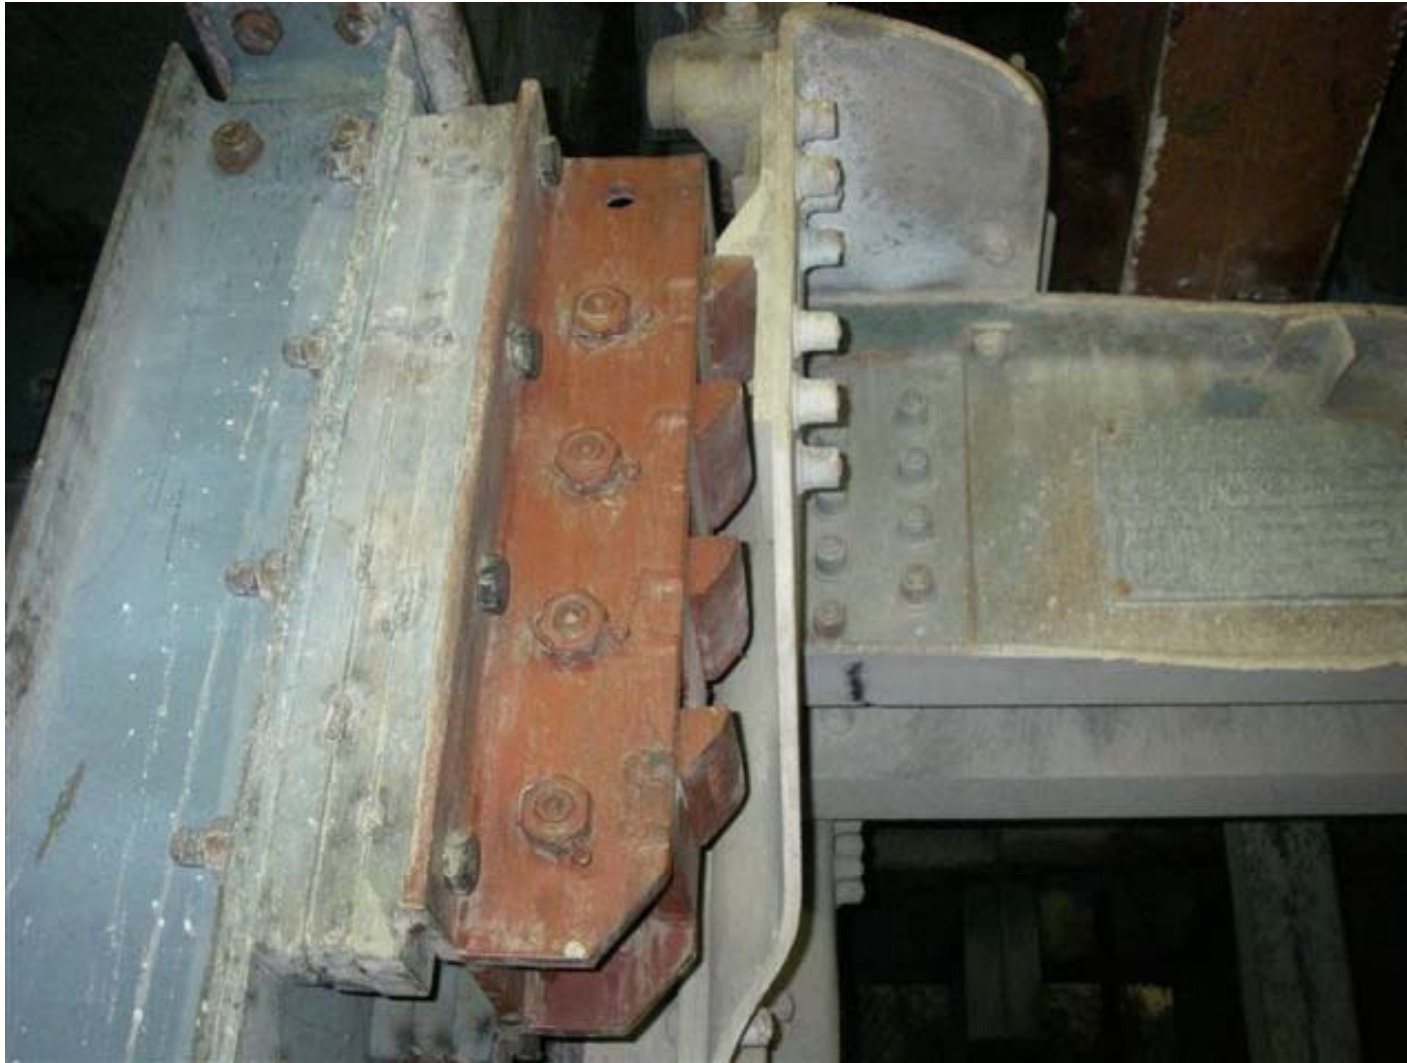
Bridle on top of jack catch

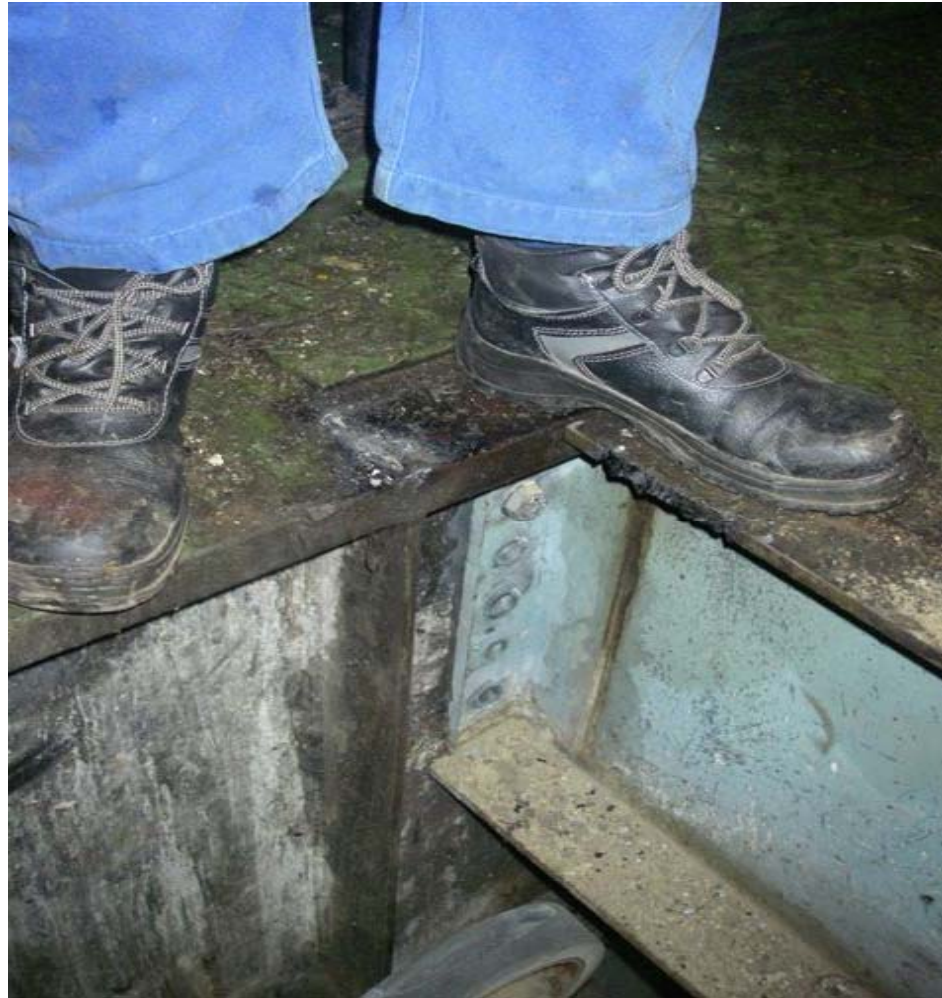
**Sheared bolts on support beam**

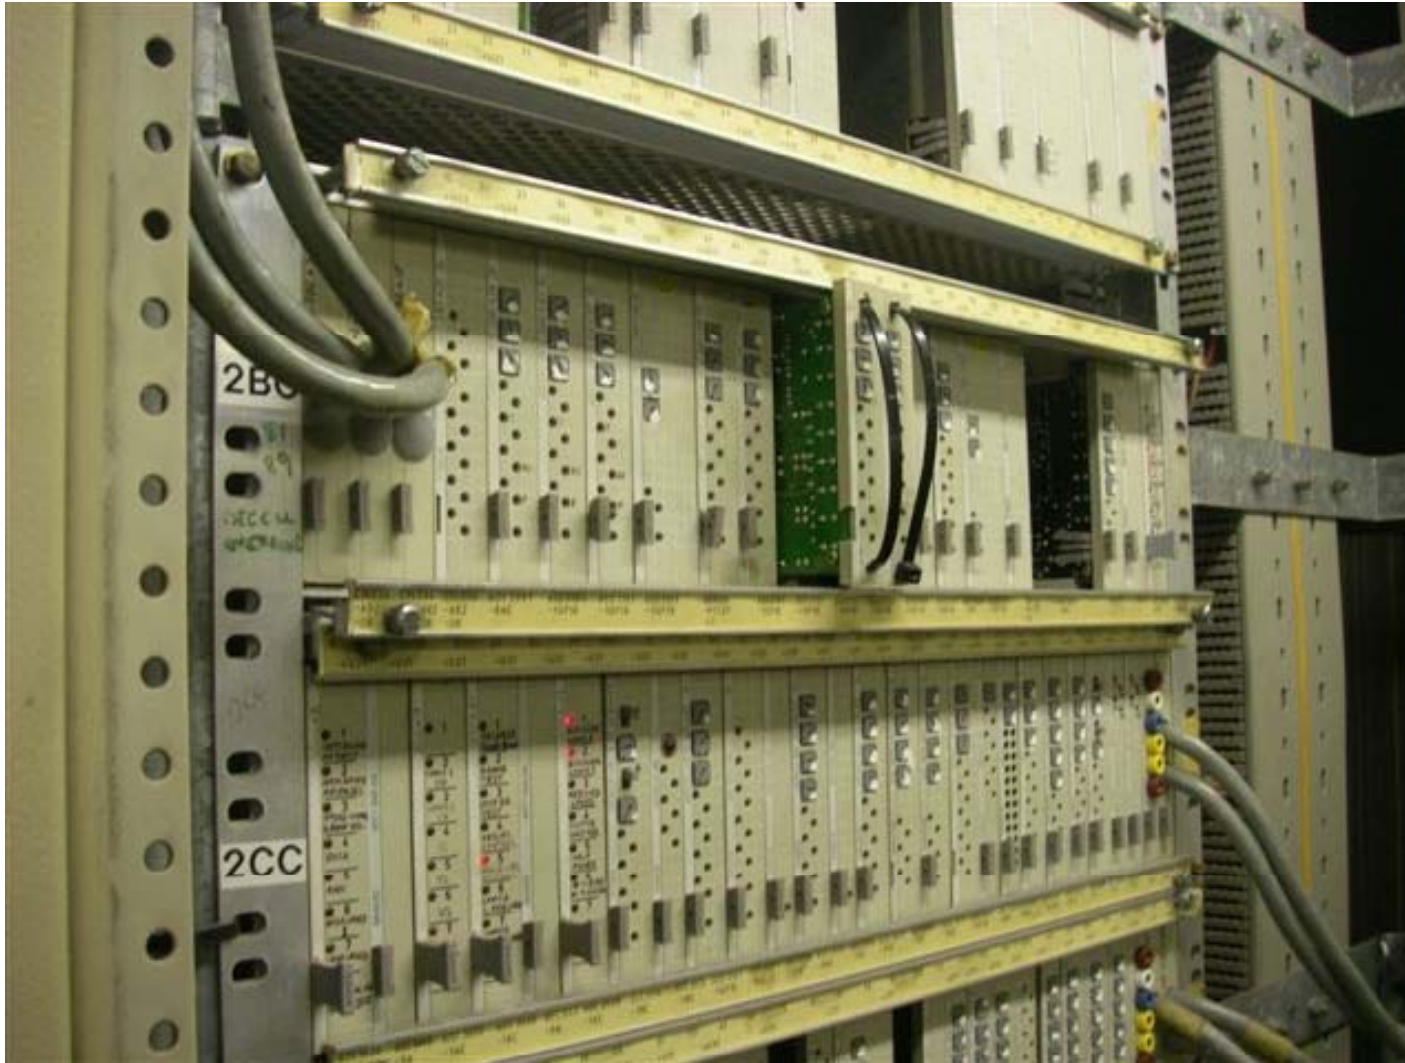
Deceleration cards removed

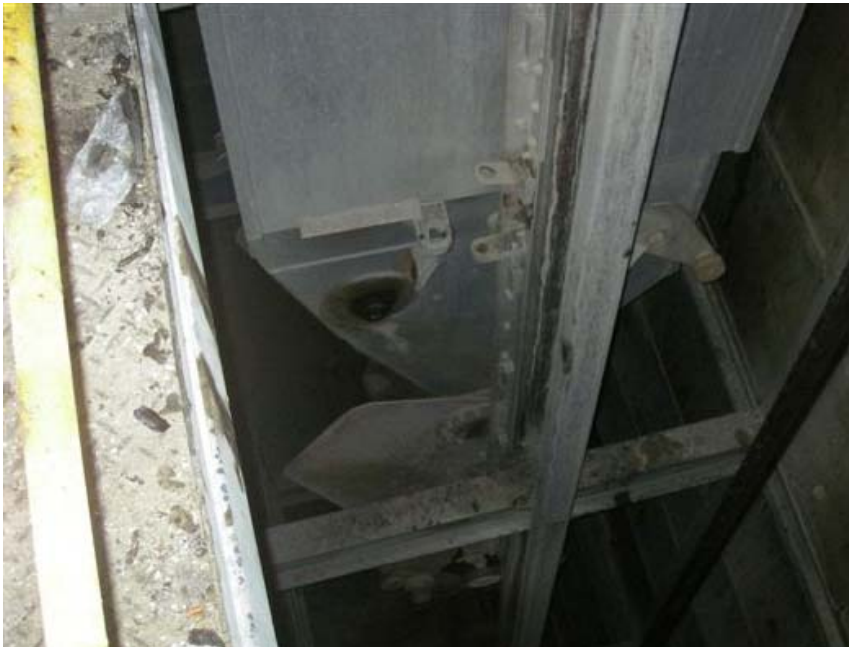
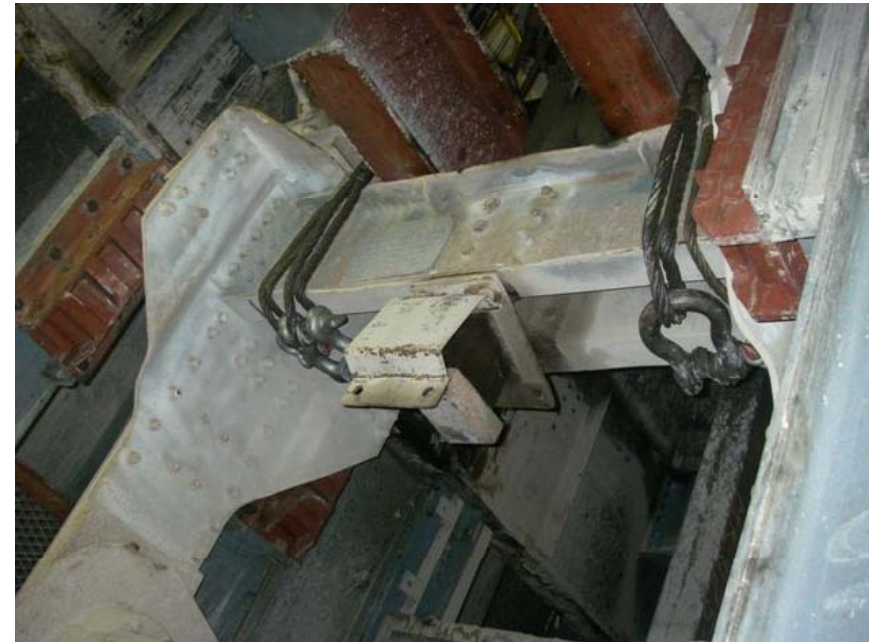
**SKIP IN HEADGEAR SECURING AND DAMAGES**

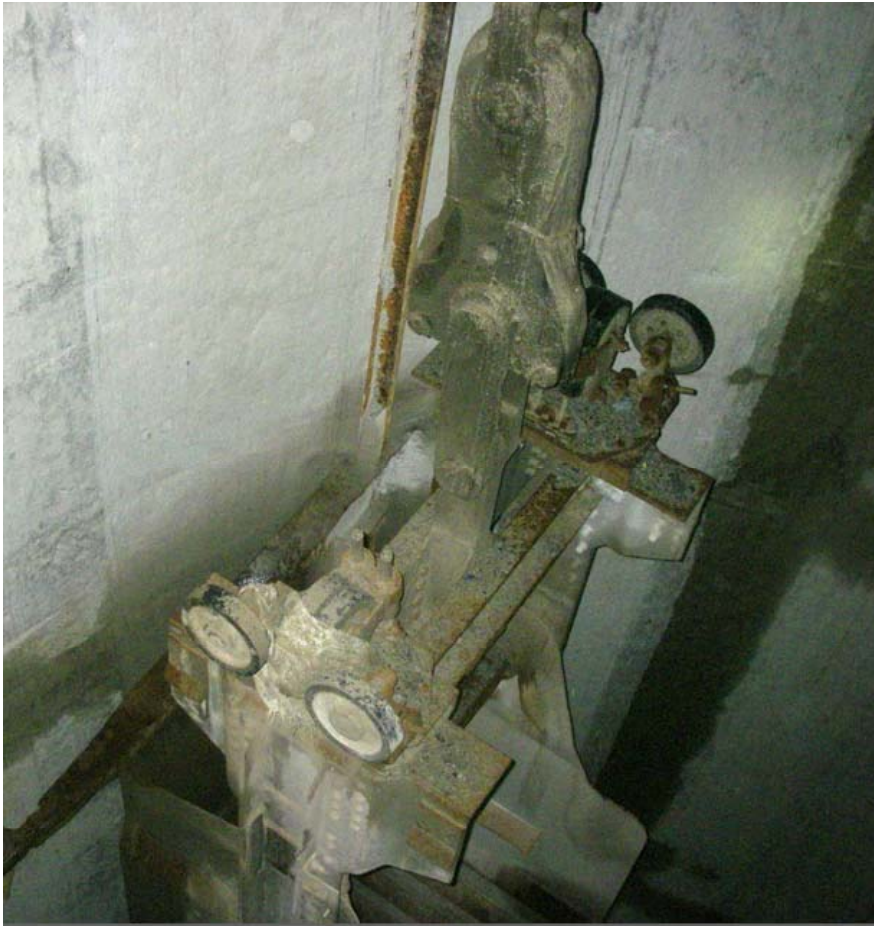
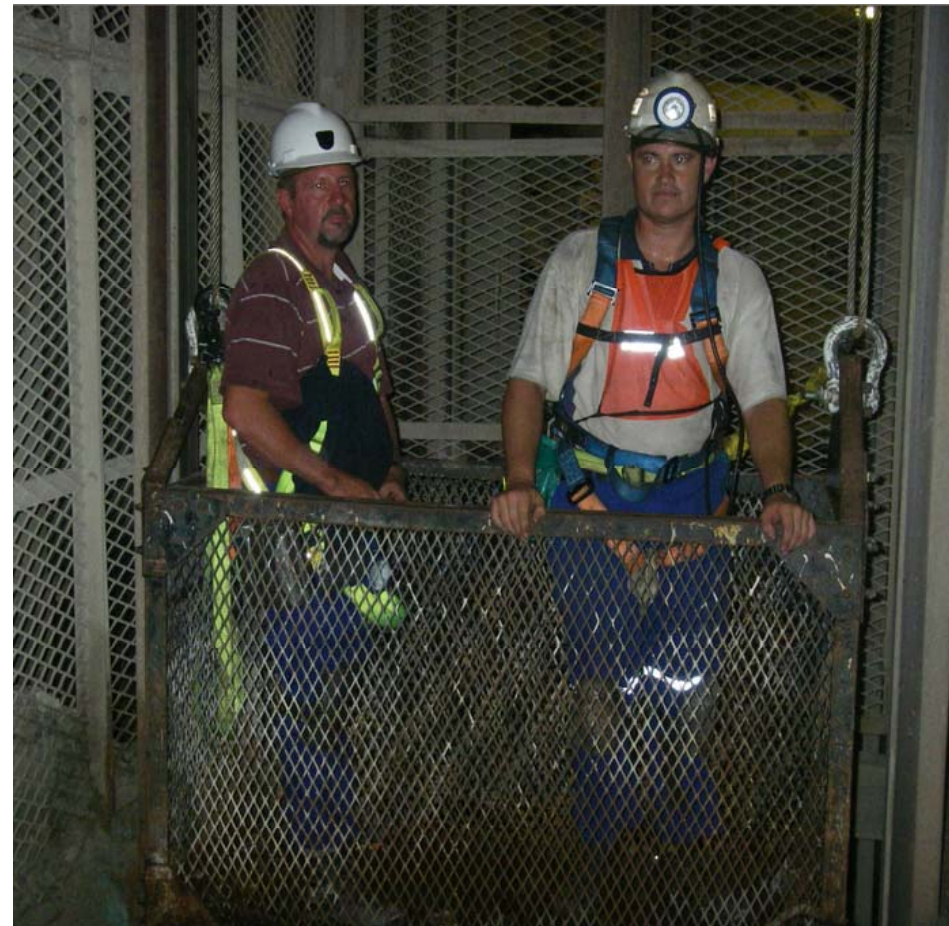
SKIP IN BOTTOM AND INSPECTION OF SKIP
