No 16 Shaft Project

Stage Rope Incident
19 April 2011

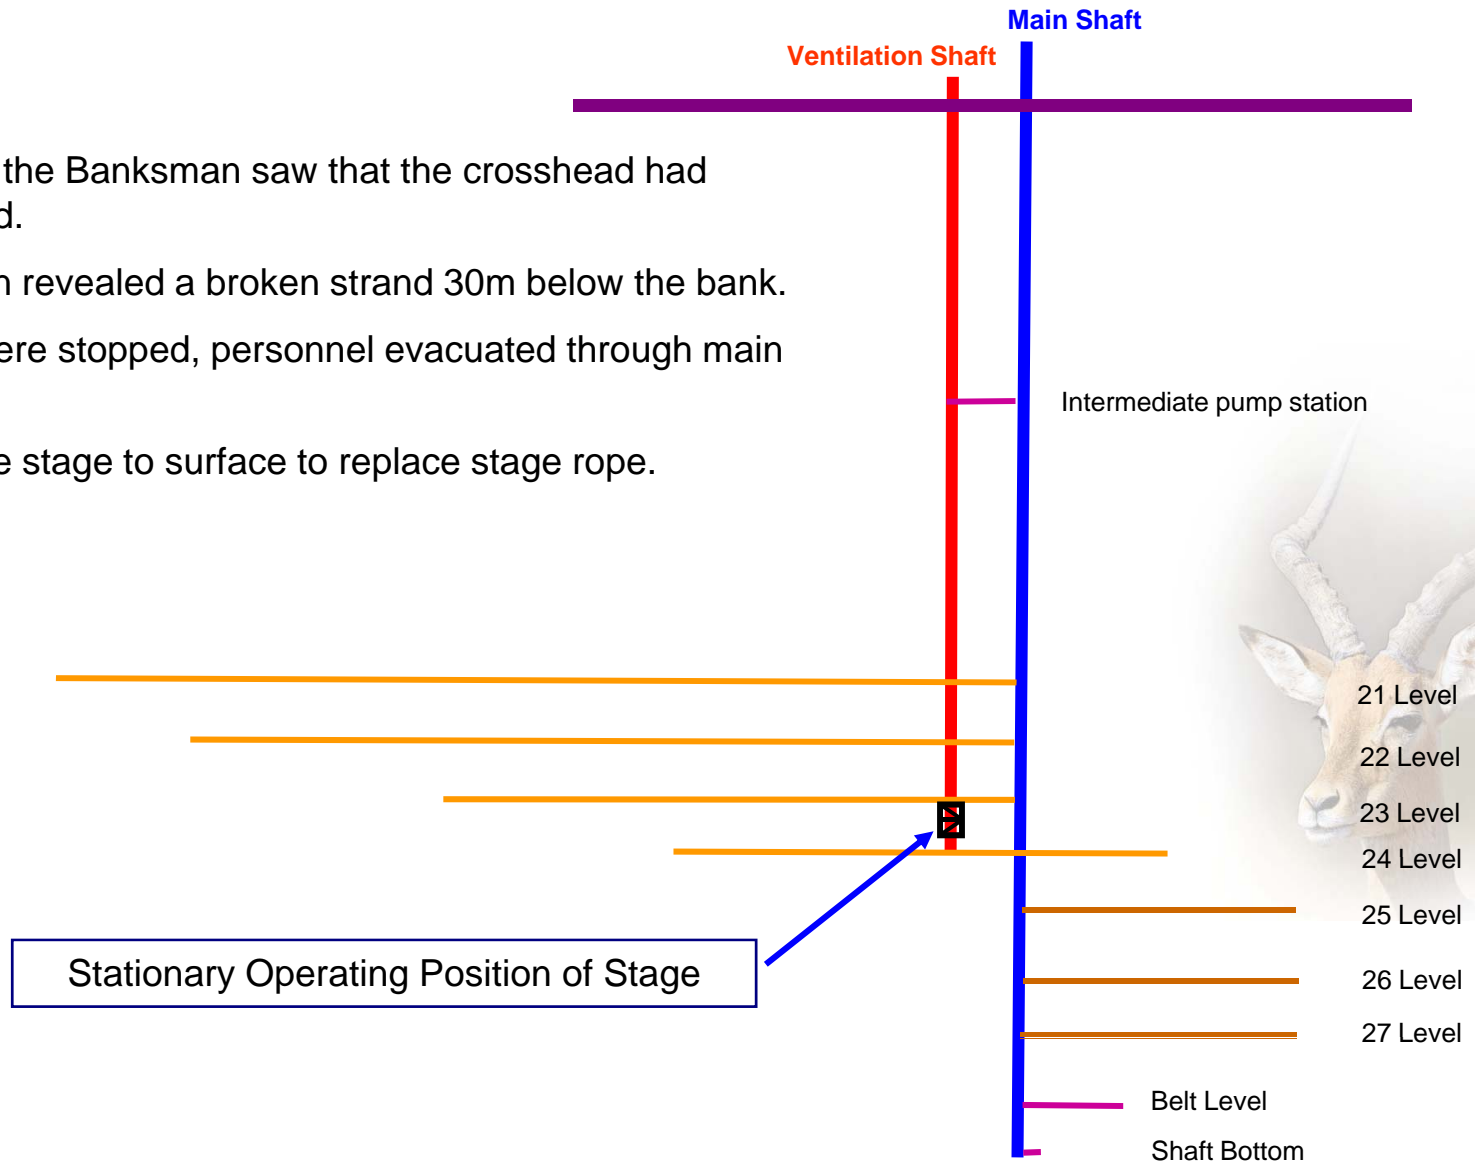
- On 19 February the Banksman saw that the crosshead had picked up a strand.
- Visual inspection revealed a broken strand 30m below the bank.
- All operations were stopped, personnel evacuated through main shaft.
- Decided to move stage to surface to replace stage rope.

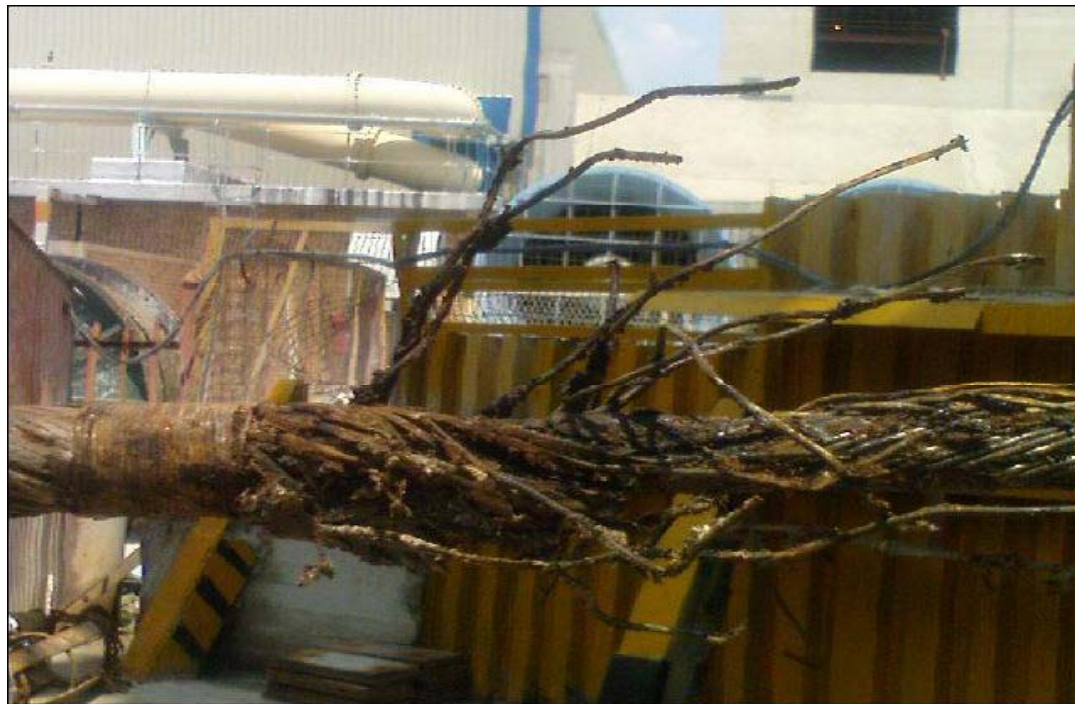
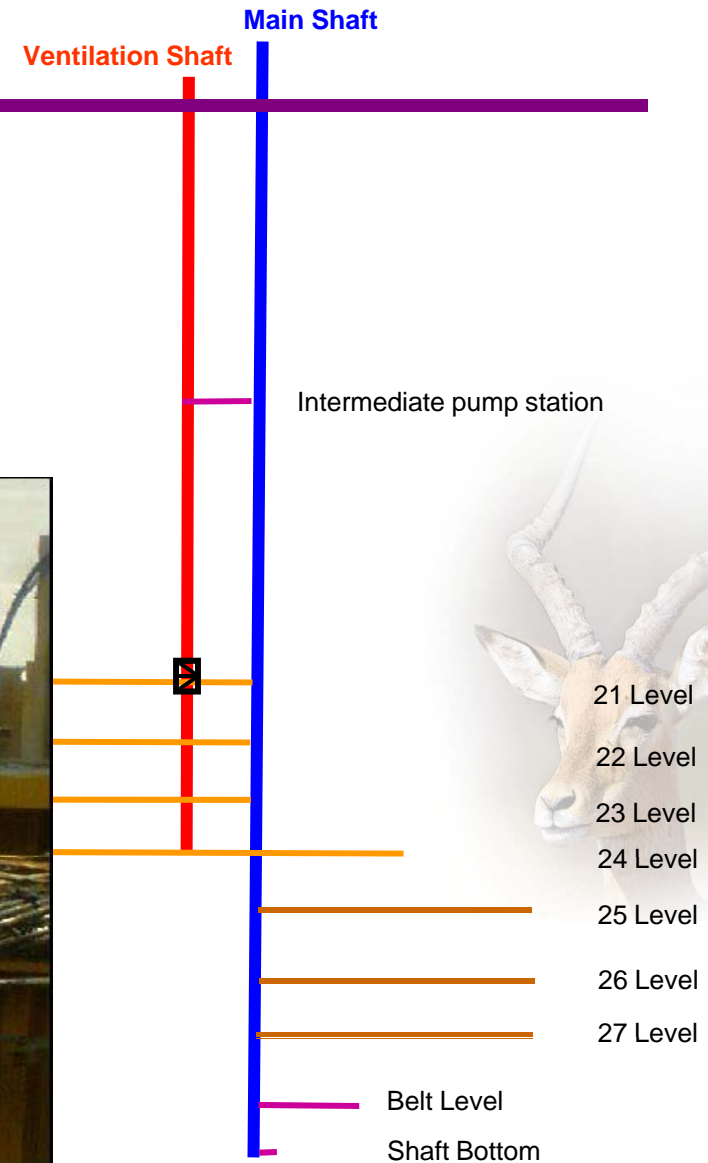
- Engineer instructed the Rigger to visually inspect damaged section of stage rope at frequent intervals.
- Further deterioration of the rope necessitated stage to be secured on 21 level

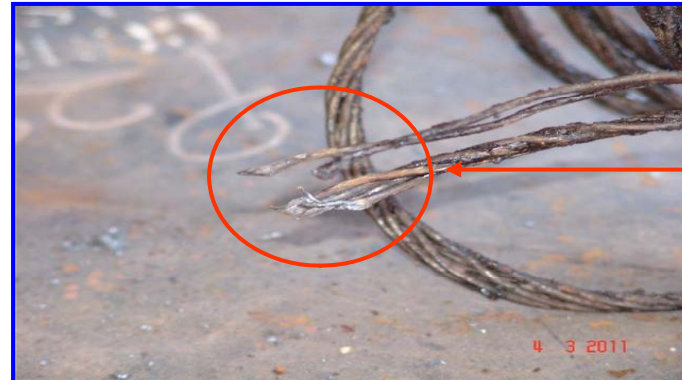
Blue discoloration indicative of heat transfer

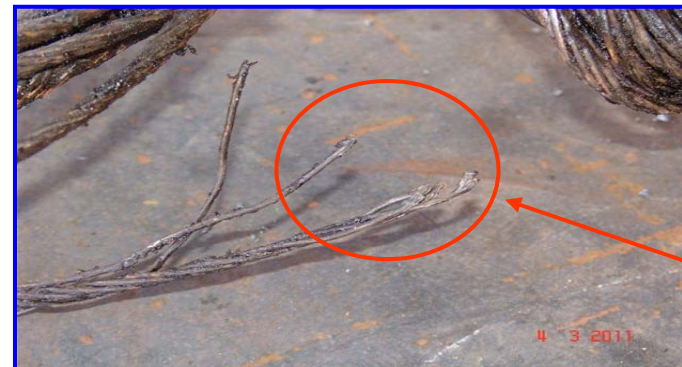
Localized material loss indicative of severe mechanical wear

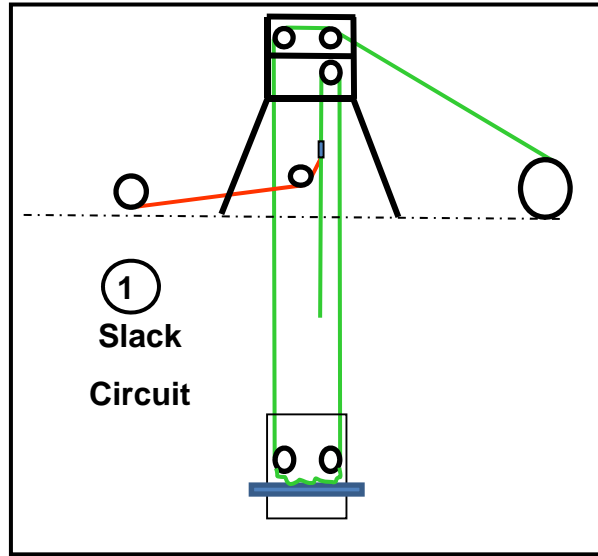
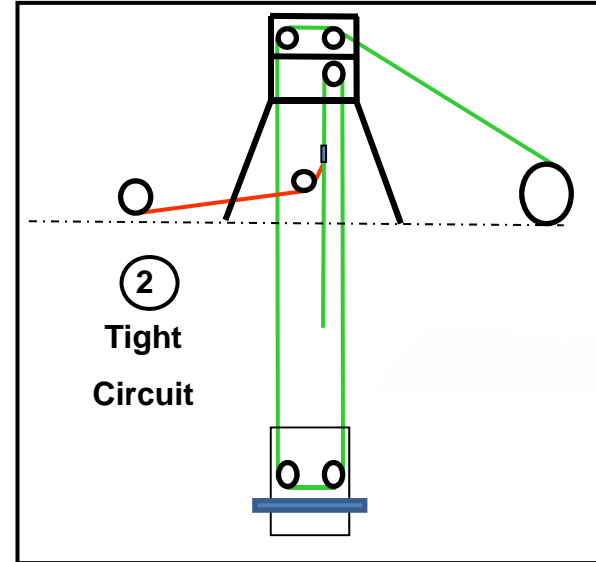
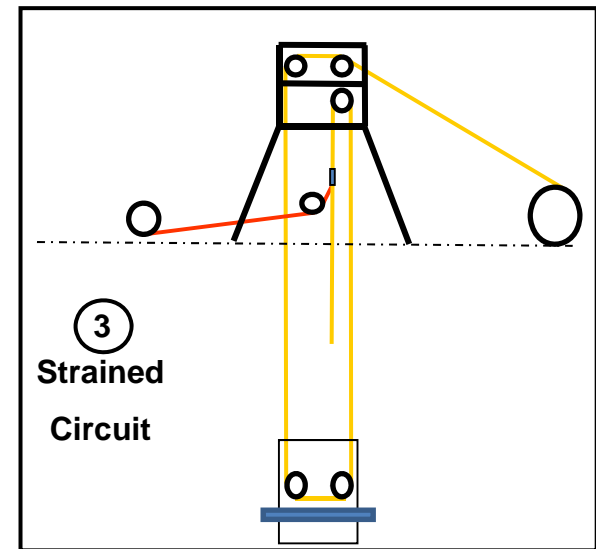
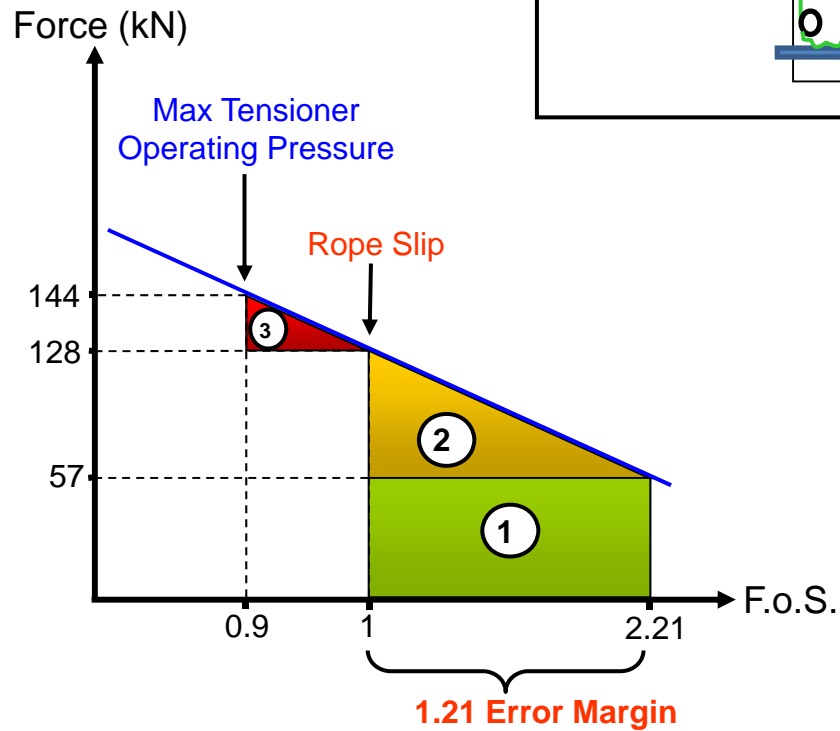
ROPE SLIP SCENARIOS

- **Using four Crosby clips left no margin for error – F.o.S. of 1.21 is negligible**
 - **Fluctuation between the slack, tight and strained circuit was inherent to the rope-up method used.**
- **Incident might have been caused by:**
 - **Crosby clips not tightened properly.**
 - **Not enough slack was paid out, system changed from tight to strained from the onset.**
- **The eight clamps specified by the procedure would have been sufficient for slack, tight and strained system, even if they were only hand tightened.**
