Mponeng Mine Vertical Transport

Pipe bogey foul shaft steelwork
during slinging operation

Werner Grobbelaar
Vertical Transport Manager

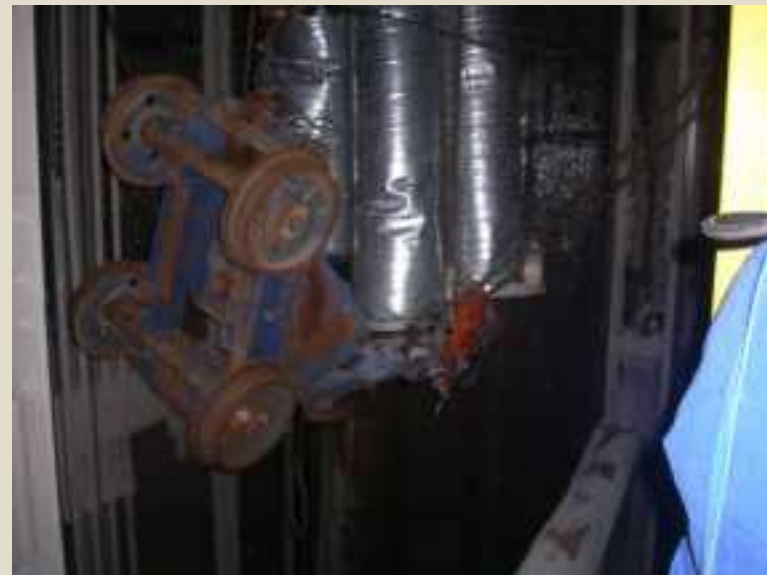
During normal slinging operations on the Main shaft East Man Winder on Tuesday 7 March 2006 at approximately 11:00 am a bogey carrying four 250mm chilled water pipes became lodged on the shaft steelworks between the underlay and overlay compartments. During an insito investigation following the incident it was observed that the overlay conveyance was sitting on top of the fouled bogey and that an amount of winder rope had coiled on top of the conveyance forming a cork screw. It was further observed that at least one of the chilled water pipes was hanging outside the bogey.

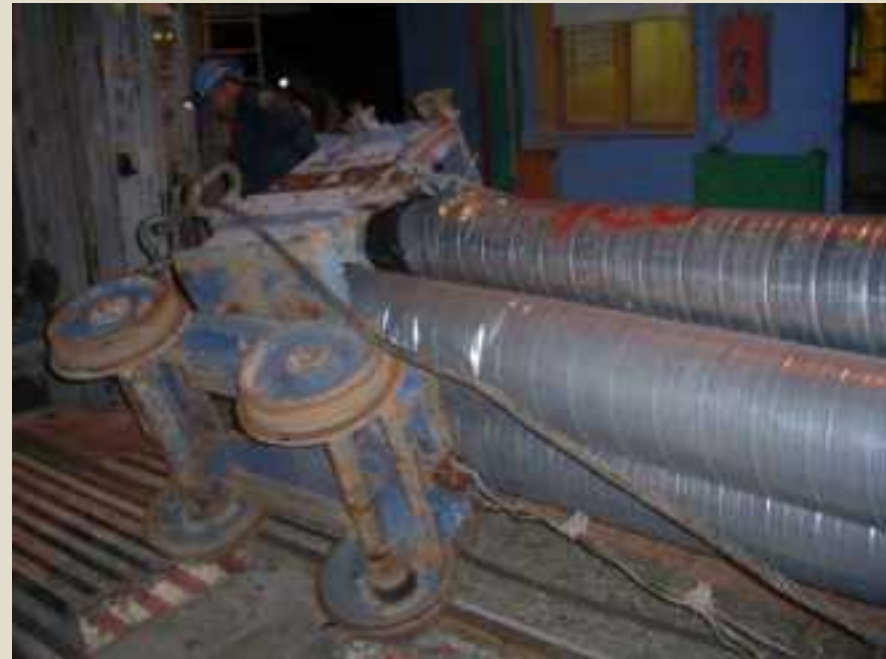
- The bogey was raised to surface using the kinked rope
- 9 hours after the incident the bogey was recovered on surface
- The kinked rope was cut, a new front end made and the kinked portion was sent for destructive testing

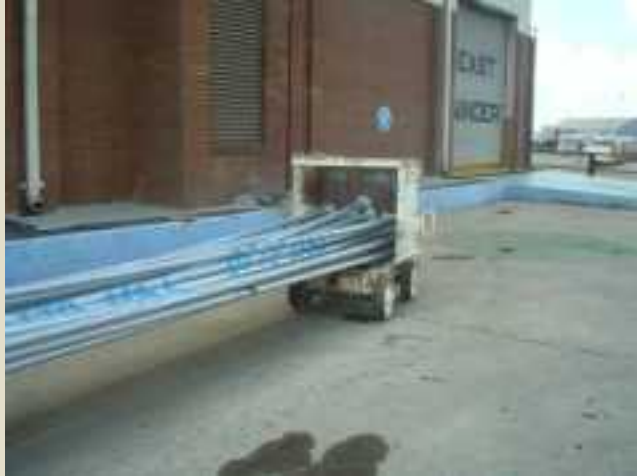
Wrong bogey used

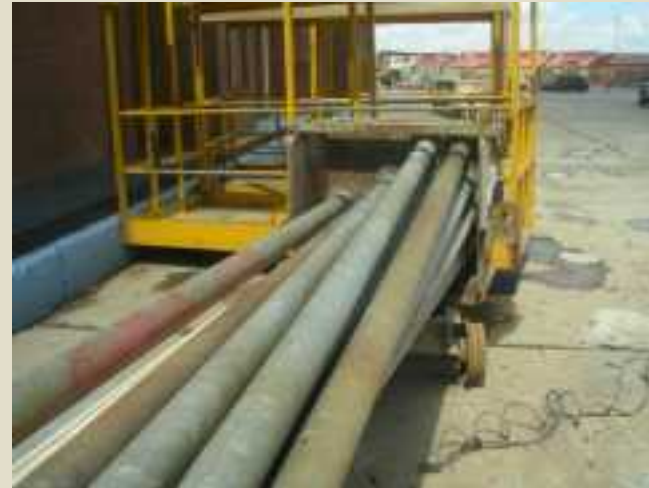
Loaded off centre

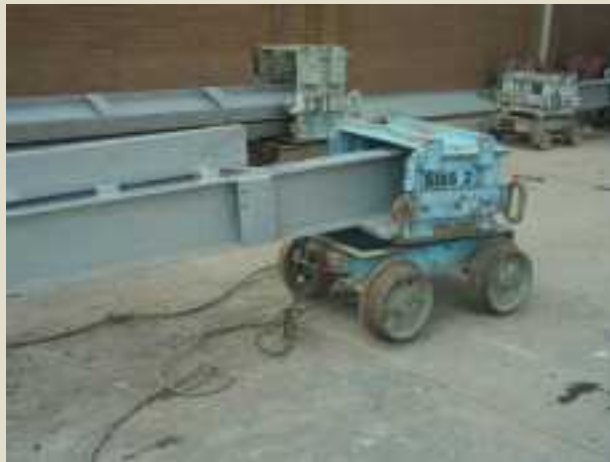
Transport sling too long

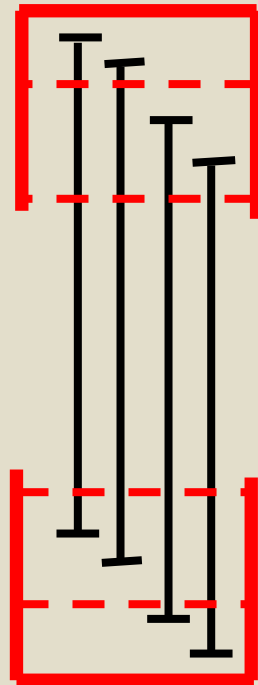
Unsymmetrically loaded bogey

- The bogey will hang skew in the shaft
- Pipes can come off the bogey
- Need to use a shackle to compensate for skewness

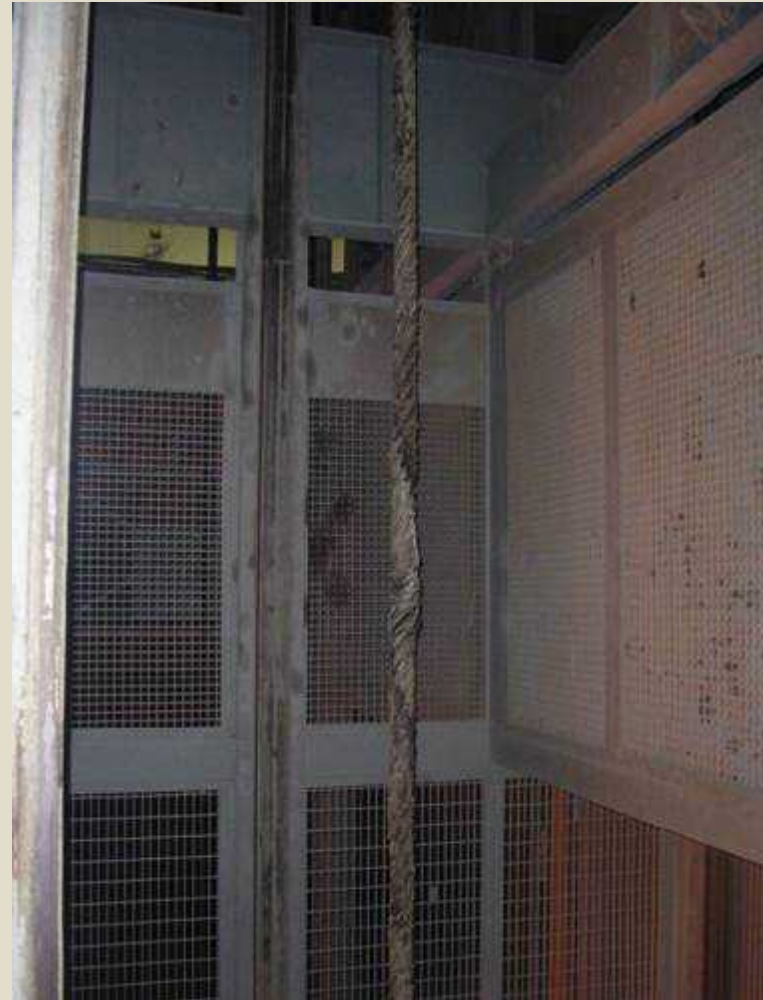
- The value of electronic slack rope device.
- With proper assessment and under controlled conditions, a kinked rope can be used to lift the conveyance.

Minimum Breaking Force = 2943 kN

Test results (kinked rope) = 2629 kN
