3 Shaft - Slack Rope Incident 12 July 2006

Beatrix Gold Mine - North Section
Man Winder Slack Rope

Presentation by: Clinton Richardson

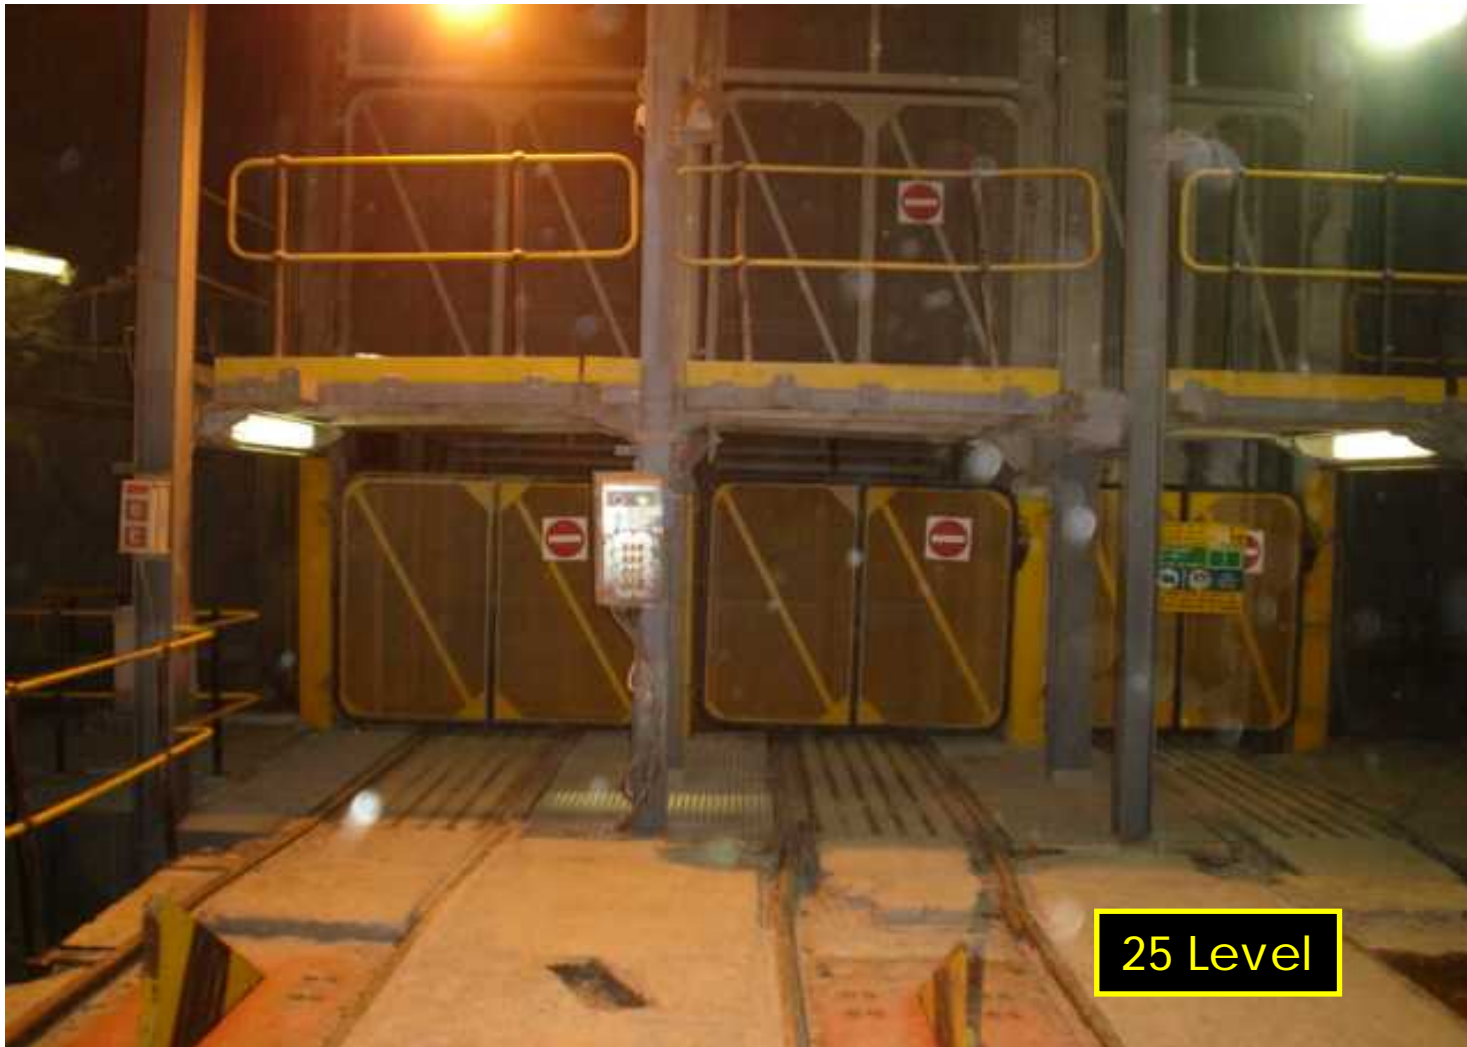
25 Level Station

- The conveyance in the mean time was stuck on 25 Level held up with the pipe sprag causing the winder rope to be paid out on top of the conveyance.
 - Subsequent to this, a box controller who was on 25 level came past the station and noticed the slack rope. He phoned the driver, and notified him about the condition and also informed the people in the cage . People in the cage were evacuated

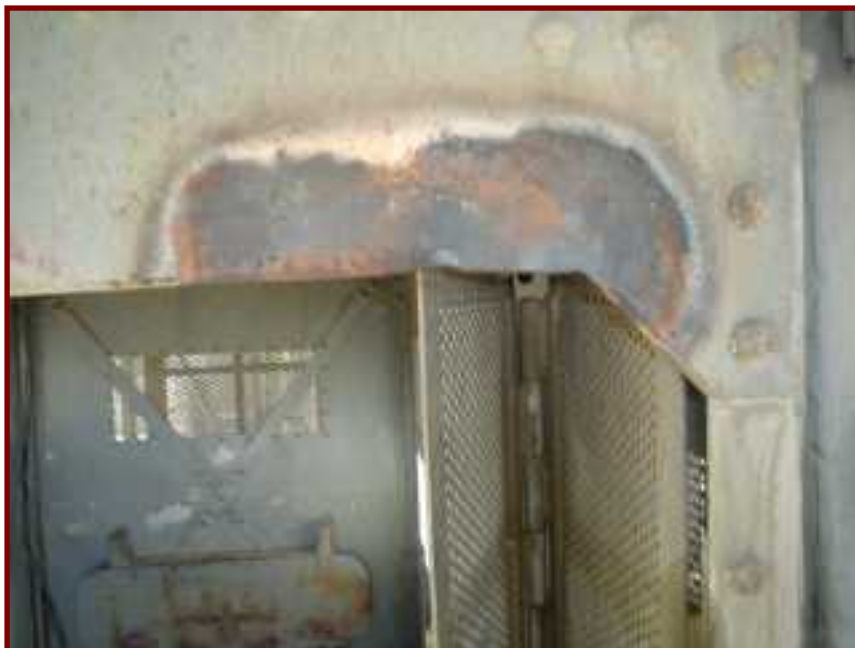
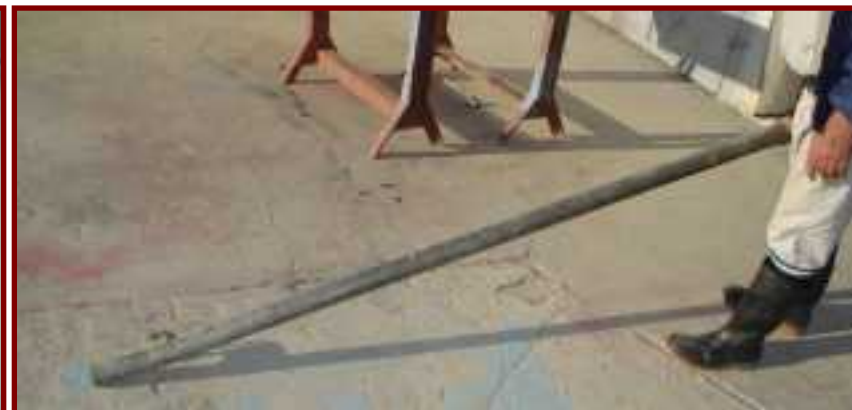
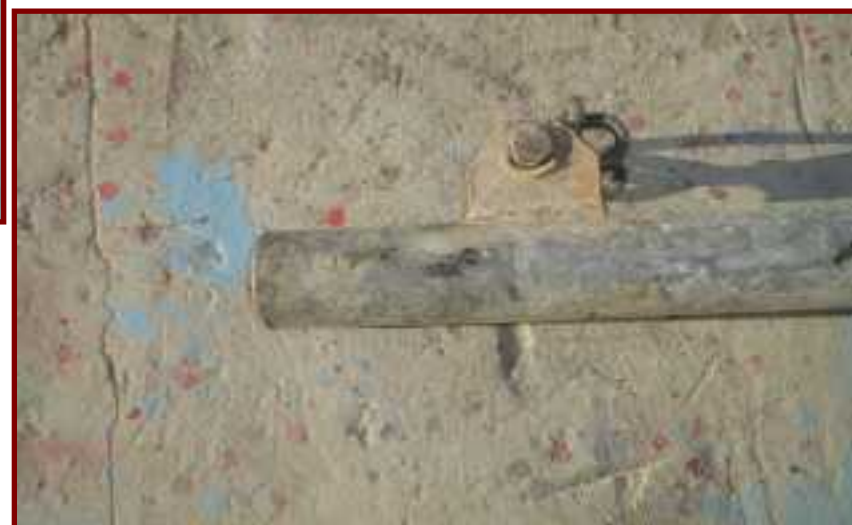
Photographs

Findings	Recommendations
<ul style="list-style-type: none"> • The pipe sprag, with its chain attached to it, can be removed and placed on the station outside the cage. • Pipe sprag visibility. • Slack/Tight Rope detection system inadequate. • Cage design • Station design • Emergency procedures when slack rope alarm is activated • Camera system 	<ul style="list-style-type: none"> • Shaft personnel have been instructed to ensure that the pipe sprag is inserted correctly when transporting cars and that it is placed in its storage position before any winder movement. • Paint sprag to be more visible. • Current system design doesn't cater for all types of slack and tight rope conditions. • Artisan at the winder 24 hour to reset of the slack rope system. (Eliminate nuisance trips – Immediate Remedial Action) • Check list was implemented for reset procedure. • Design for doors, locks and sprags for cages. • Illumination on stations to be sufficient • Limit the gap to 20 mm between station floor and shaft gate • All winders must be stopped for slack rope alarms. • Provide all busy levels with a camera system to monitor operations.
