DRIEFONTEIN GOLD MINE

Safety Seminar

Pillar Steelwork – Ground Movement

YaRona Shaft (4#)

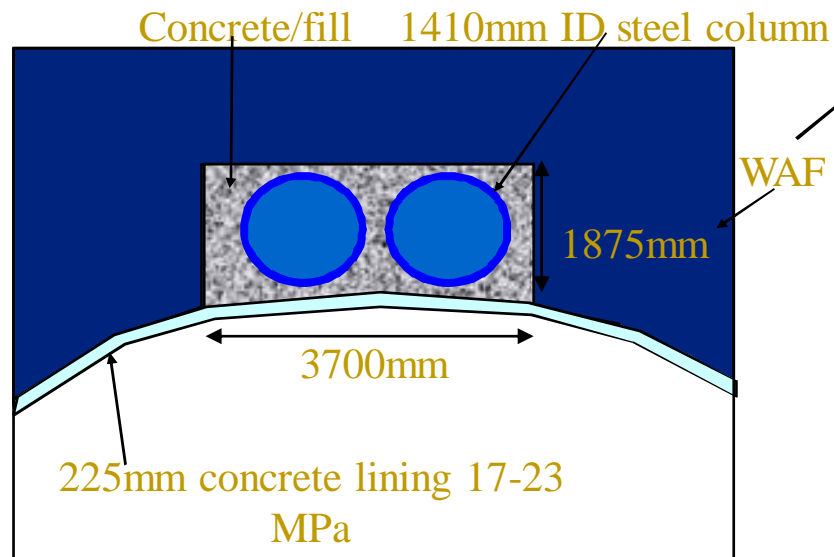
Background of the Pillar (chase)

Highest probability of failure lies in the hangingwall of the reef up to 18m from top reef contact on the chase side of the barrel

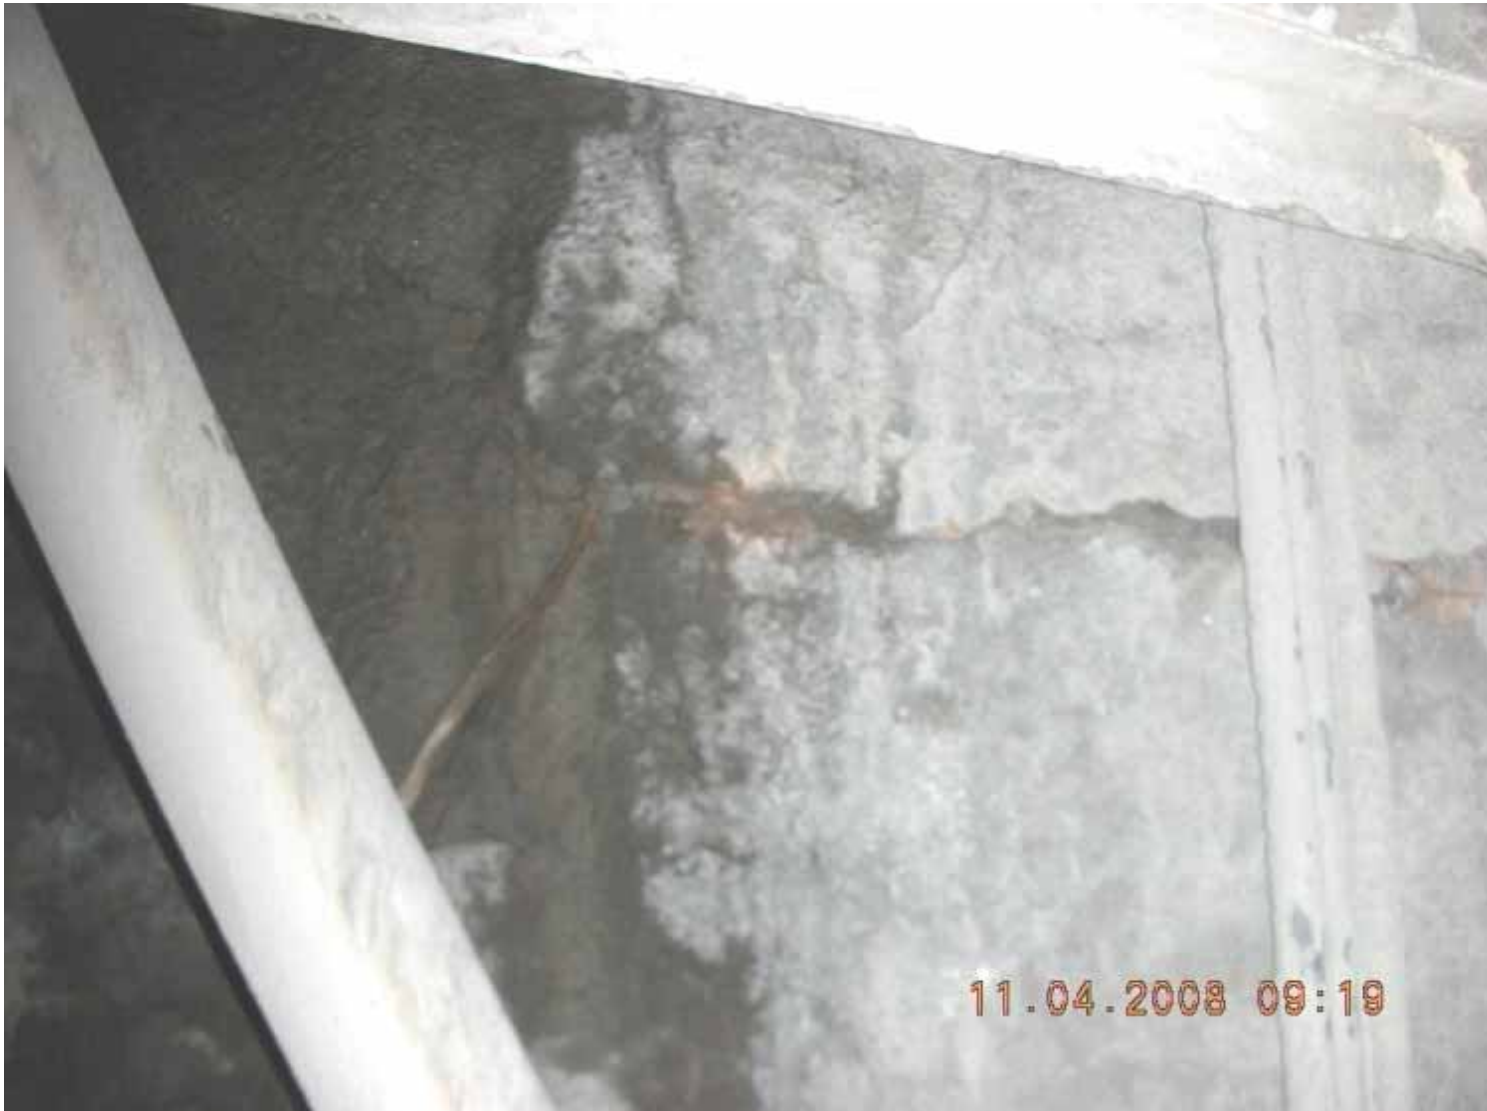
Description of the Incident and findings

- ❑ Incident reported on the sub shaft the 11 April 2008
- ❑ With shaft examination, found counter weight on the west side rubbing against the guides
- ❑ Morning shift was hoisted with the east side conveyance
- ❑ Investigation team went down afternoon shift and found guide gauge measurements between 901 and 910mm (Standard size 940)
- ❑ Found side wall pressure on the west side caused sidewall movement
- ❑ Found pipe dividers still in tact with the shaft barrel between 31 and 32 levels on the west side (Preventing tower from hanging free)
- ❑ Found spear guides on the west side closer to 32L compared to the east side

- ❑ Loosen guide brackets bolted onto cleat and jack guides to standard size of 940mm

- ❑ Move the spear guide on the west side closer to 31 level
- ❑ Took 4 guides out against the side wall below 32 level

- ❑ Pipe dividers between 31 and 32 levels was removed
- ❑ Plumb wires were installed between 31 and 34 levels measuring between the steel work and side wall
