Accident at 38 Level Waste Tip

J.L. de Beer

Main Shaft

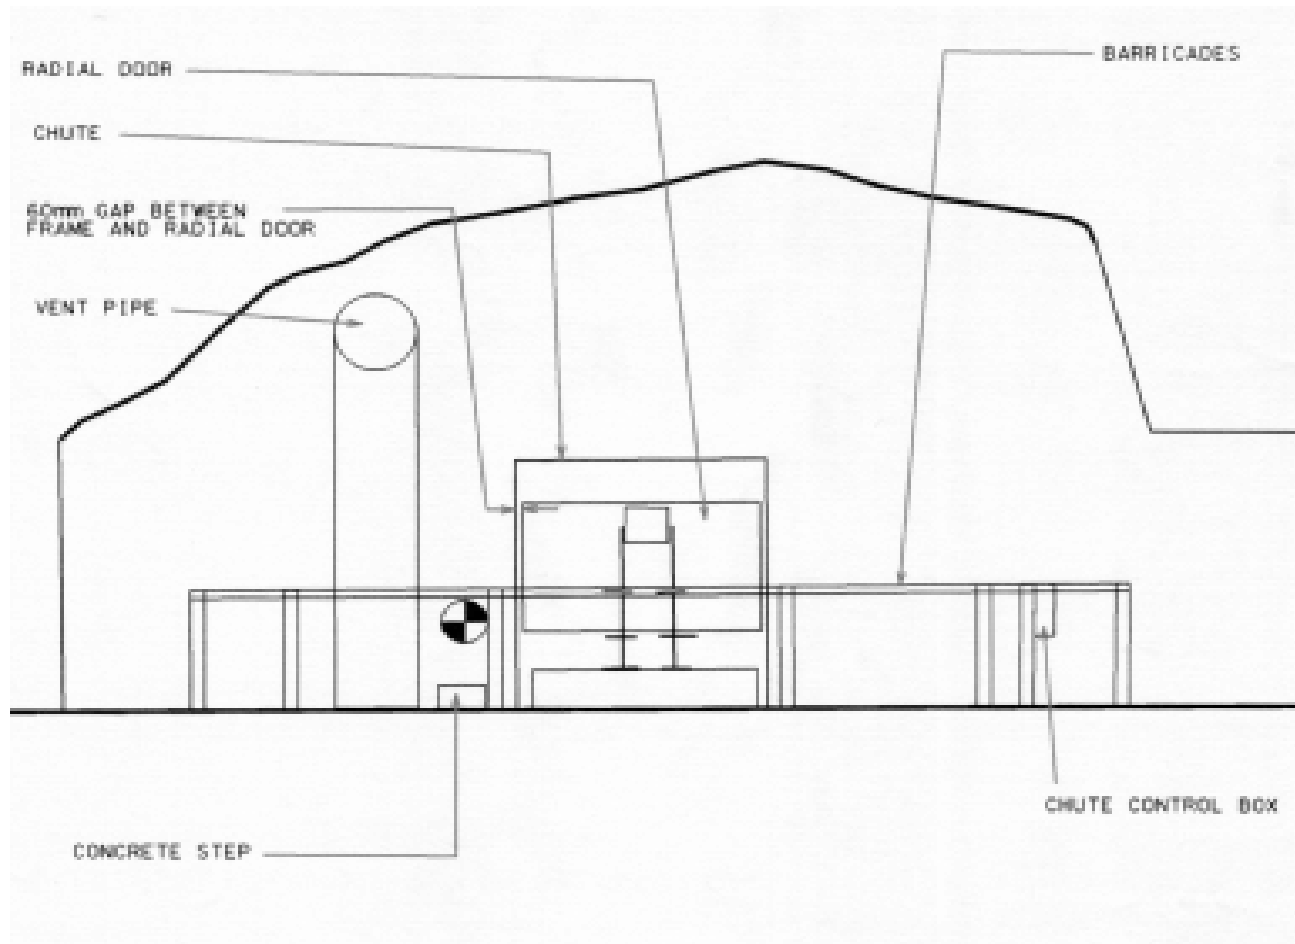
Section

- The now deceased said he was going to have a look why the rock has stopped running.
- At the same time it is alleged the Shaft Timber man proceeded to the controls and closed the door.
- It is also alleged that the now deceased went to the chute and it is assumed he looked up into the ore pass by positioning himself between the waste pass chute and the radial door, which was then closed, fatally injuring him.

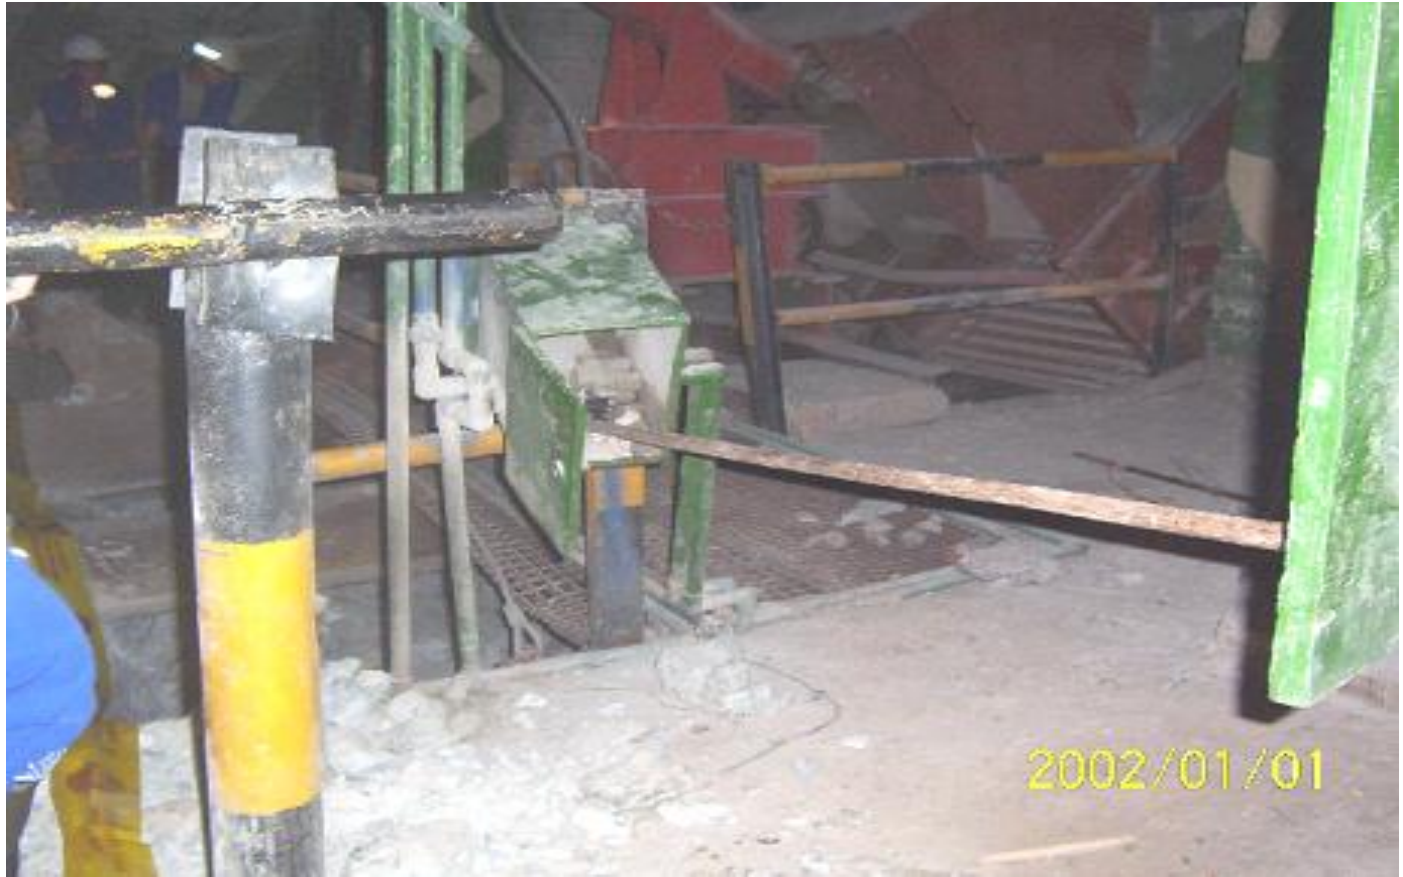
Photo of defective control

- The Shaft Timber man failed to identify dangerous conditions and apply the 5 Steps to safety or the “Stop, Fix and Continue Working” safety program.
- The Shaft Timber man failed to ensure the area was clear of persons and safe before closing the radial door.
- The Radial door control valve was defective.
- The accident side of the chute could not be seen when the radial door was in the open position.
- Poor illumination in the area.

<u>ACTION</u>	<u>COMPLETION DATE</u>	<u>RESPONSIBLE PERSON</u>
The control valve was replaced	15/07/2004	Fitter
The illumination in the area was rectified.	15/07/2004	Electrician
Damaged grating on the walkway was replaced.	15/07/2004	Boilermaker
Monthly over inspections of the tip areas	Monthly	Foreman Fitter, Foreman Boilermaker, Shaft Foreman, Mine Overseer (3 Monthly)
Monthly inspections of all tipping arrangements as per Standard procedure	Monthly	Boilermaker

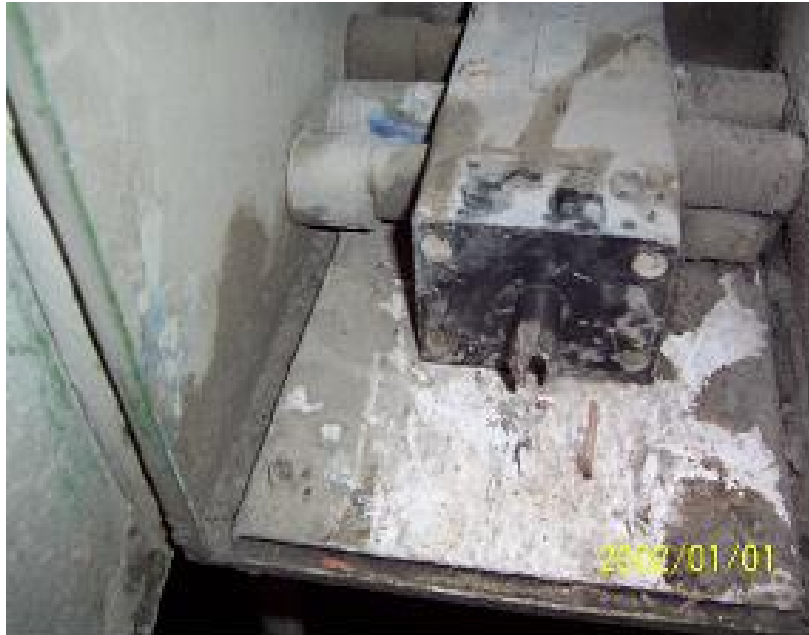
Defective control

- System failure in that substandard equipment i.e. broken controls were not reported to maintenance crews through correct channels. “Stop, Fix and continue” instructions and the 5 steps to safety were ignored.
- Poor inspections / supervision and planned maintenance of chute, radial door and controls.
- Legal requirement failure in that areas of responsibility were not clearly defined.

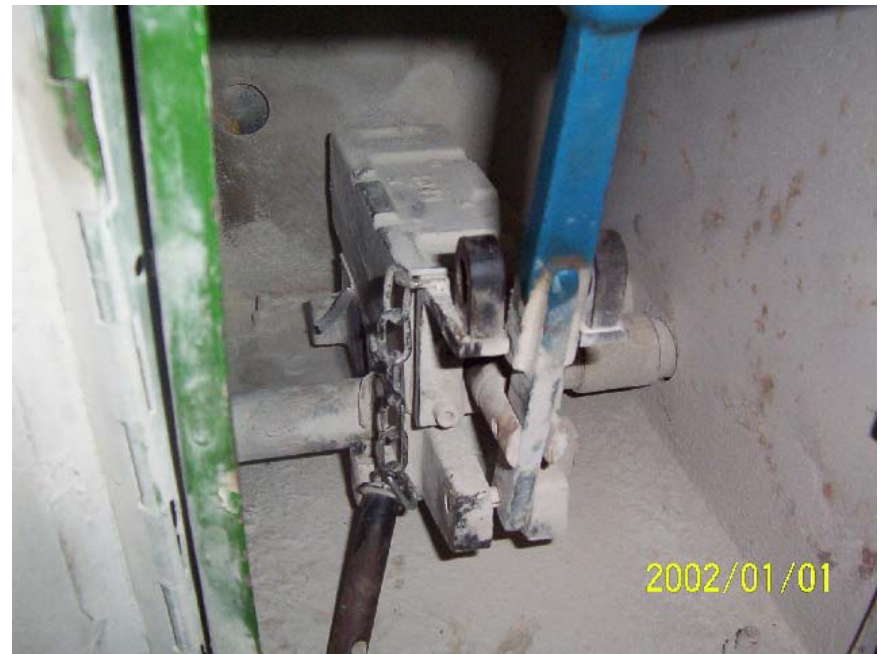
Correct control

4/2 way Norgren valve

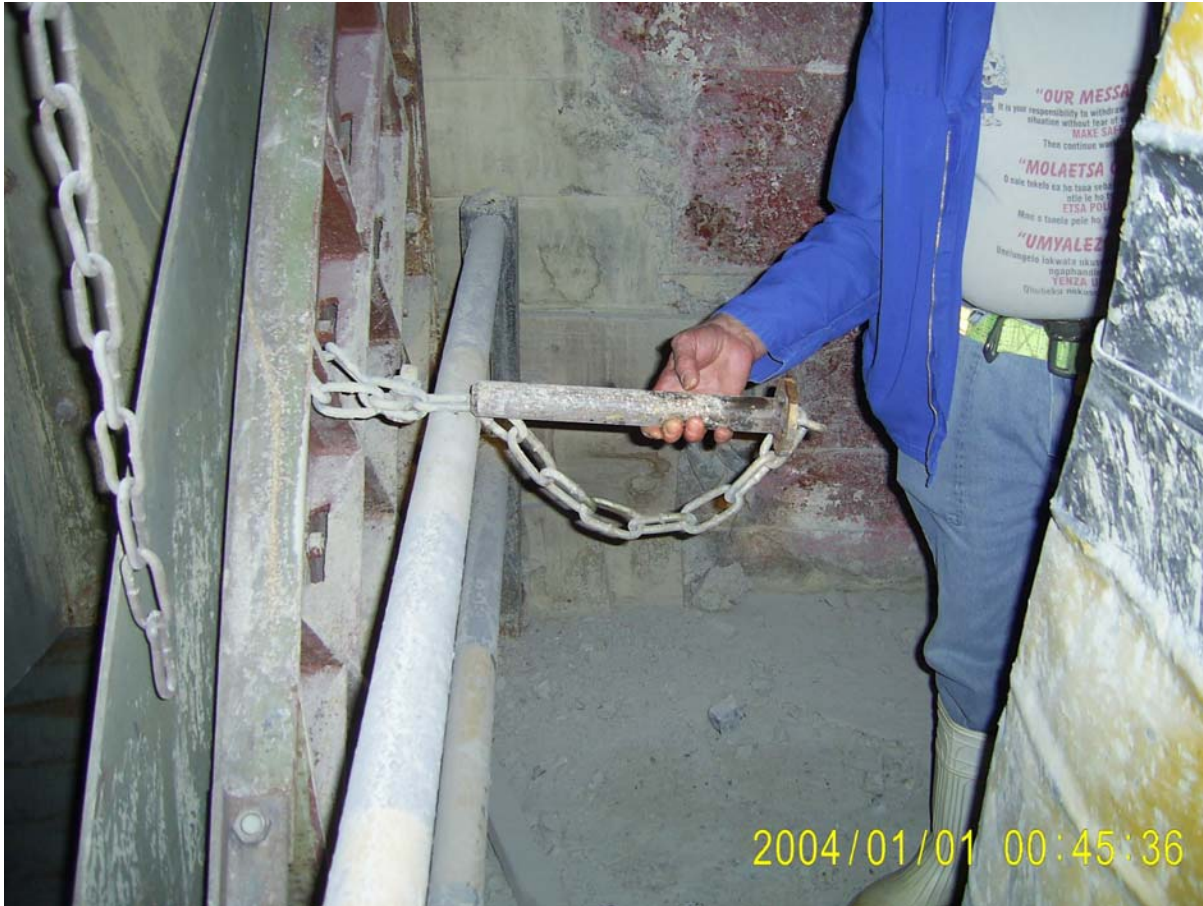
Photos of current chute installations

- Action plan currently in place namely:
 - Maintenance schedules enforced
 - Standard inspections enforced
 - Lockable chute control
 - Safety pin on radial door
 - Area of responsibilities signed off by supervisors
