Great Noligwa Mine Electrical Flash Accident

Mini Substation Details

Equipment N°:	M258
Switchgear:	Lucy (OCB)
Last overhaul:	1995
Manufacturer:	Steelcor
Installation date:	1996
Last serviced:	08-09-2004
Load:	Two mini-substation in parallel
Status:	Temporary installation, was due to be removed

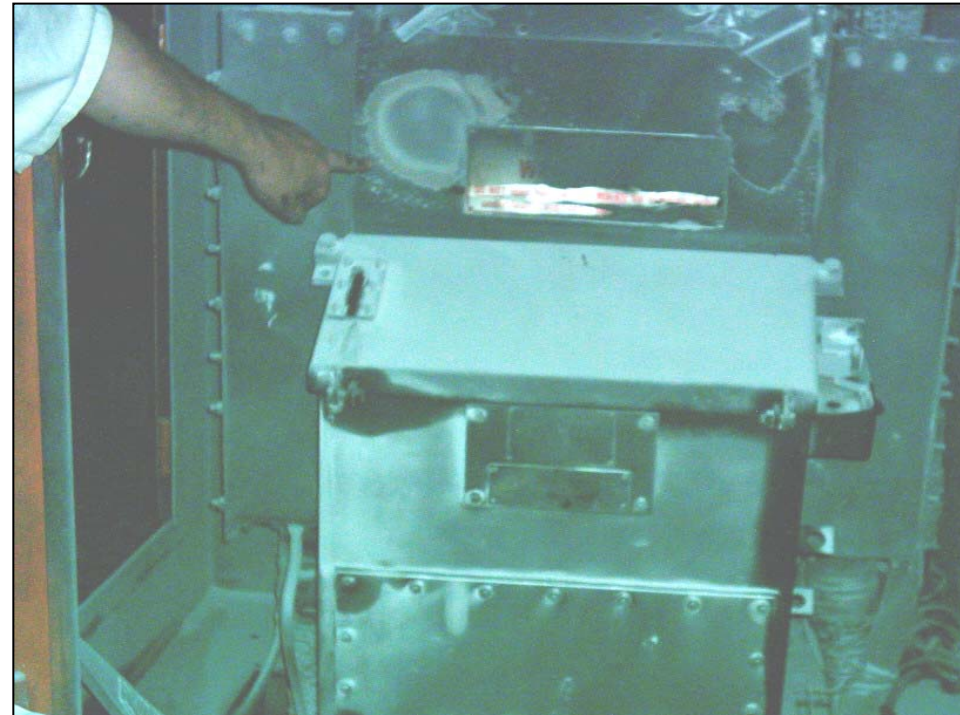
For the flash to take place the following conditions had to prevail:

- **There was not enough oil in the switchgear to quench the arc.**
- **The switching was done while the mini-substation was still on load. The mini-substation feeding the raise bore machine had no load, but the mini-substation feeding the SV3 area was still under load, as it was not switched off.**

- **Had all mini substation audited, to determine the amount and location of mini substation with similar oil circuit breakers. (19 identified)**
- **A schedule was setup to inspect these mini substation, and bring them up to standard over the Christmas period. Seven had been inspected over the Christmas break the other 12 was done on the Sundays of January 2005.**
- **A total of two mini-substation required its oil to be refilled to the recommended level, and one of the mini-substation needed to be replaced because it failed its load test.**

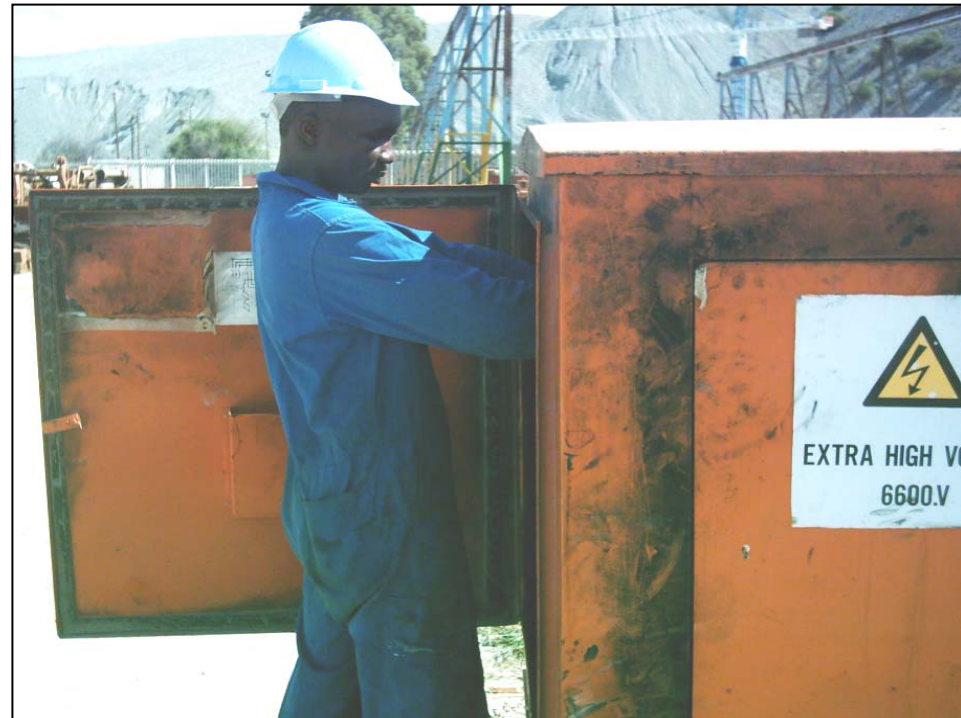
The artisan could not move out of the way of the flash fast enough, because he had to stand right up against the mini-substation to be able to do the switching. Due to the short switching handle.

This resulted in the heat of the flash being concentrated on his hands, fore arms, face and lower neck.

- Increased the length of the switching handle, so as to take the person at least 500mm away from the mini-substation.
- Cut holes into the doors of the mini-substation to facilitate switching with the doors closed.
- Increased the holding points and hinge strength of the door, so as to strengthen the door itself.
- OEM have been instructed to install an oil level site glass on all the OCB switchgear which will be repaired in the future.

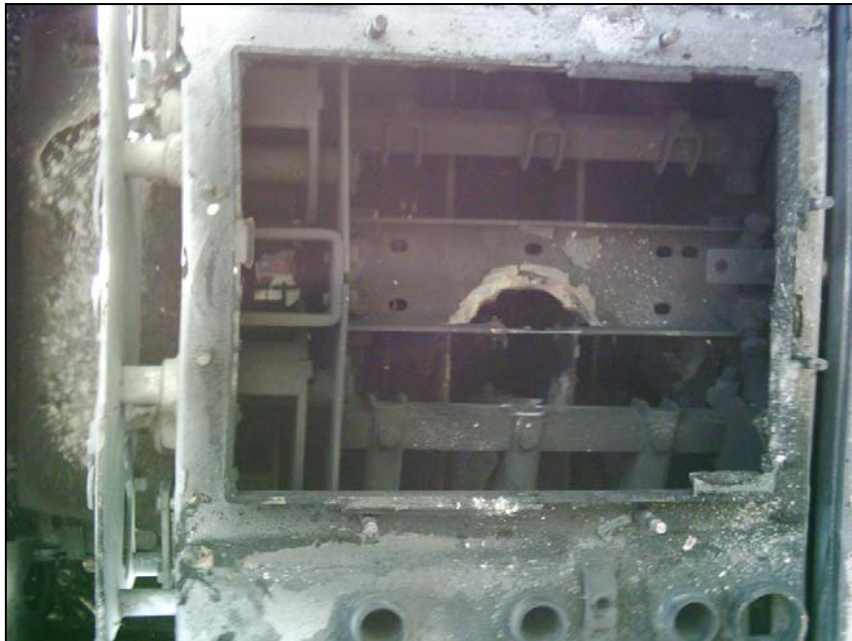
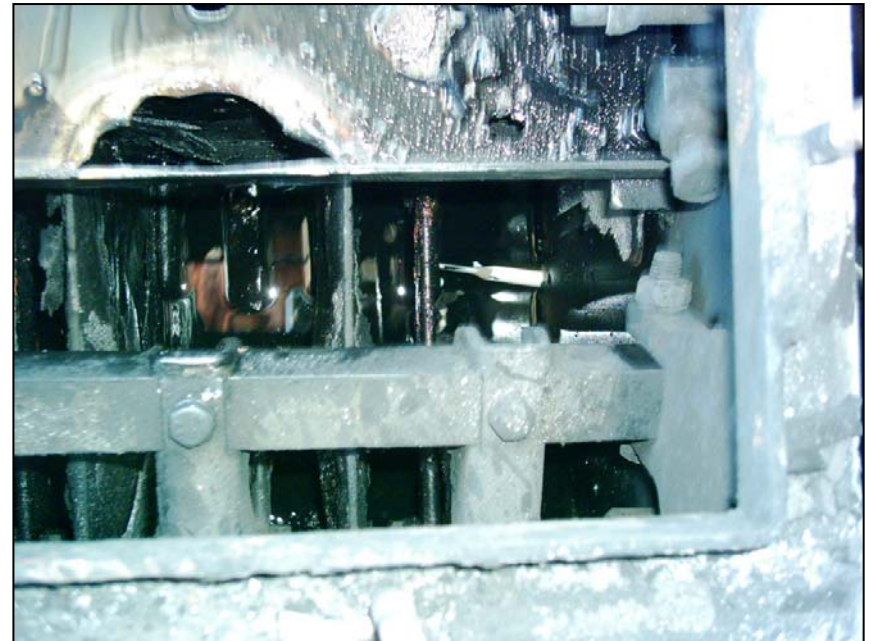
Damaged mini-substation (R168 000)

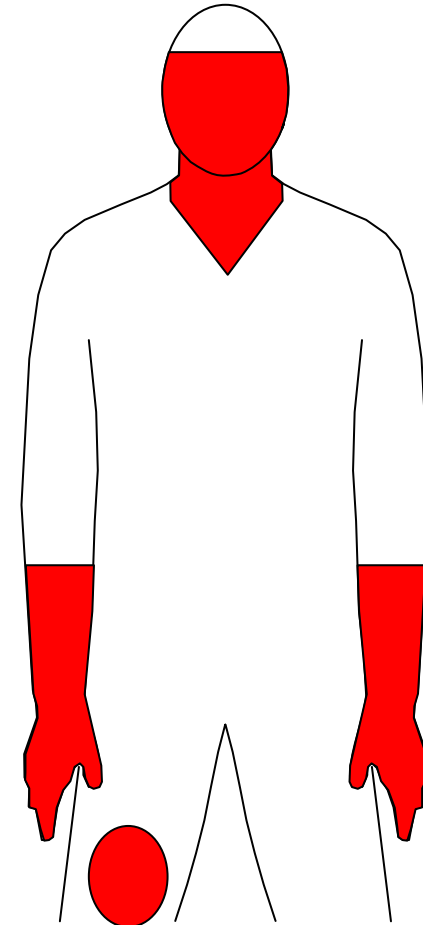
The electrician sustained 1st and 2nd degree burns to his face, lower neck, hands, forearms and right thigh and was off from work for an estimated four and a half months.
