In Memory of

Danizele Isaac Vula

7 February 1968 to 24 June 2005

Description of Accident

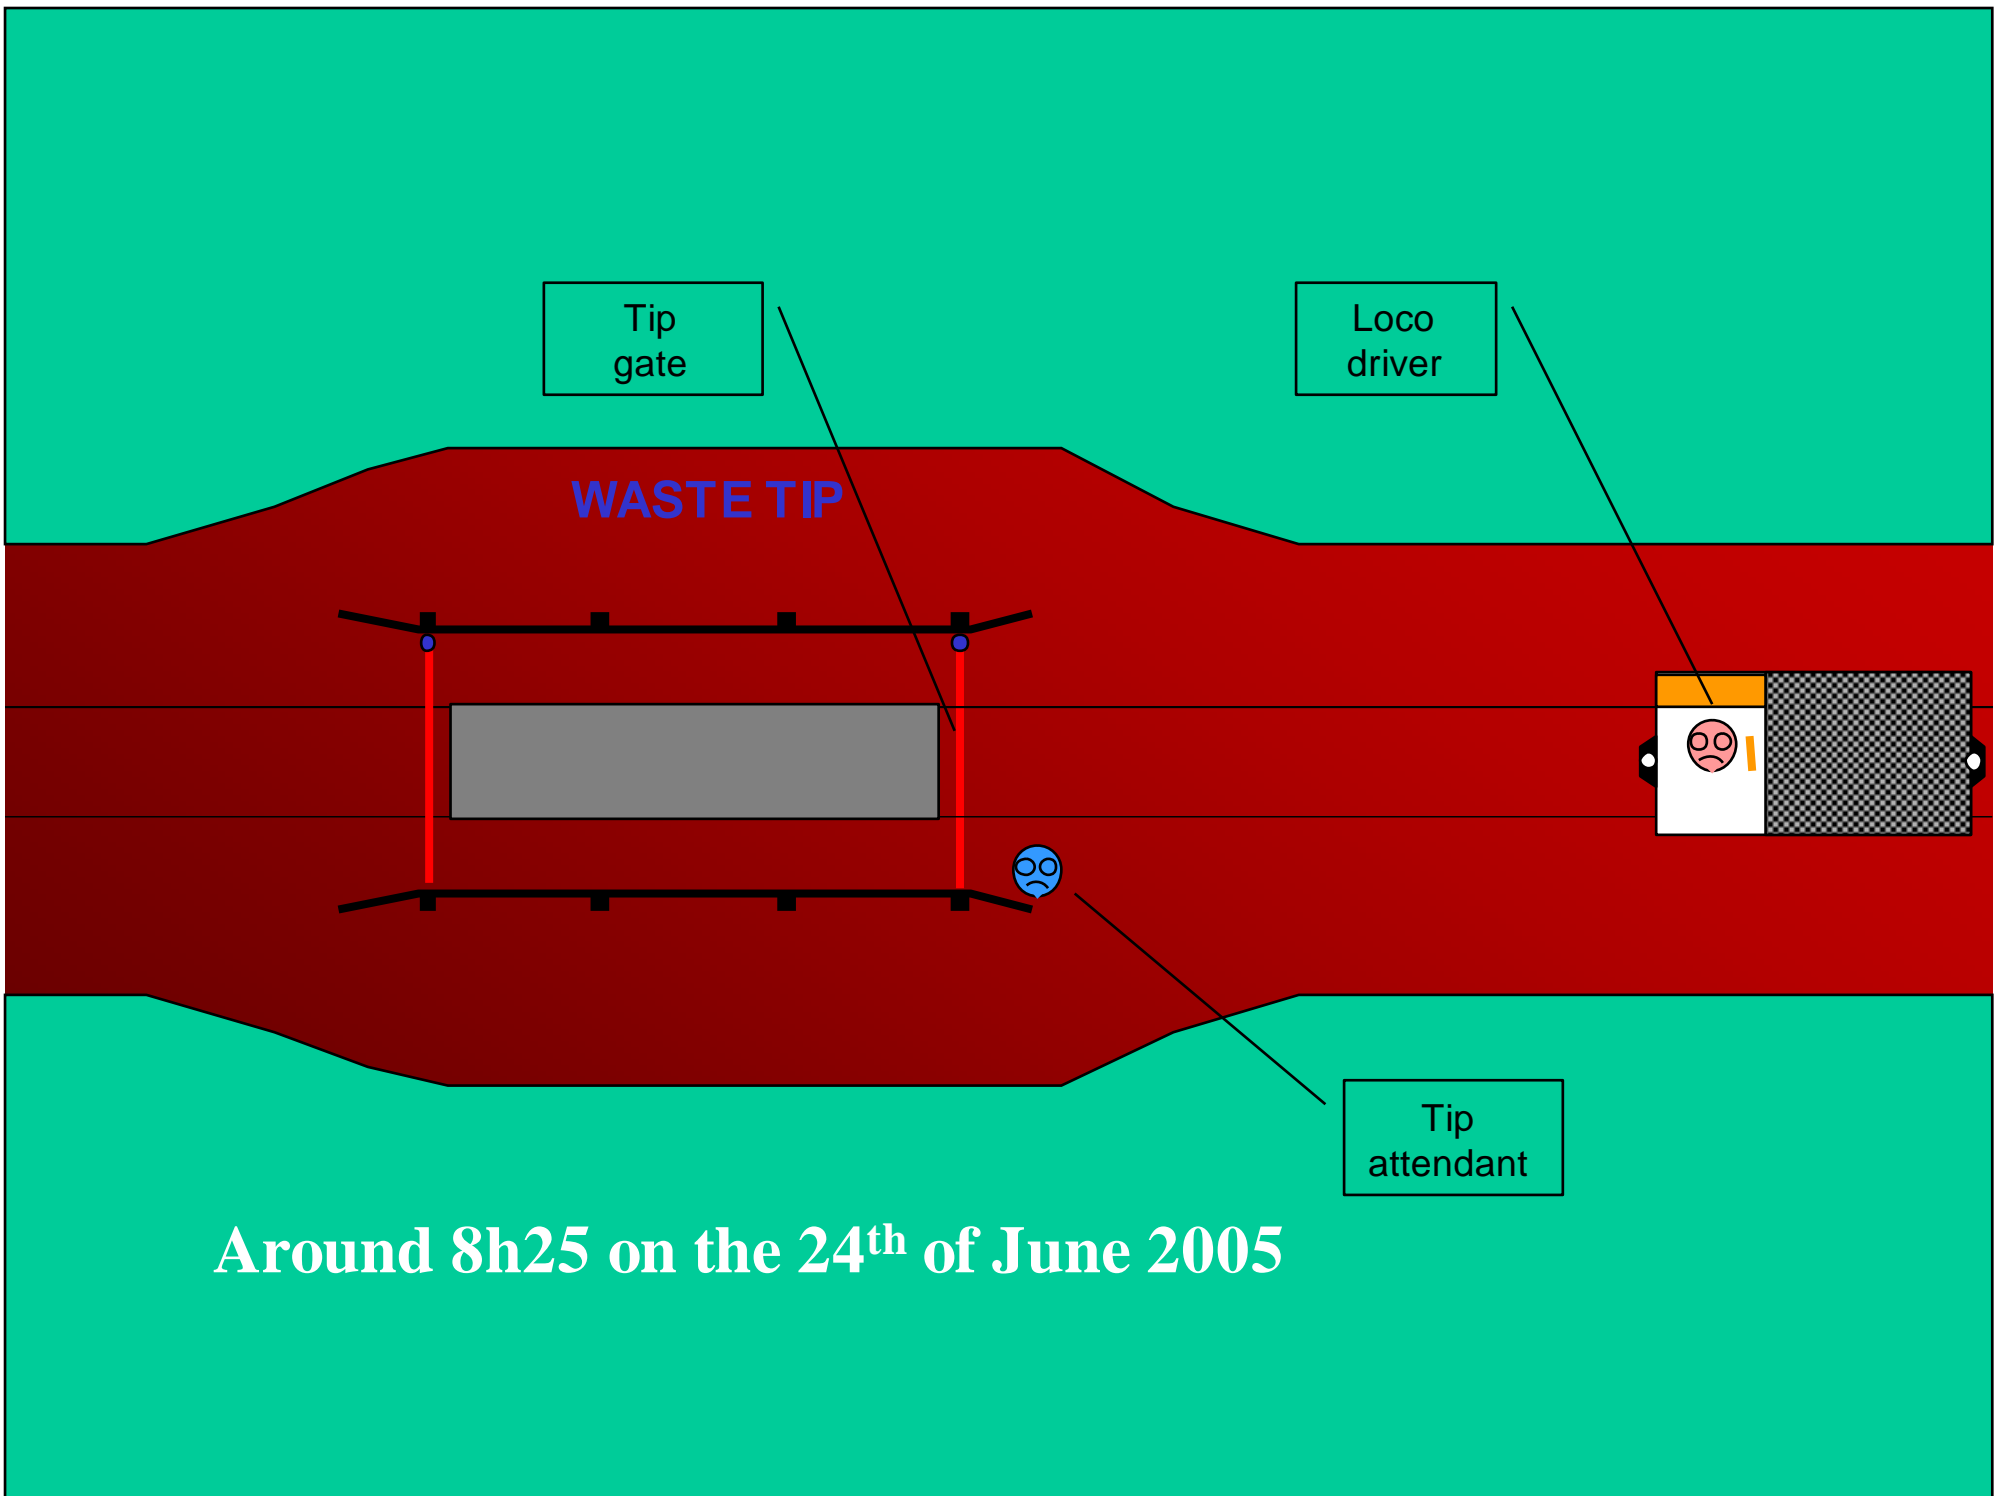
- On impact, the leading edge of the barricade then entered into the drivers cabin of the locomotive via a vacant light housing and this penetrated Danizeles' pelvic area ejecting him from the cabin and bringing the locomotive to an abrupt halt. Danizele was laying on the footwall alongside the locomotive after having been ejected.
- Mothobi immediately ran to the tip telephone and informed the control room of the accident who immediately alerted the paramedics.
- On returning to the scene Mothobi summoned the help of a Miner and Shift Overseer that where close to the station. The paramedics arrived shortly afterwards but unfortunately, Danizele had already passed away. The time was approximately 08h45.

Around 8h25 on the 24th of June 2005

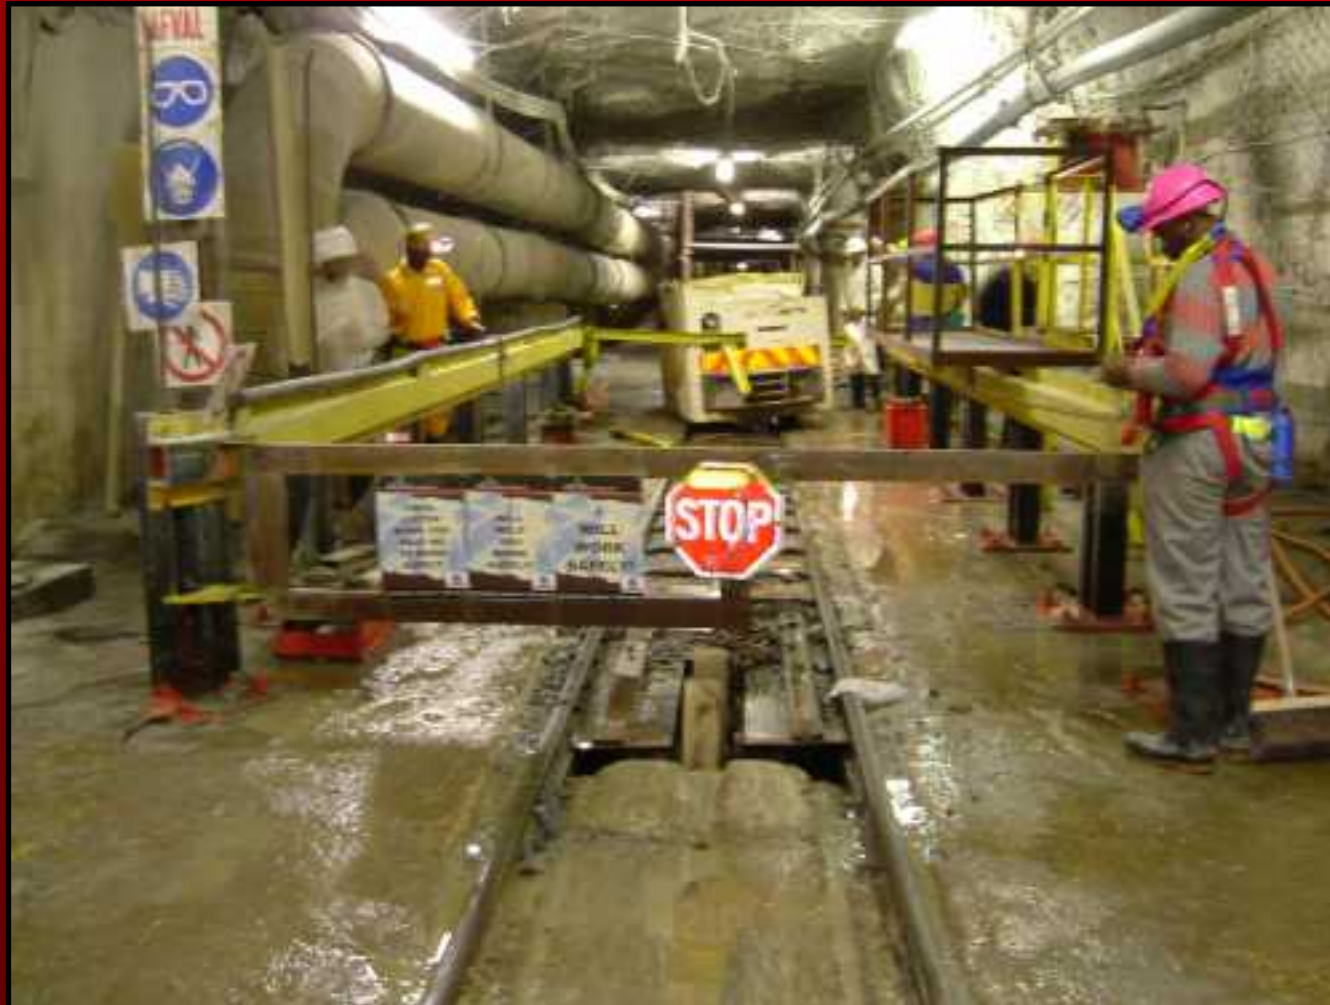
The Way Forward

- *Failure to conduct an issue based risk assessment on the farmgate tip barricade installations.*
- *Failure in the continuous risk assessment process in that neither the vacant light housing nor the farmgate were identified as potential hazards.*

- *The gates were never intended for the purposes of stopping a locomotive but instead for preventing people from inadvertently walking over the tips.*
- *All tips are fitted with sliding tip covers that are kept closed at all times except when tipping takes place.*

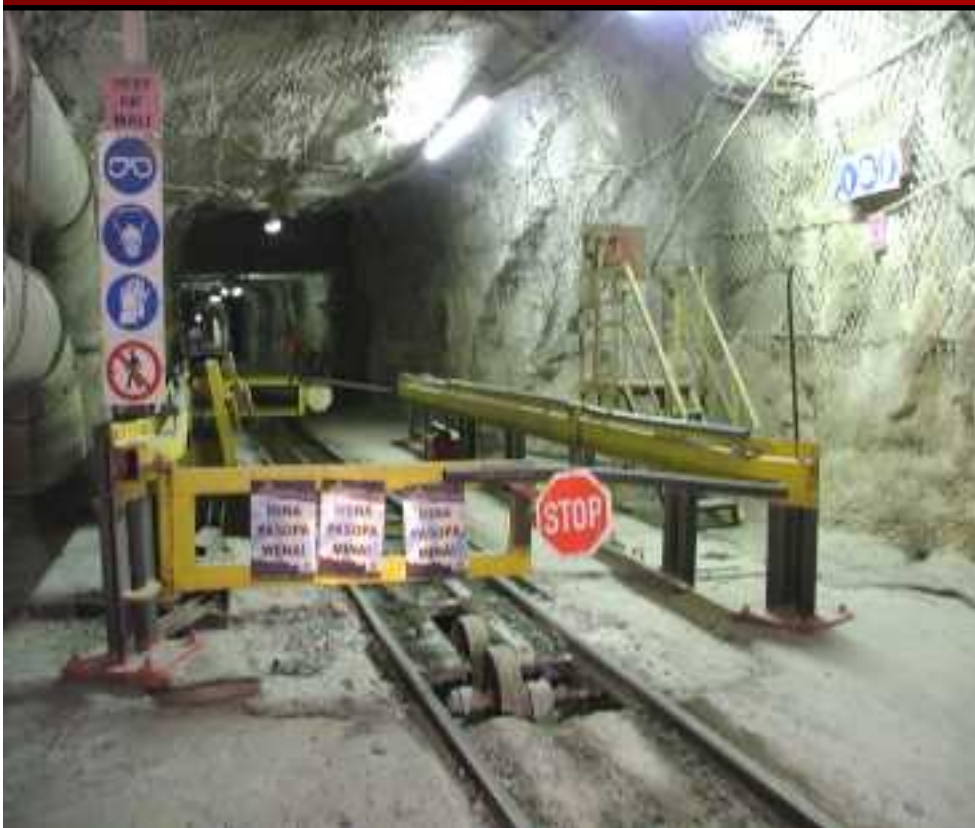
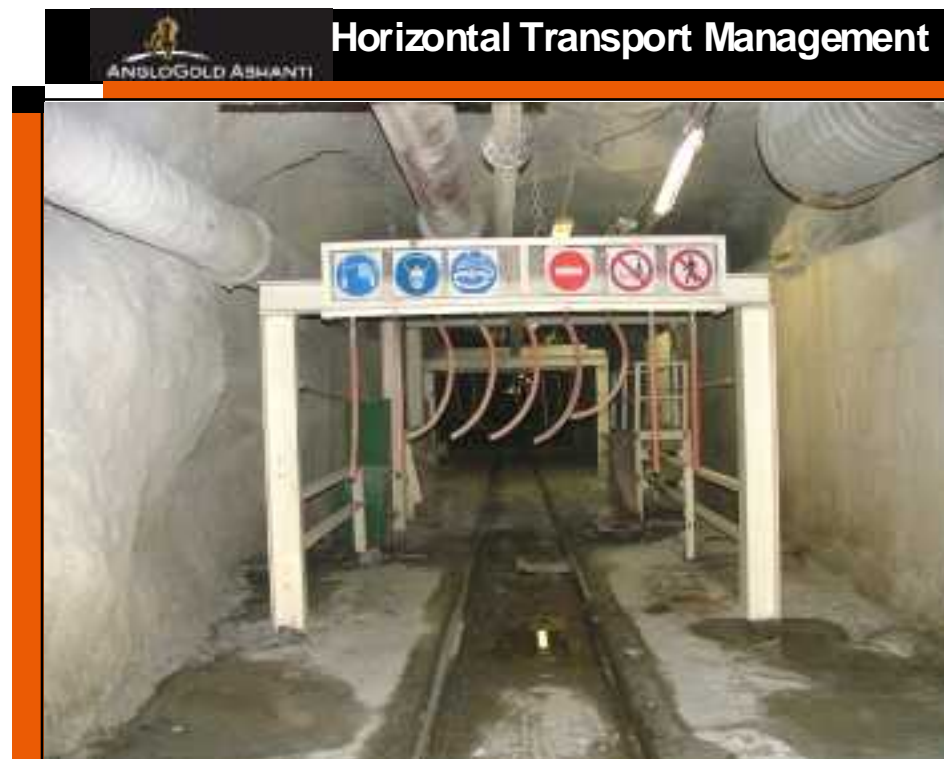
Sub Standard Conditions The Way Forward

- *Farmgate constructed with a leading edge at a height that could enter the locomotive cabin via a light socket.*

- All farmgate barricades to be altered to the “new” design using PVC until the ‘new” tip barricades are completed.
- 1350 level under construction and the new PVC barricade is in place.
