# **THE INVESTIGATION INTO THE TESTING OF A CONVEYANCE IN AN OVERWIND CONDITION: ROPE CONNECTED**

**Coenie Mynhardt**

**Engineering Manager - Winders**

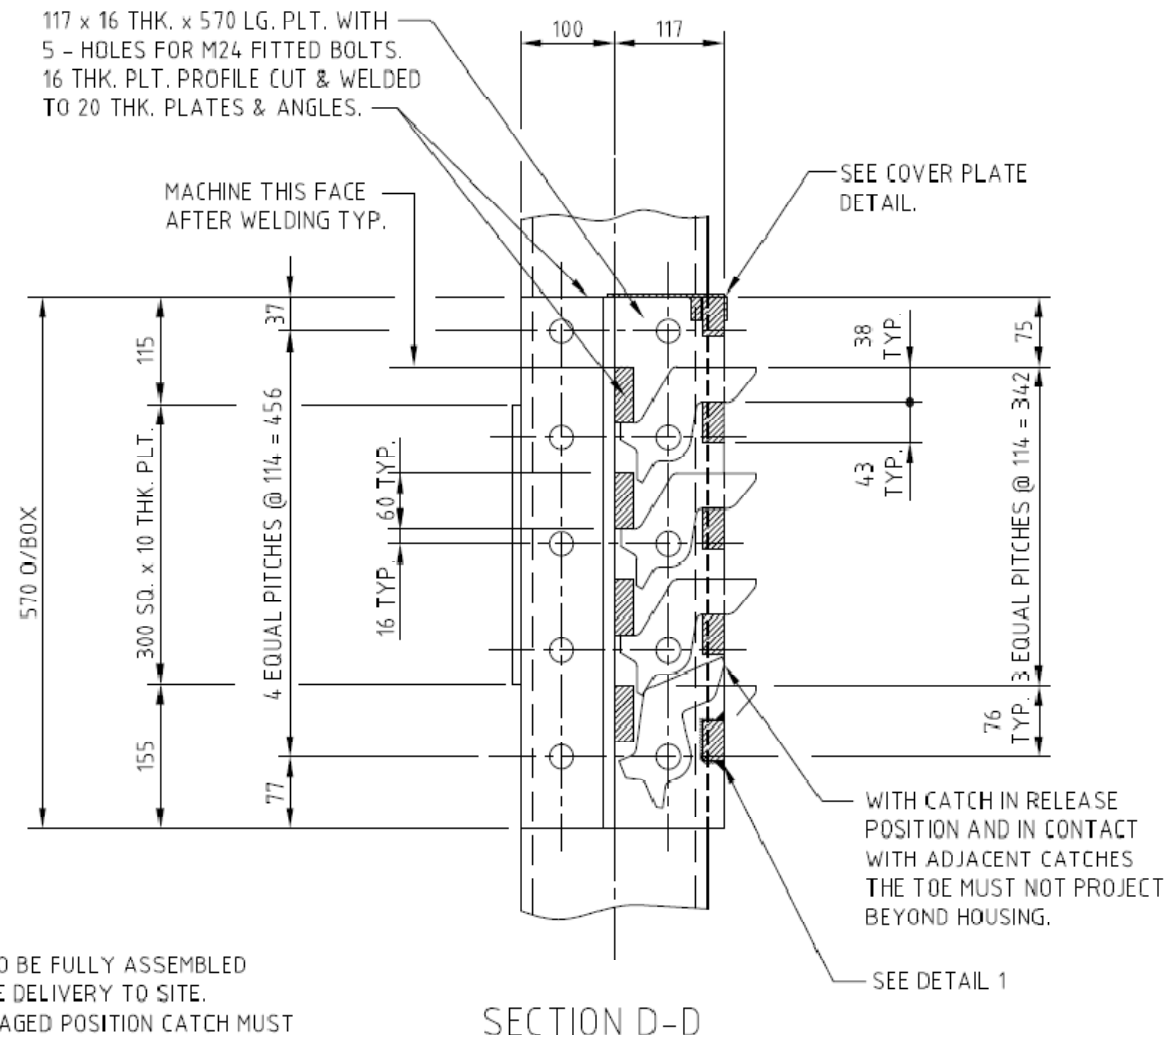
# Jack catch detail

NOTE :-  
JACK CATCH BOX TO BE FULLY ASSEMBLED  
ASSEMBLED BEFORE DELIVERY TO SITE.  
WITH CATCH IN ENGAGED POSITION CATCH MUST  
NOT BEAR ON BOLT WHEN LOAD IS APPLIED.

JACK CATCH BOX DETAIL

12 - OFF REQD. AS DRAWN

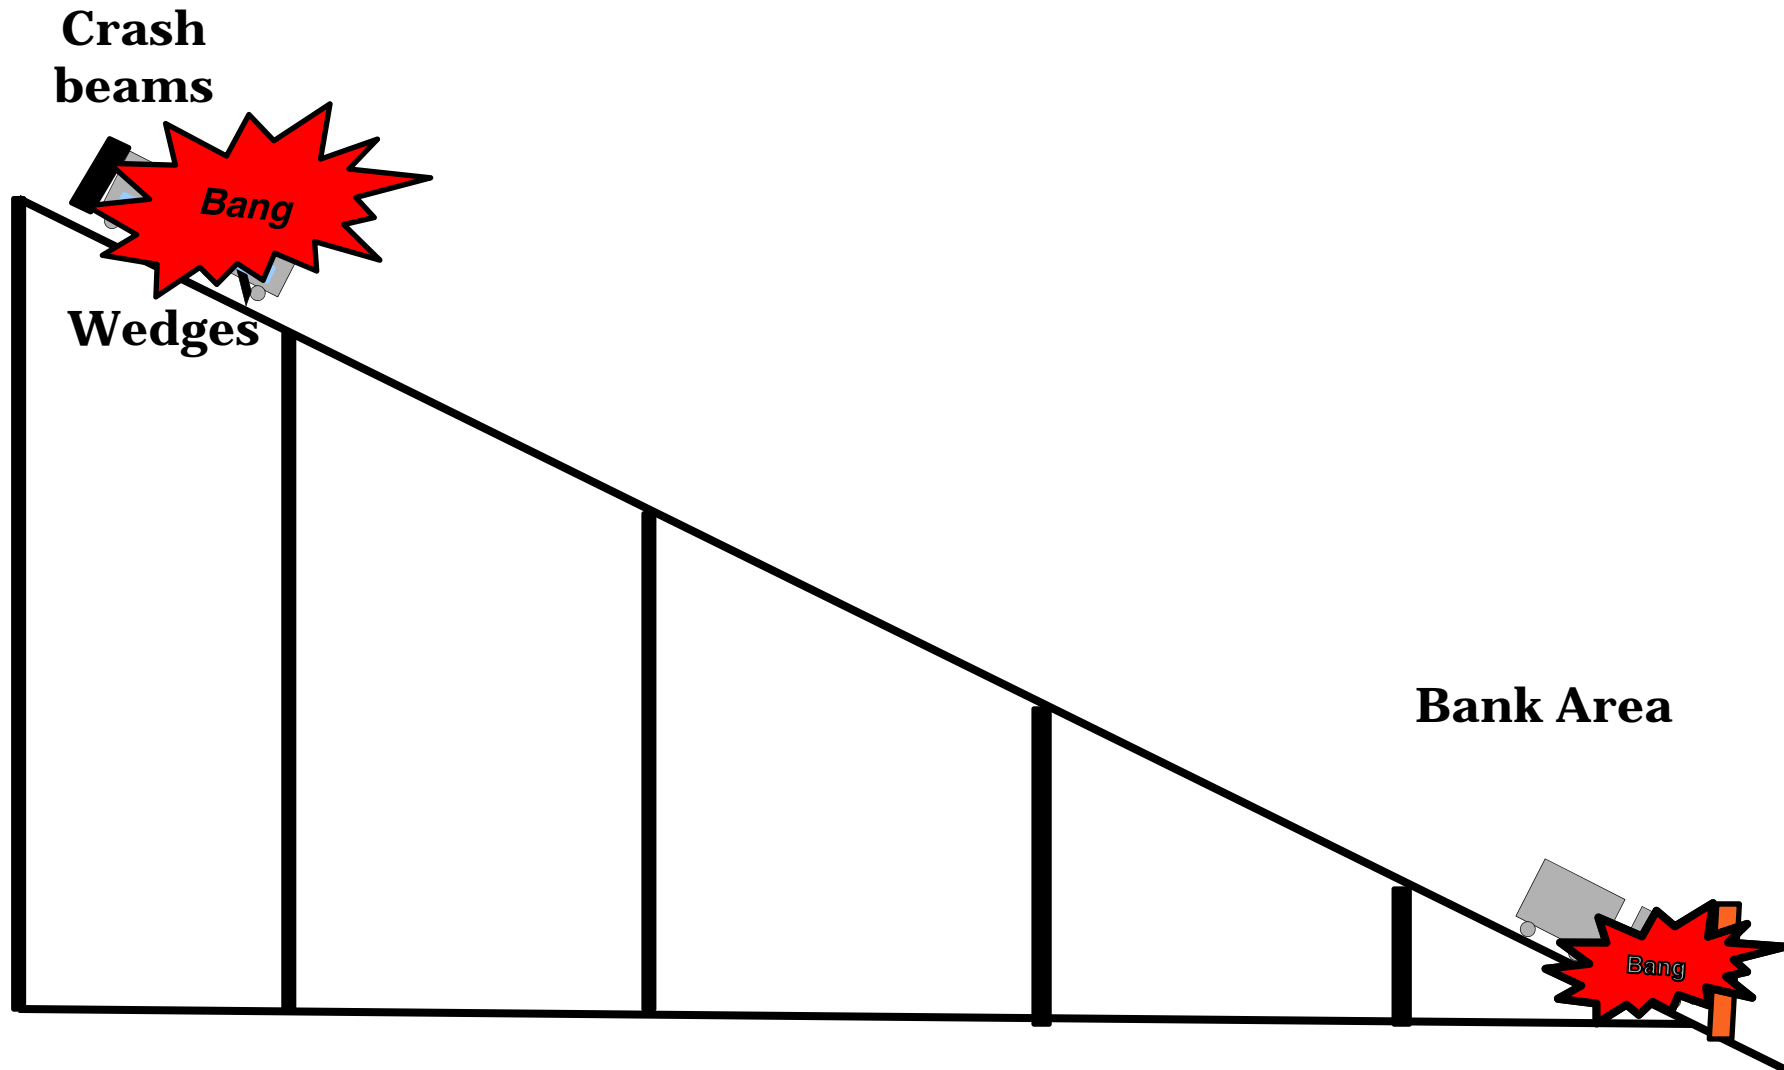
# Decline shaft overwind simulation

- On Friday 21-01-2011 the engineering team at the decline winder planned to cut a 45m front-end
- At ± 12:45 pm the bell operator signaled the driver to remove bad coil from the drum
- The conveyances were pulled from the bank into the shaft, lowered a few turns and raised at full speed towards the headgear
- As the conveyances reached the top of the headgear the conveyance crashed into the crash beams which resulted in the rope disconnecting from the leading conveyance
- Both conveyances travelled down the headgear and crashed above the shaft opening

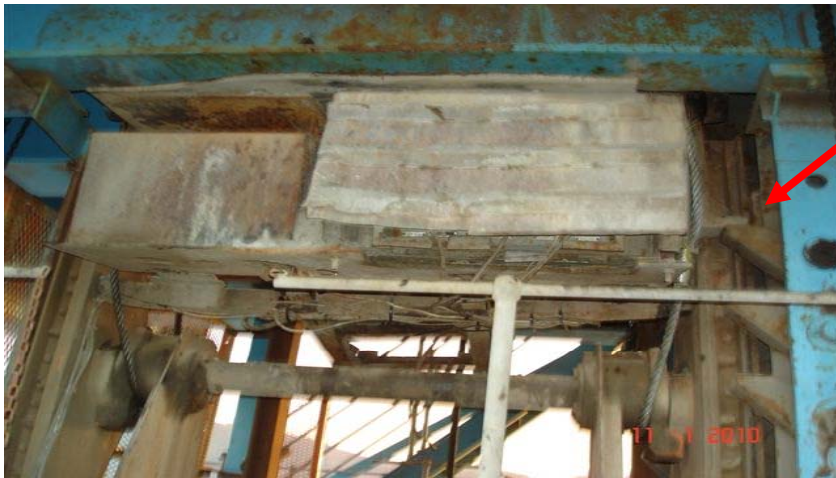
- Replaced rock winder ropes
- The next day a long and short rope condition was measured and the required length to be cut determined
- The underlay conveyance was hoisted to the bank and suspended and the task of cutting the rope was performed
- The underlay conveyance was hoisted to the tip position to set the overwind trips
- An overwind occurred when the underlay conveyance was hoisted past the tip position
- The rope dislodged and the conveyance was suspended in the jack catches

Skip Secured  
in Jack  
catches

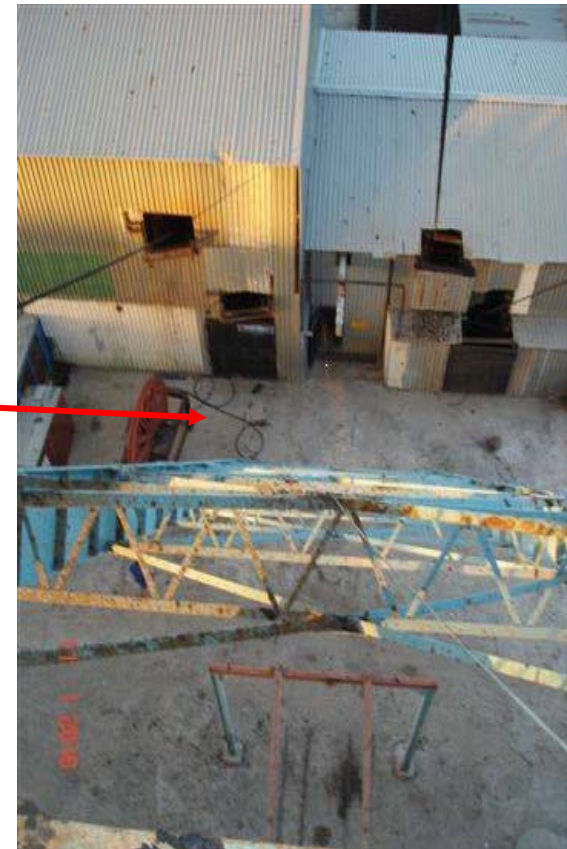
The detached  
front end of  
the rope

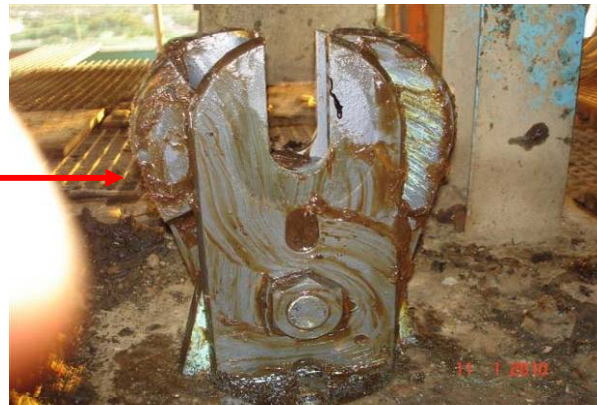
Safety Detachment  
Hook in the open  
position

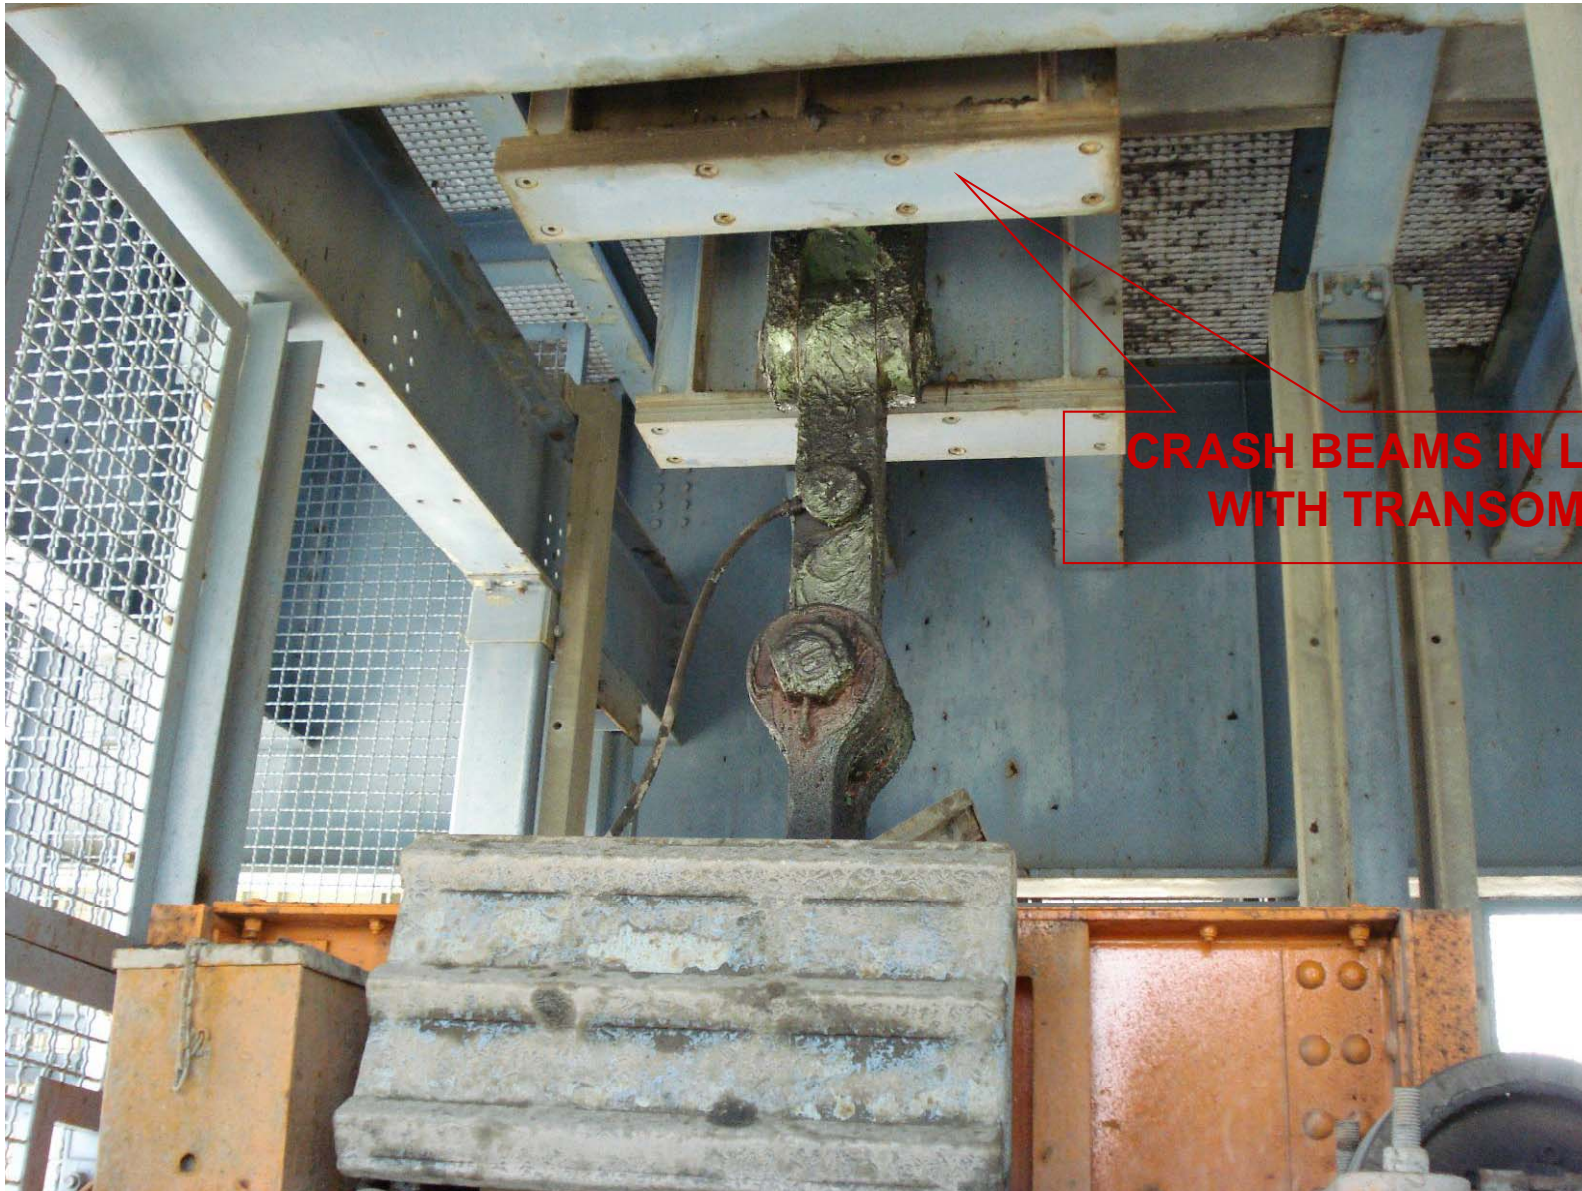
**CRASH BEAMS IN LINE  
WITH TRANSOM**

- The crash beam clearance at the prescribed lift on the humble hook shall be not more than 25mm and not less than 10mm.
- The positioning of the jack catches shall be such that they can be manually operated to allow the conveyance to be lowered out of the overwind position.

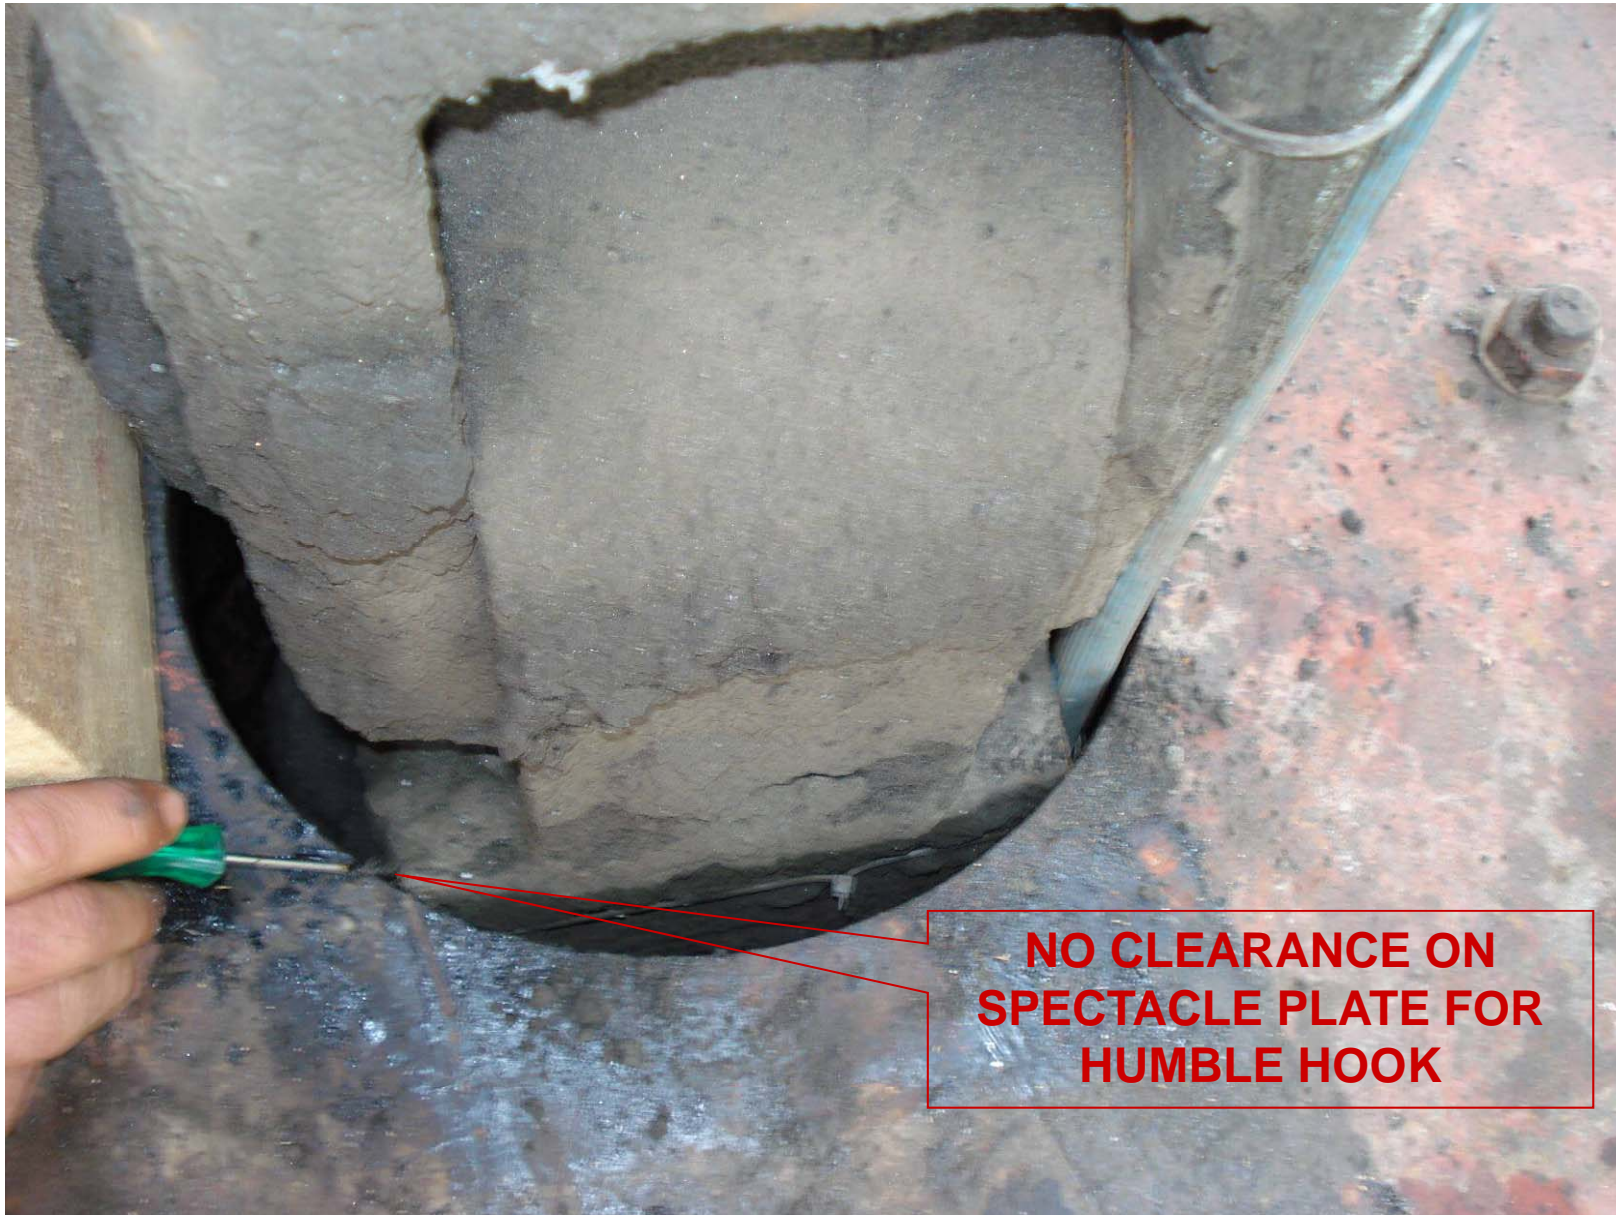
**NO CLEARANCE ON  
SPECTACLE PLATE FOR  
HUMBLE HOOK**

- The detaching hook and its spectacle plate must conform to the manufacturer's specifications in so far as correct clearance between detaching hook body and spectacle plate hole and the correct thickness, taper and radius of the spectacle plate

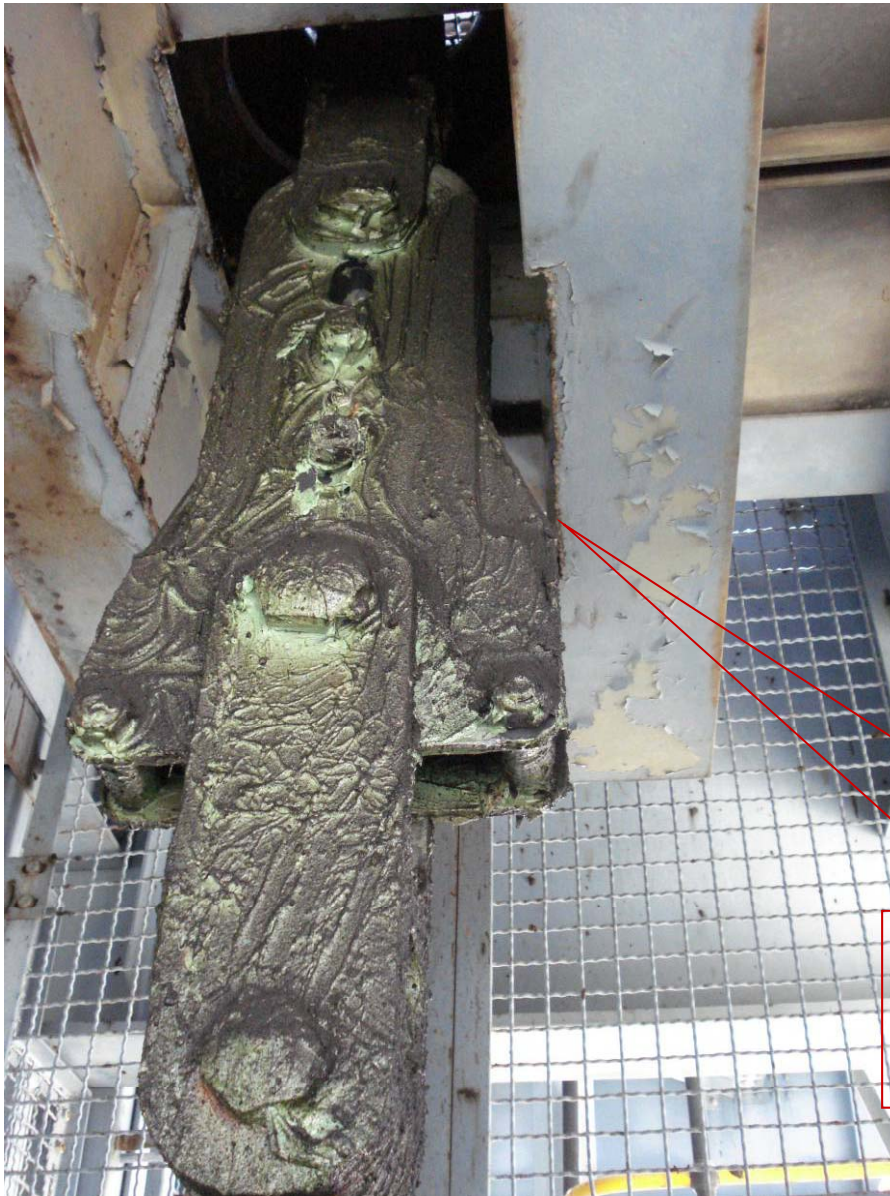
**Possible obstruction of  
Humble hook into crash  
beams**

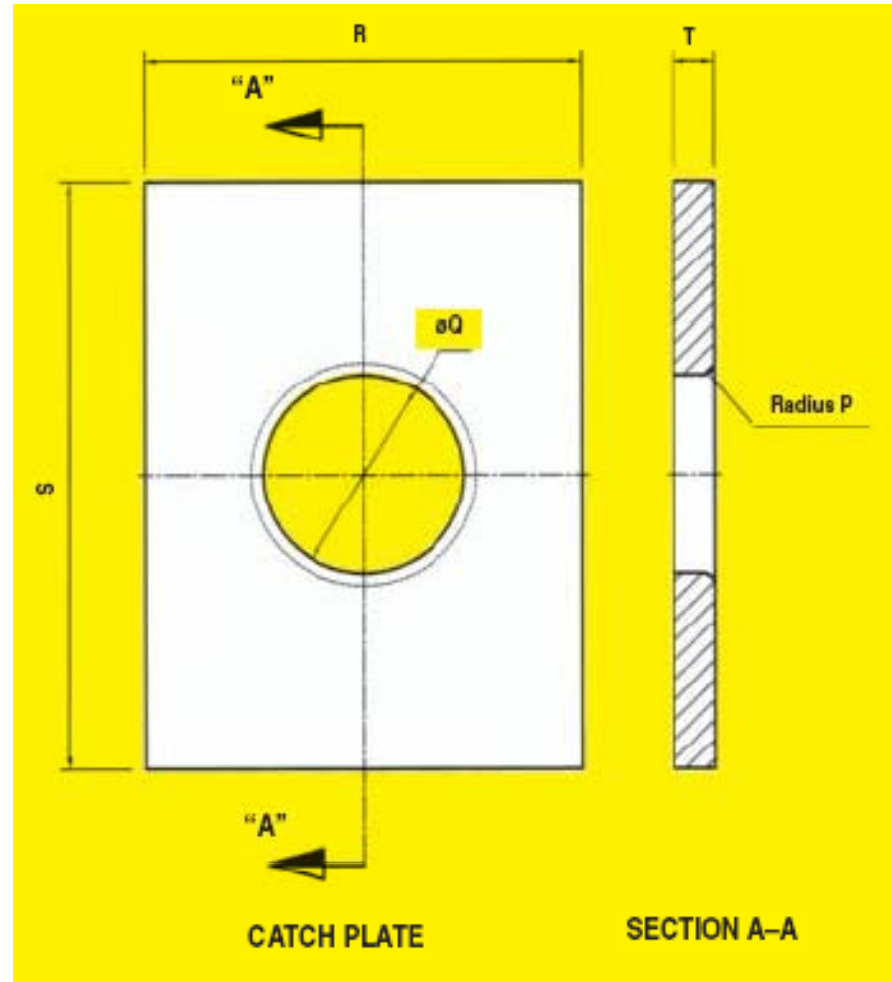
# Spectacle plate specification

- The duty and size of the detaching hook must conform to the Original Equipment Manufacturer's specification.
- The winding rope must be in the centre of the spectacle plate hole.

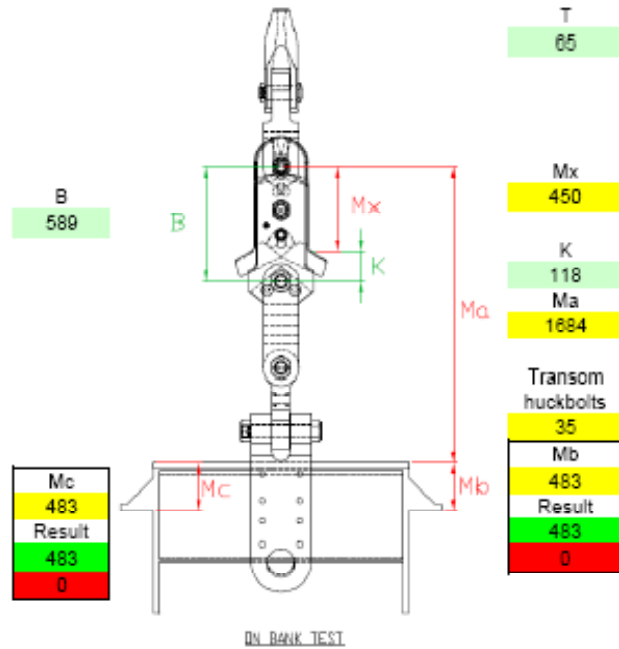
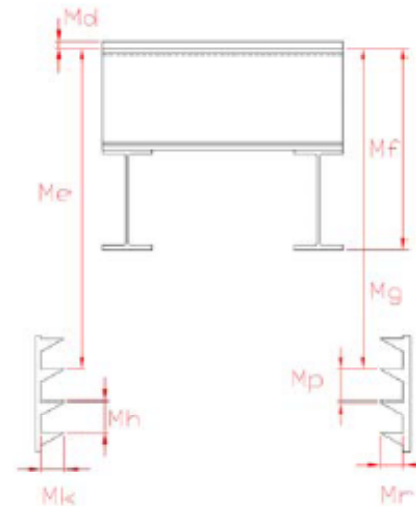
# Phase 1 tests before conveyance goes into headgear test

Jack catch drop-back clearance

Left	Right	
50	50	25mm - 75mm

Crash beam min clearance

15	15	10mm - 25mm
----	----	-------------

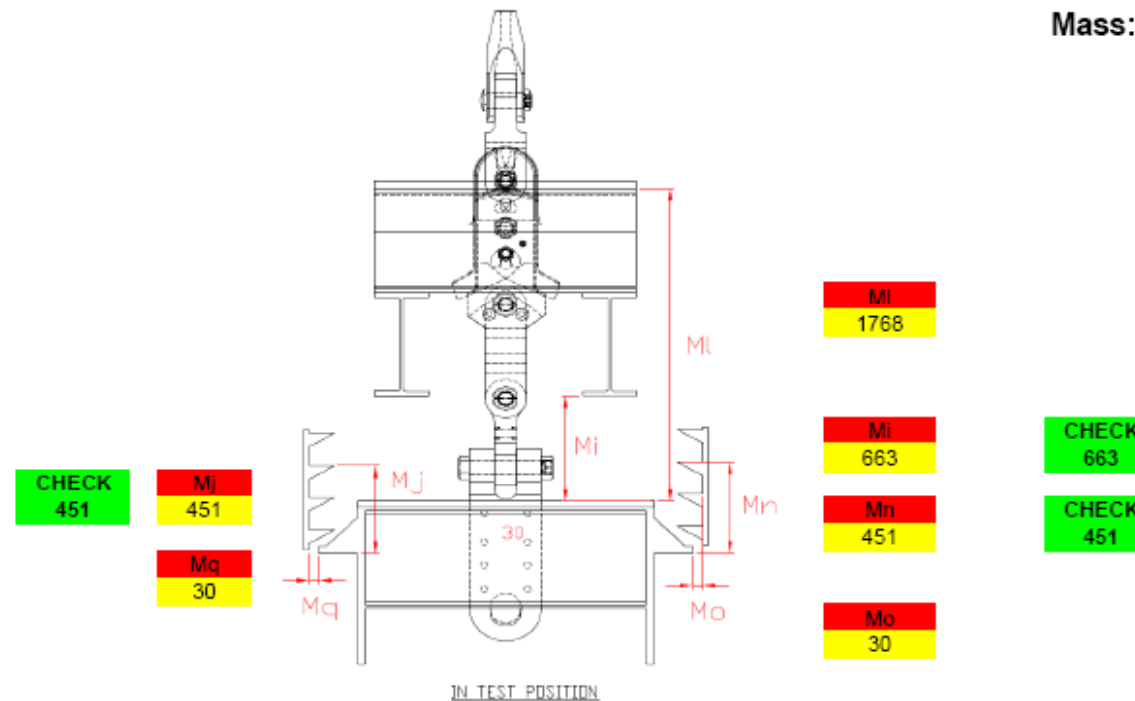
# Phase 2 test in headgear – Confirmation testing of phase 1 test results

Left	Right	
Jack catch drop-back clearance	50	50	25mm - 75mm
Crash beam min clearance	15	15	10mm - 25mm

Jack catch drop-back clearance	50	50	25mm - 75mm
Crash beam min clearance	15	15	10mm - 25mm
Jack catch contact clearance	40%	40%	40% - 60%
