AMRE SEMINAR – MAKING OUR PEOPLE WORK SAFER

## SIDE TIPPER DESIGN REVIEW FOLLOWING A KLOOF FATAL ACCIDENT

Presented by  
**Tjaart Prinsloo**

**26 July 2007**

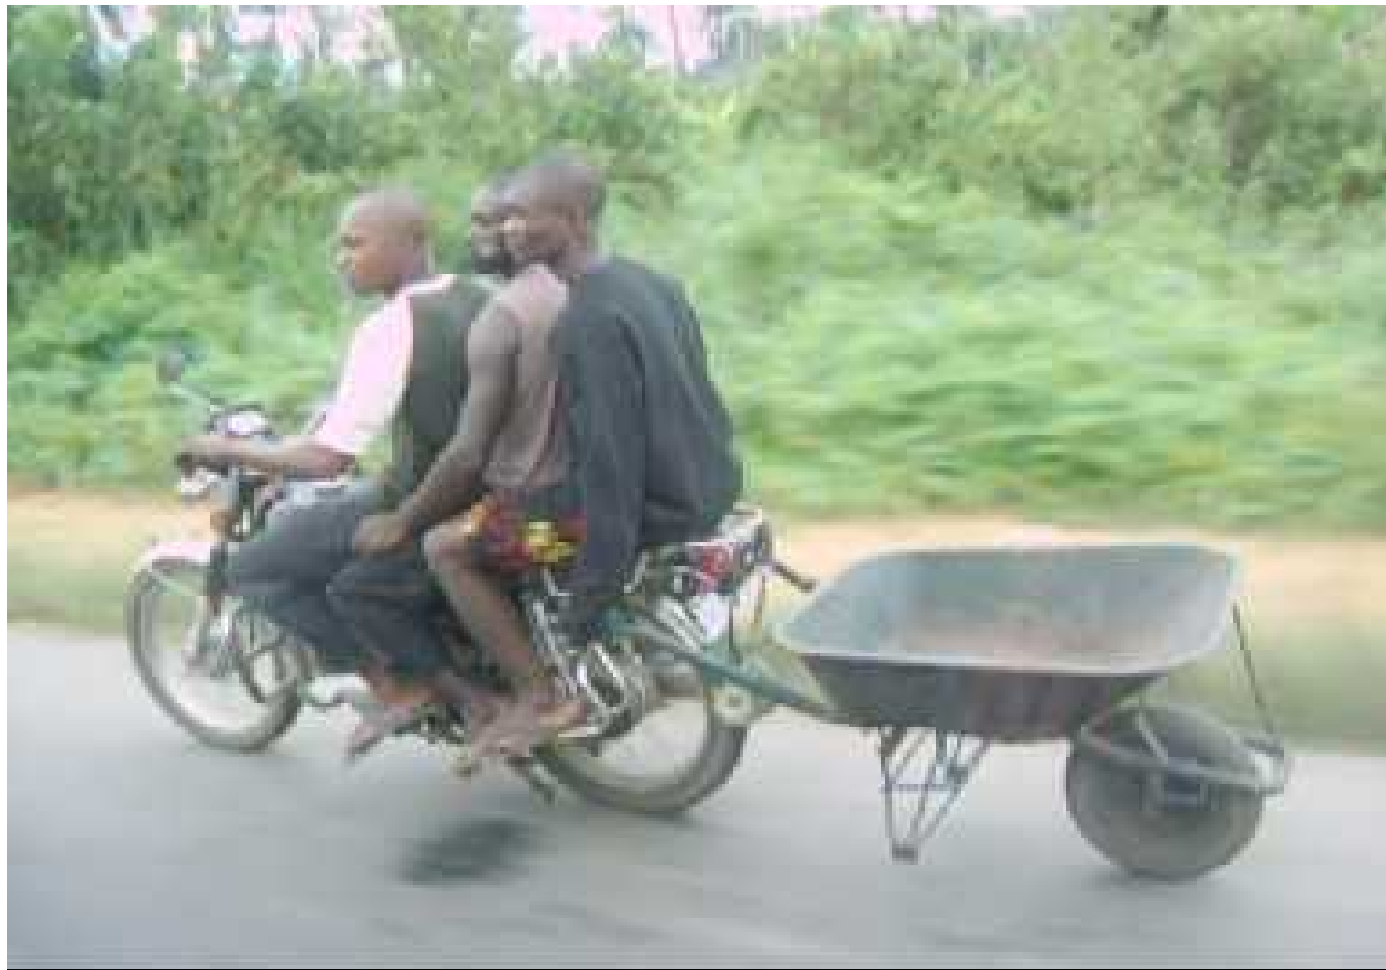
IT WORKS, .....BUT !!!!??

- Near misses (Ranging from dislodging from chassis, accidental tipping, mismatched buckets falling from support trunions)
- Injuries (Mostly minor)

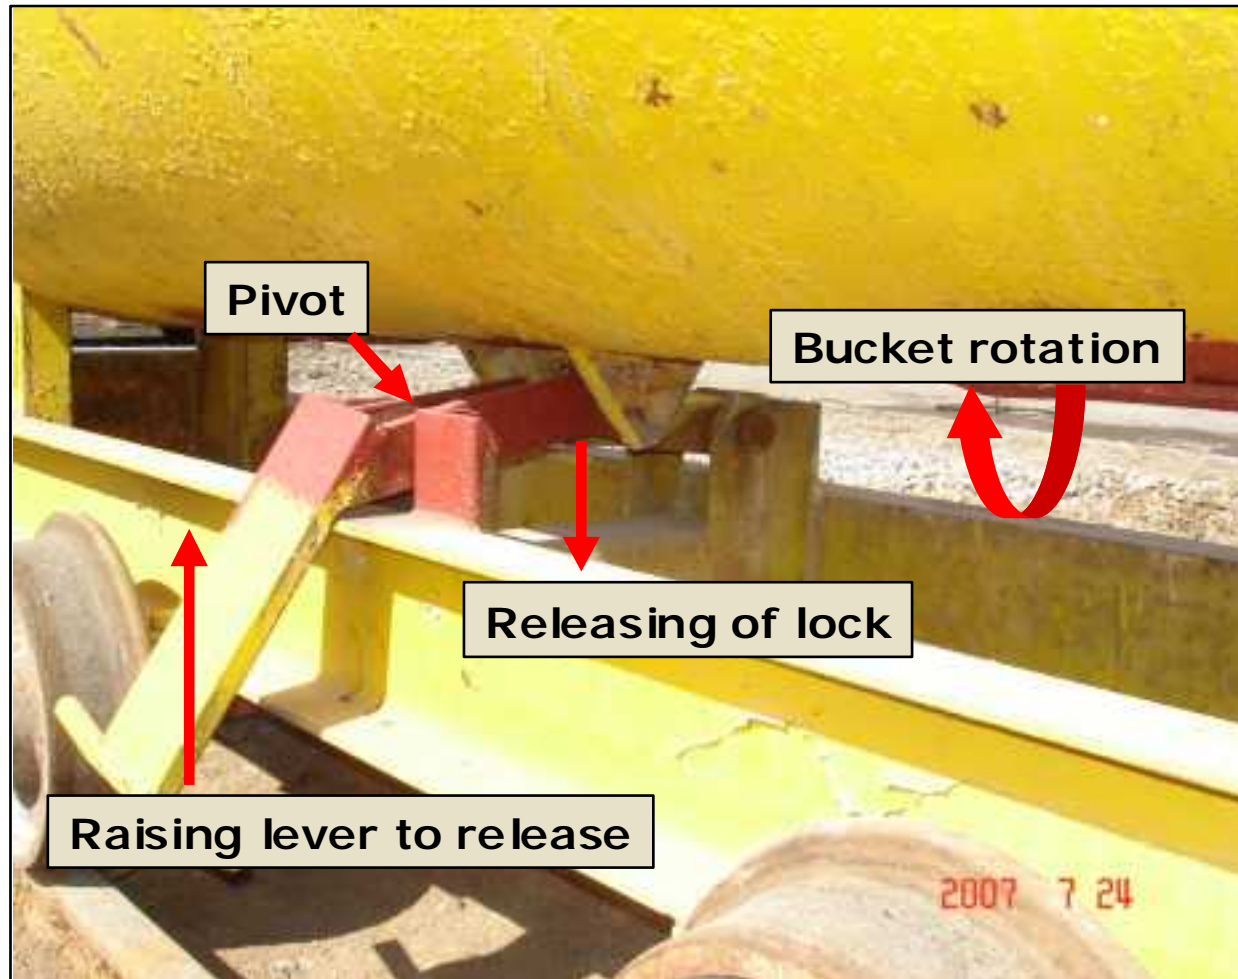
#### Bucket locking mechanism (Dual)

Whilst the drilling machine was being off-loaded, the bucket locking mechanism underneath the bucket became unlatched, allowing the tipping of the load.

The machine pulled the bucket off the chassis and trapped the Contractor between the bucket and the footwall, fatally injuring him.

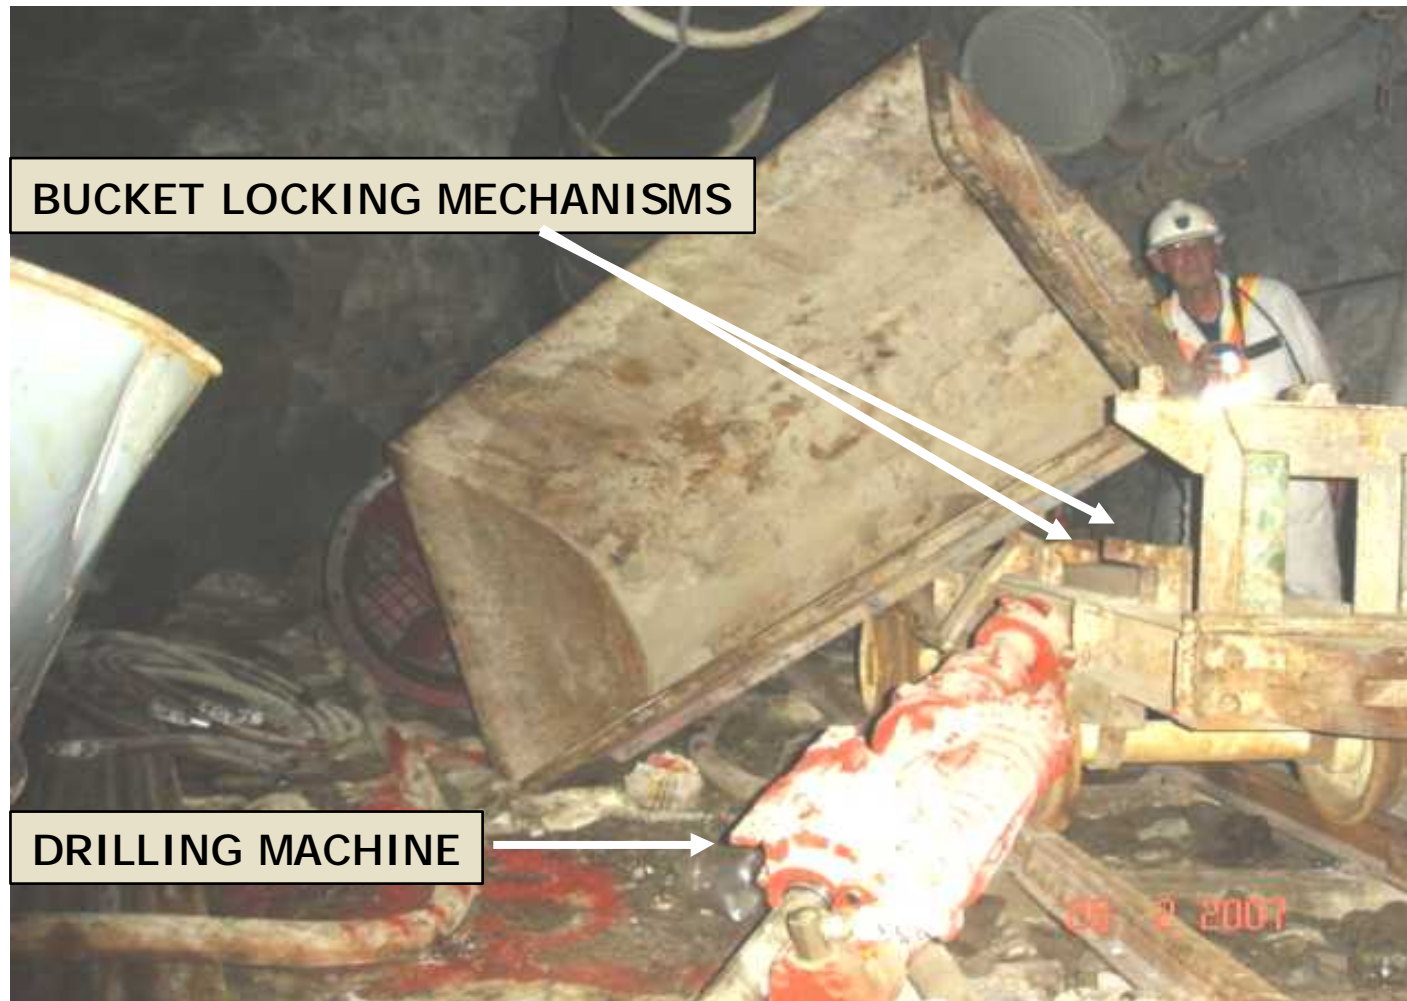
## No. 3 SHAFT FATAL ACCIDENT SCENE

In February this year, a Contractor performing drilling work at our No.3 Shaft, made use of a standard side tipper to transport a drilling machine to site. On arrival at the site, the machine had to be removed from the tipper.

Instead of tipping the tipper, as designed, the now deceased climbed into the tipper to assist with the off-loading of the machine.

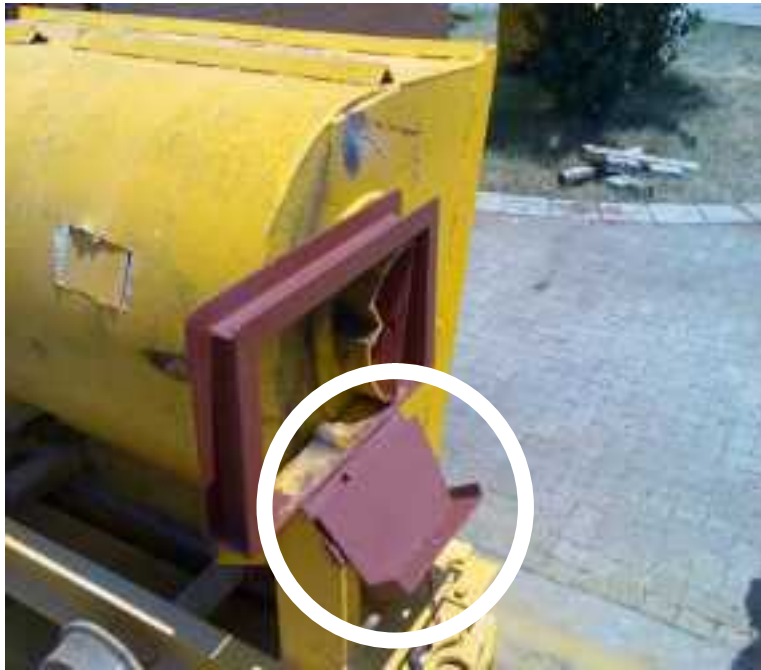
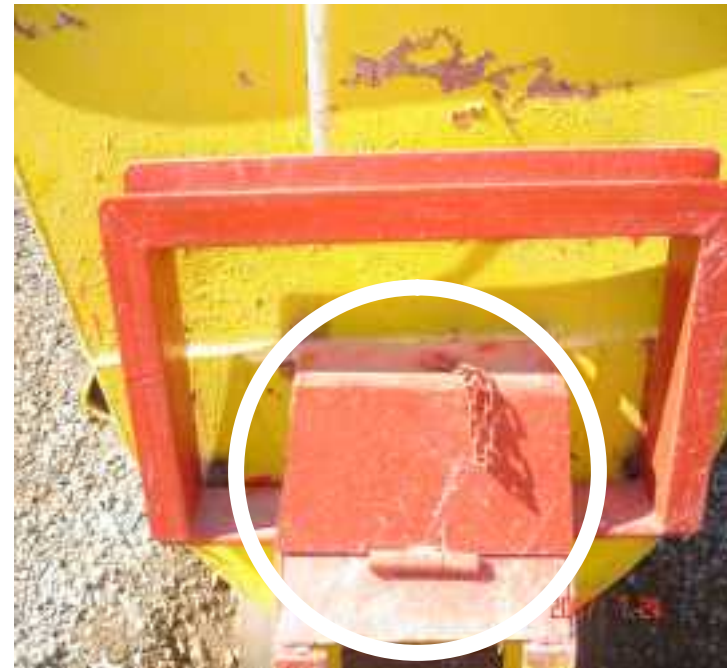
## POSITIVE LOCKING DEVICE – OPTION 1

- Current design unstable as the center of gravity is displaced away from centerline of chassis allowing the bucket to topple over.
- No means provided to contain the bucket whilst being tipped.
- Mismatched buckets are common as they are not fixed to the chassis.
- No “positive locking” device in place. (Although, the existing dual gravity activated locking mechanism works well, it could be released accidentally by accumulation of rocks or material next to the tracks)
- Unguarded nip points between bucket trunions and chassis

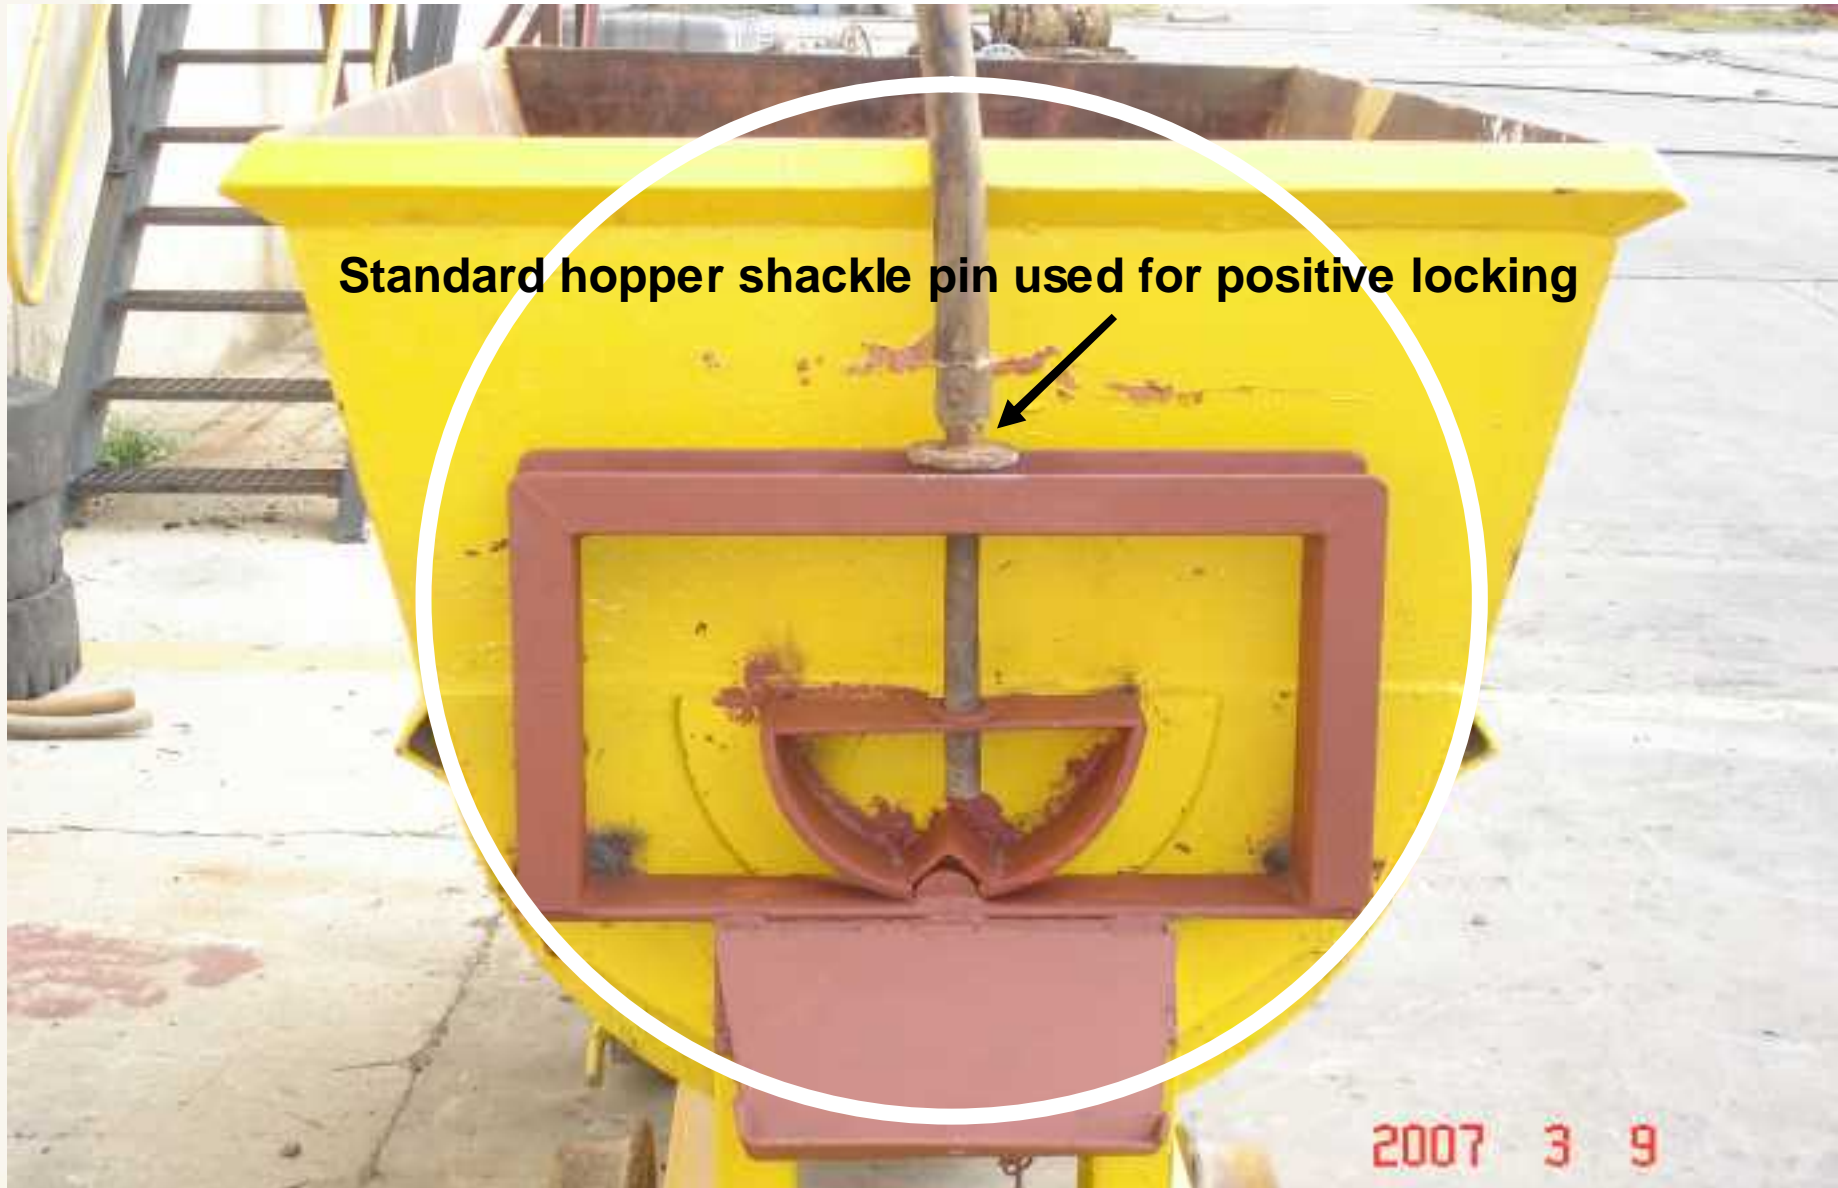
# POSITIVE LOCKING DEVICE AND RETAINER BRACKET – OPTION 2

- Current design unstable as the center of gravity is displaced away from centerline of chassis allowing the bucket to topple over.  
**(Retainer bracket)**
- No means provided to contain the bucket whilst being tipped.  
**(Retainer bracket)**
- Mismatched buckets are common as they are not fixed to the chassis.  
**(Retainer bracket)**
- No “positive locking” device in place. (Although, the existing dual gravity activated locking mechanism works well, it could be released accidentally by accumulation of rocks or materials next to the tracks)  
**(Shackle pin locking)**
- Unguarded nip points between bucket trunions and chassis  
**(Expanded metal guarding)**

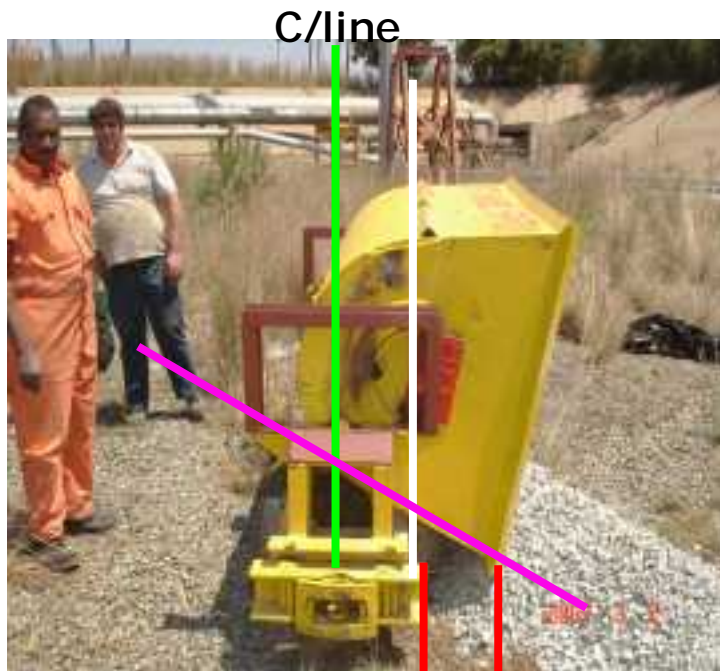
Modified tipper

- “Positive” locking facility on bucket utilising standard coupling pin.
- Bucket cannot topple over and dislodge from chassis
- Center of gravity in the tipped position is more in line with centerline of chassis
- Improved discharge of load (away from tracks)
- Should the side tipper fall over, the bucket will not dislodge from the chassis.
- Bucket should remain in tipped position after tipping
- Mismatched buckets/chassis will not occur as car remains as a unit.
- Guarding of nip points achieved
- Modification costs are low as readily available material is used.
- Modifications can be done on-site
