No 16 Shaft Project

Stage Rope Incident
19 April 2011

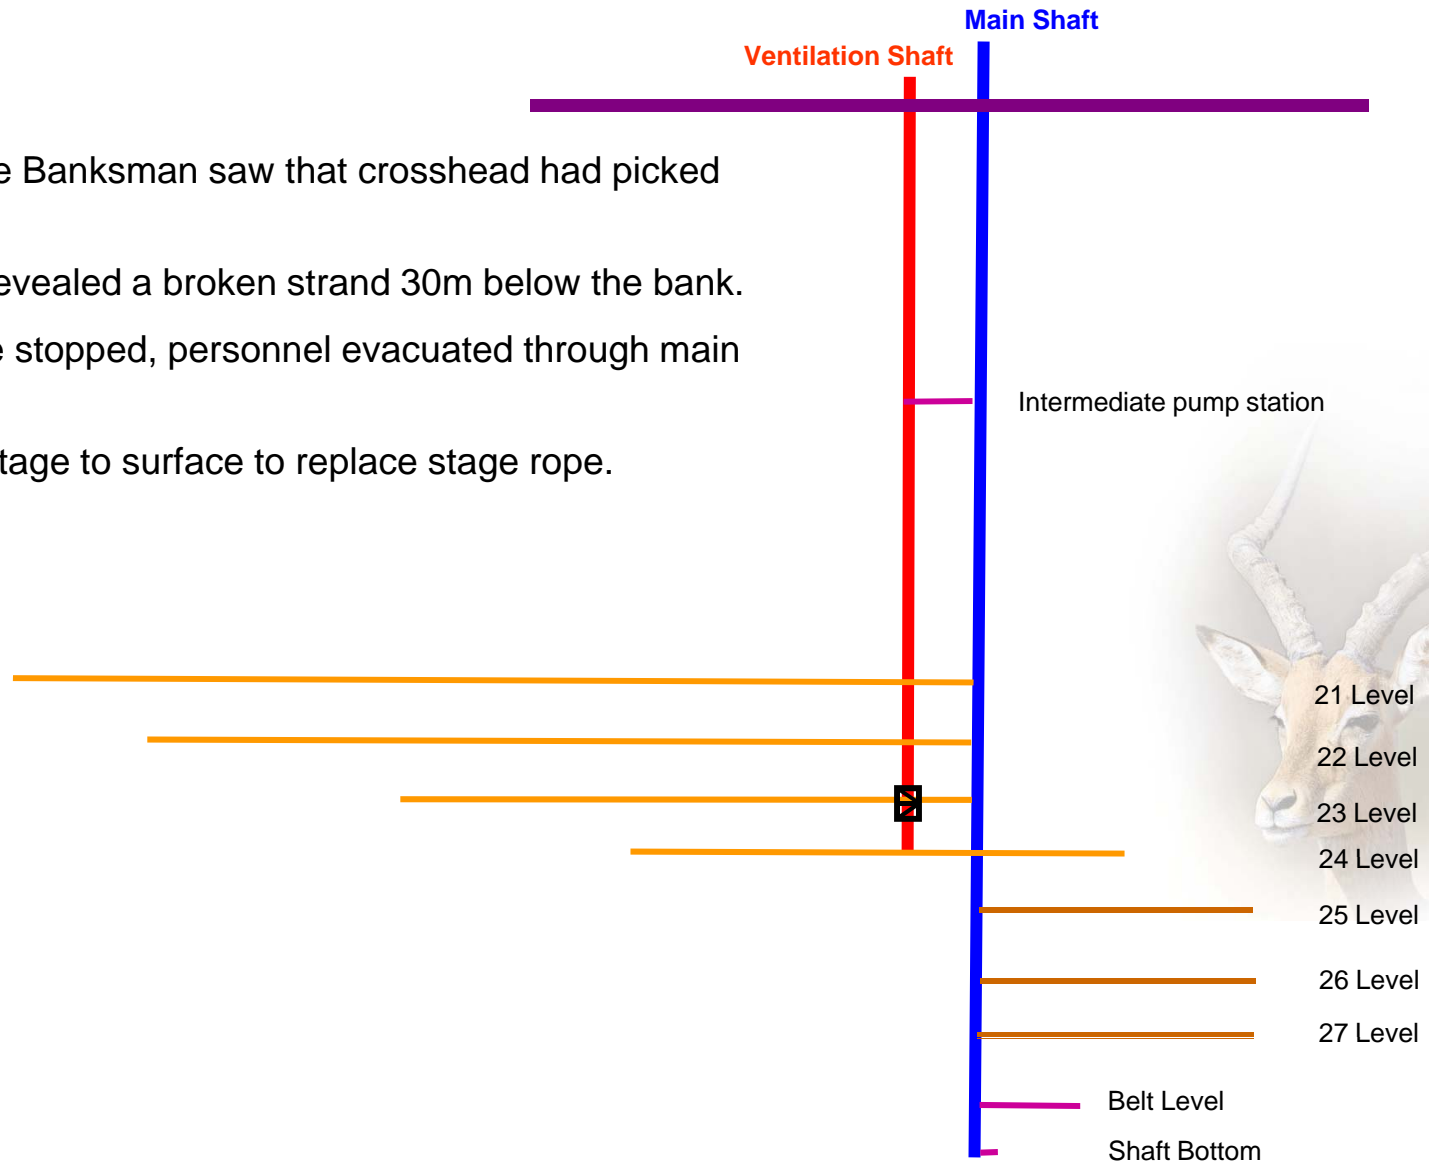
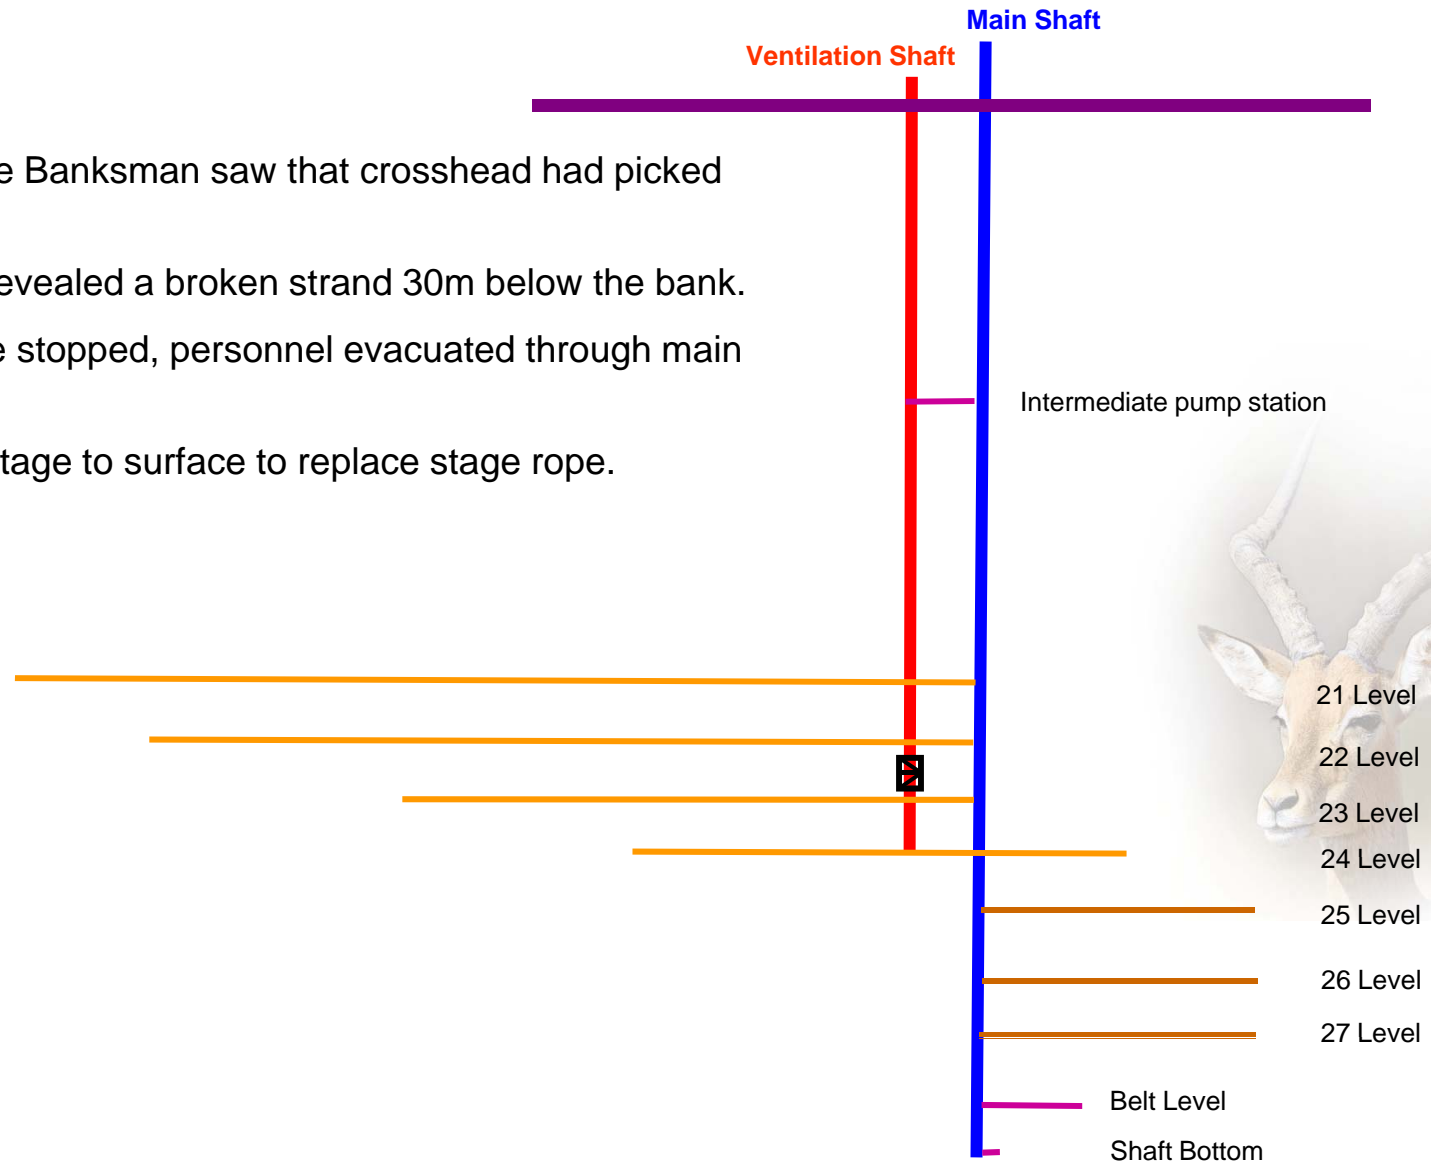
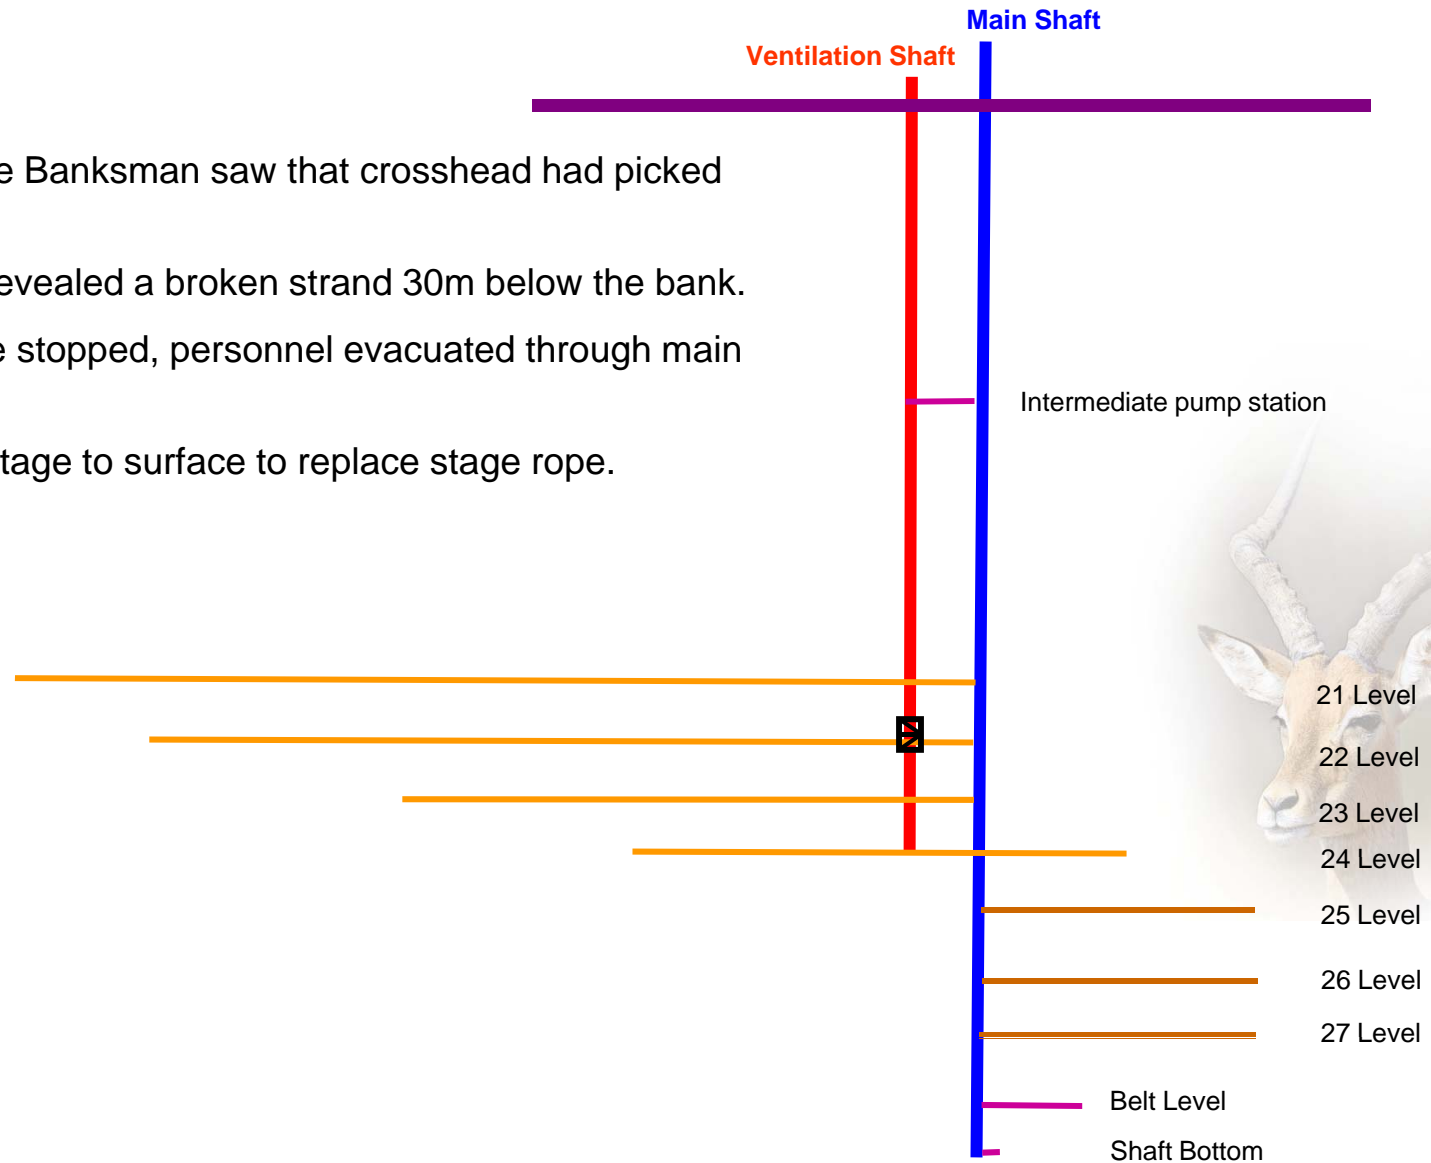
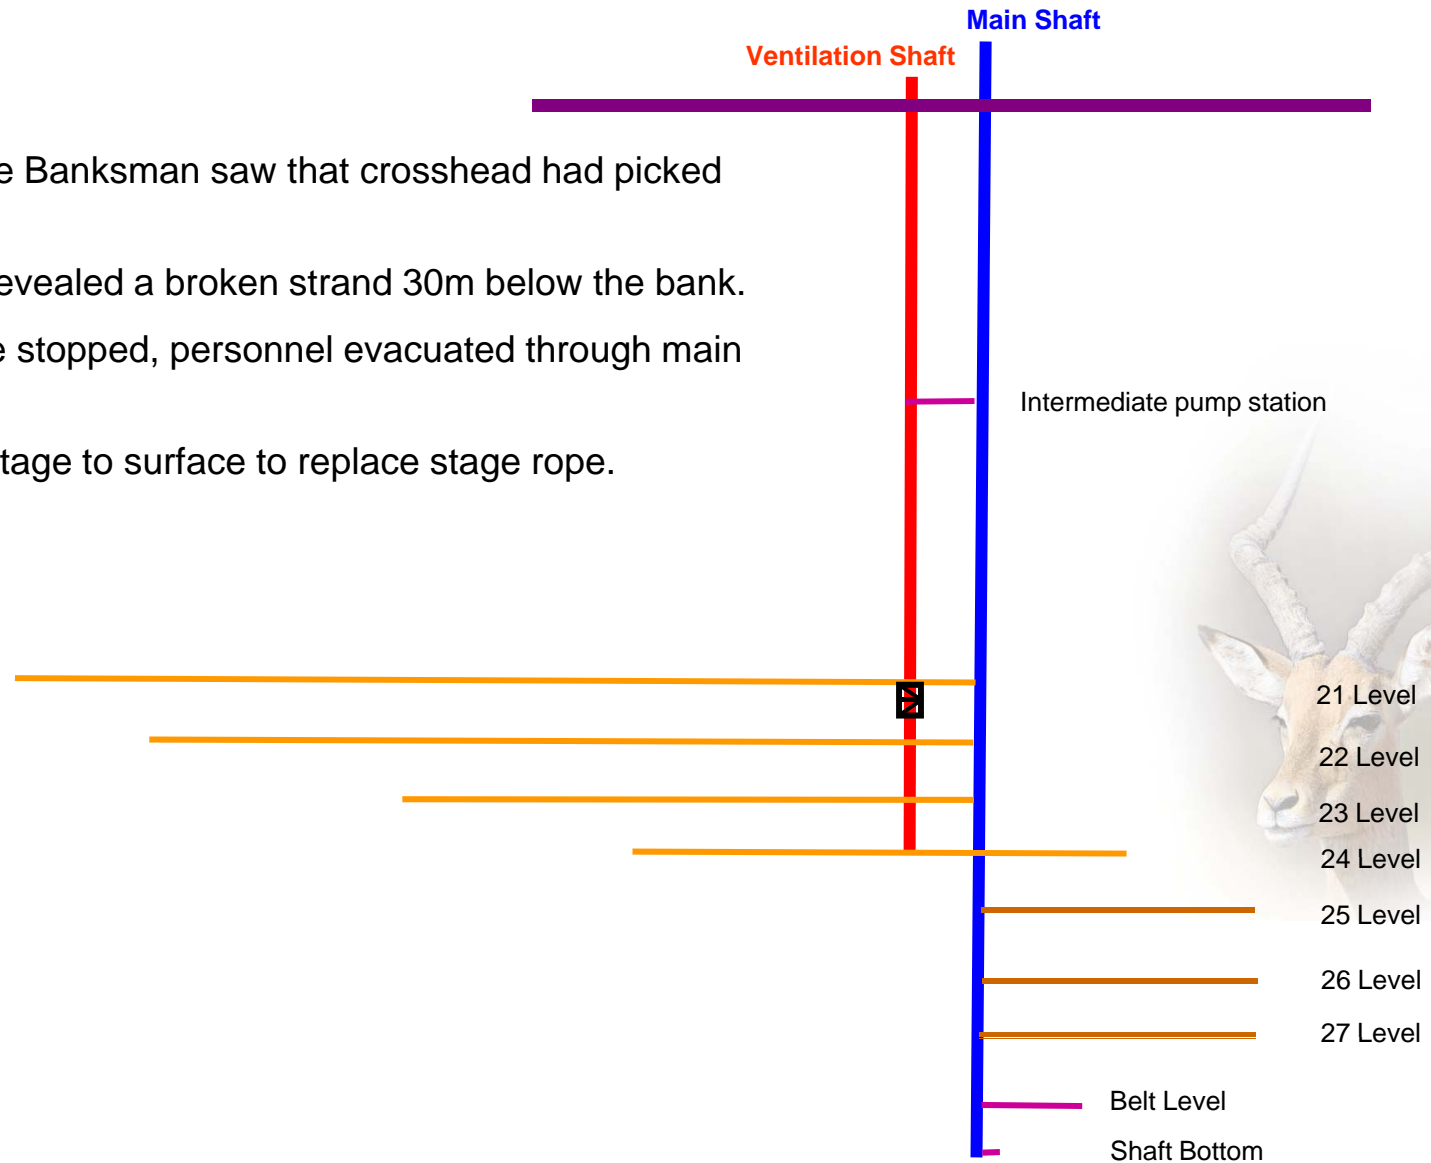
- On 19 February the Banksman saw that crosshead had picked up a strand.
- Visual inspection revealed a broken strand 30m below the bank.
- All operations were stopped, personnel evacuated through main shaft.
- Decided to move stage to surface to replace stage rope.

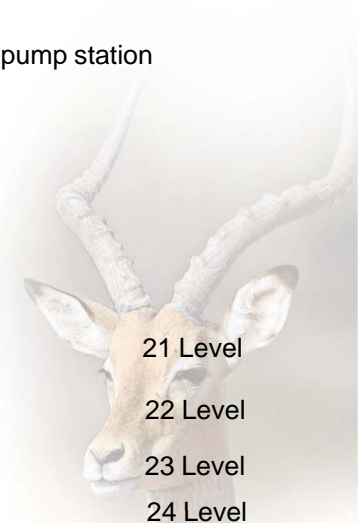
- Engineer instructed the Rigger to visually inspect damaged section of stage rope at frequent intervals.
- Further deterioration of the rope necessitated stage to be secured on 21 level

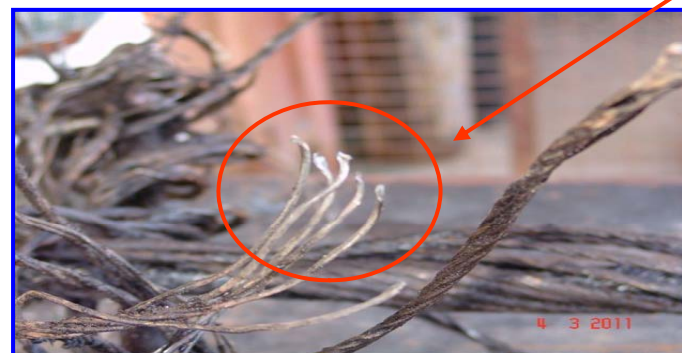
Localized material loss indicative of severe mechanical wear

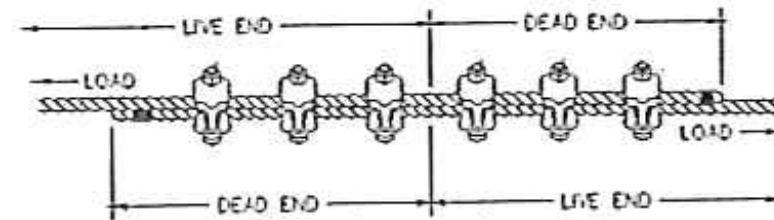
If a pulley (sheave) is used for turning back the wire rope, add one additional clip. See Figure 4.

If a greater number of clips are used than show in the table, the amount of turn-back should be increased proportionately.

- Double the amount of turn back
- Double the amount of clamps

- Check torque after load application
