Mponeng Mine Vertical Transport

Pipe bogey foul shaft steelwork
during slinging operation

Werner Grobbelaar
Vertical Transport Manager

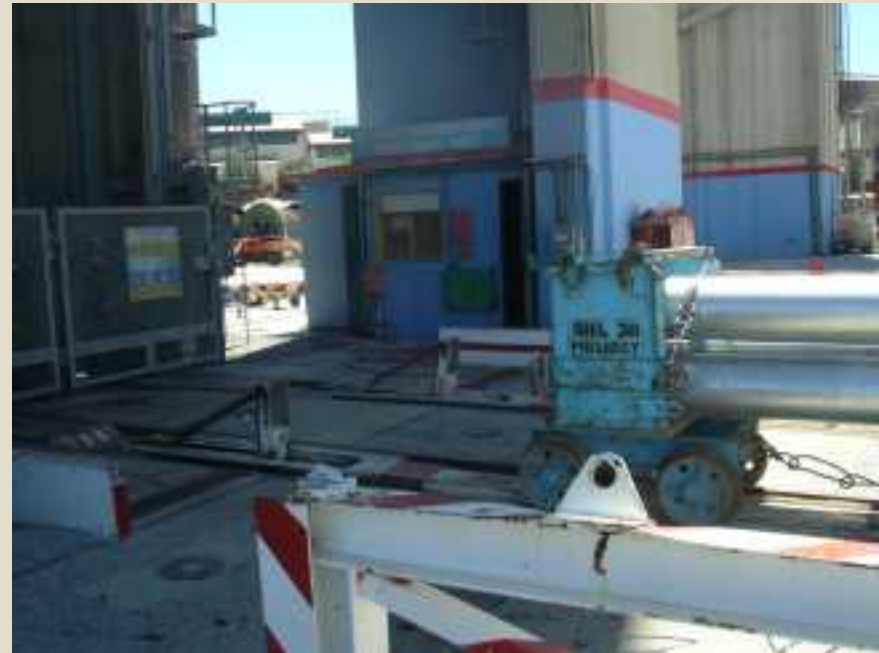
- The incident took place during normal slinging operations
- The 7th bogey loaded with four 250 mm lagged chilled water pipes was pulled into the shaft
- The bogey was steadied and the cage was rung away
- Engineering Assistant working on another conveyance heard a noise in the shaft
- The assistant went to tell the banksman

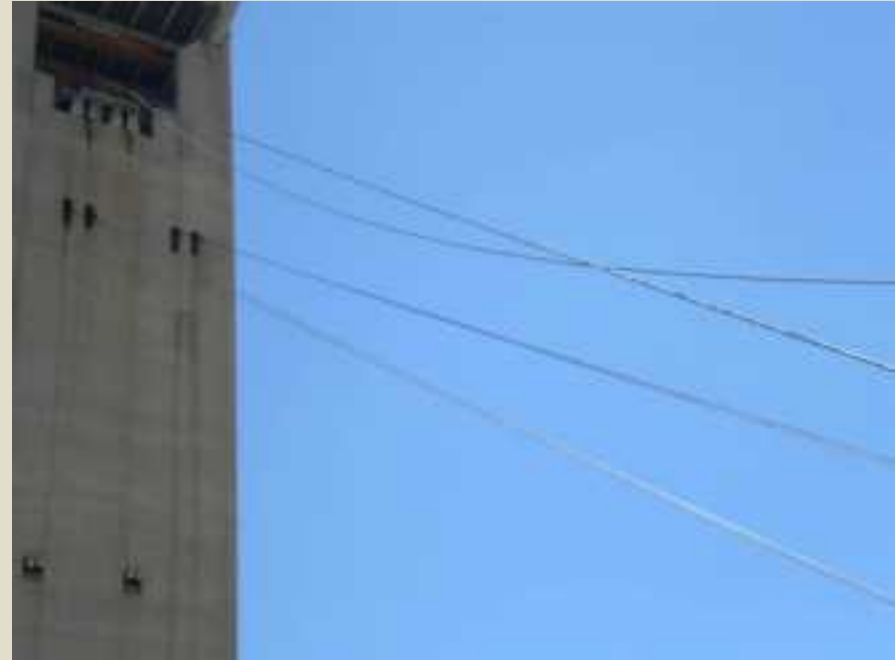
- Before the assistant could reach the banksman the winder tripped on electronic slack rope
- The banksman immediately activated the long bell
- The engineer was notified

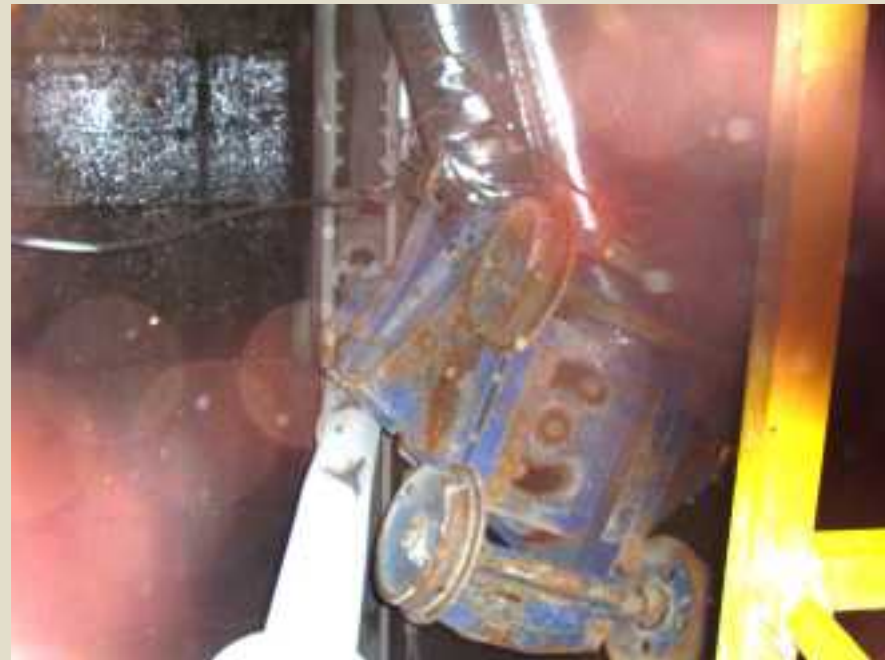
- The West Man Wider was rigged up to do shaft examination on single in order to assess the extent of the situation.
- Upon investigation it was found that the bogey of pipes fouled the shaft steelwork
- Fortunately none of the pipes fell down the shaft and thus no major damage to the shaft

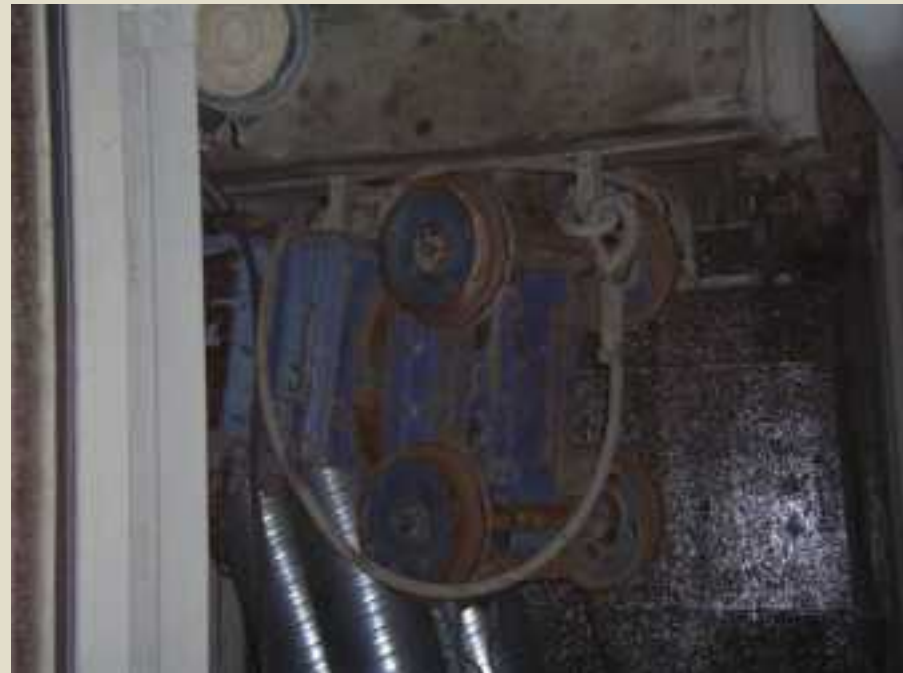
- The conveyance had come to rest on top of the bogey, which caused the slack rope and the subsequent corkscrew of the rope
- **A retrieving procedure was drawn up (one plan)**
- Retrieving operations began

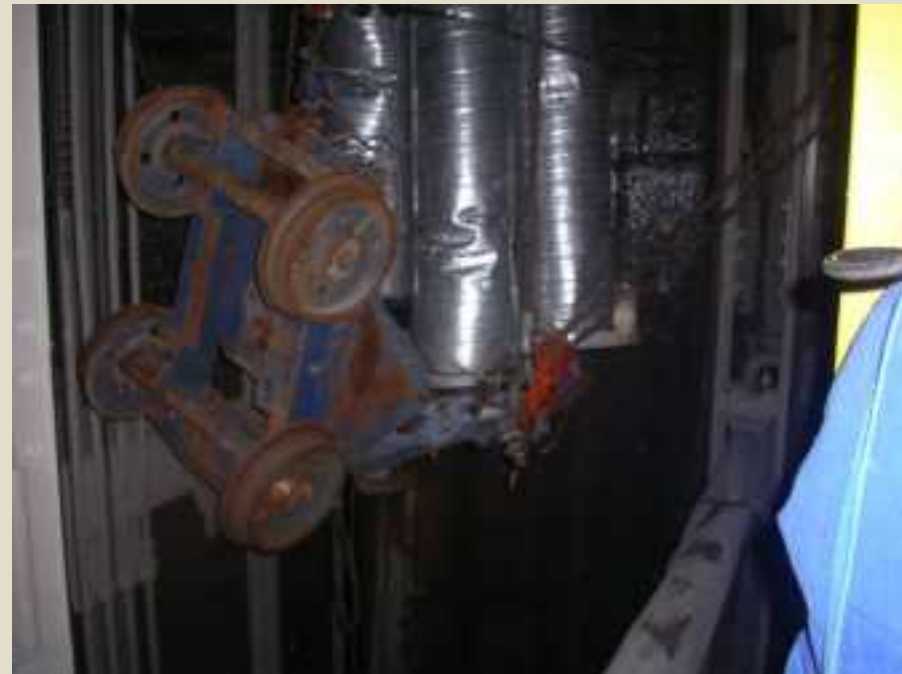
- A complete plan was formalised before retrieval of the bogey began
- Only the prescribed plan was to be followed with only one person in charge
- Everyone involved was briefed regarding each person's roles and responsibilities
- Chilled water pipes were supported to the bogey by means of chain blocks

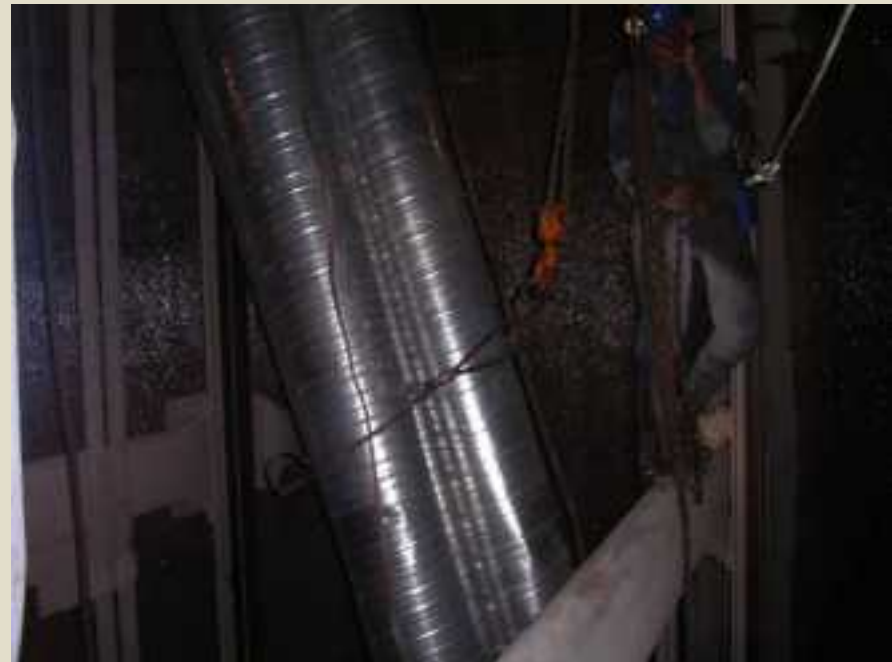
- The bogey together with the chilled water pipes was secured to the shaft steelwork
- The conveyance was raised slowly to take up the slack in the rope
- The condition of the kink in the rope was assessed in order to establish whether it could be used to raise the conveyance and bogey

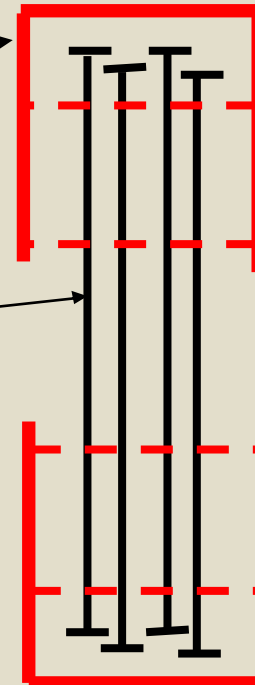
Symmetrically loaded bogey

- The bogey will hang skew in the shaft
- Pipes can come off the bogey
- Need to use a shackle to compensate for skewness

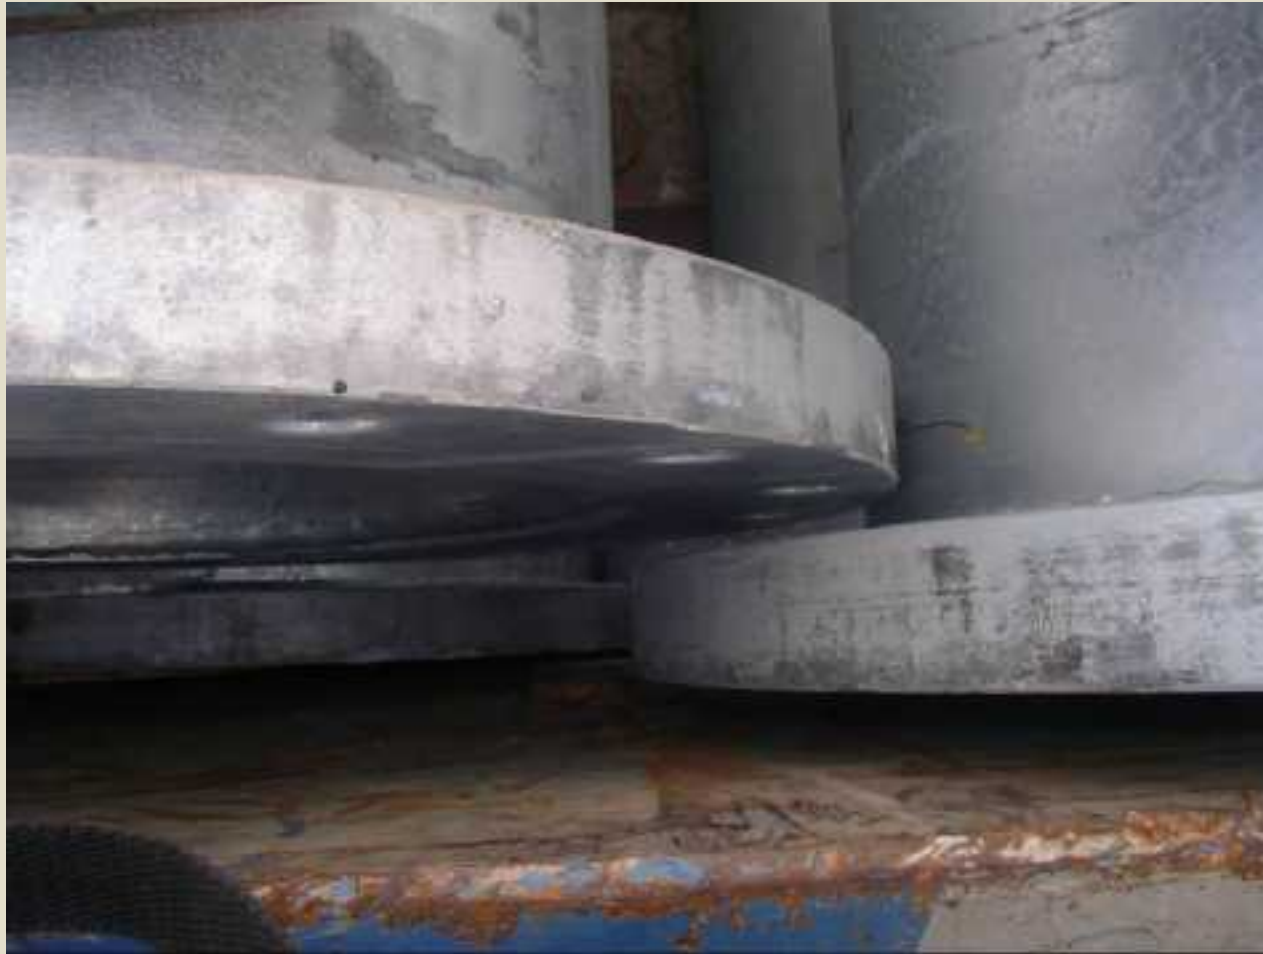
Correct loading of a bogey

Pipes loaded to ensure symmetry

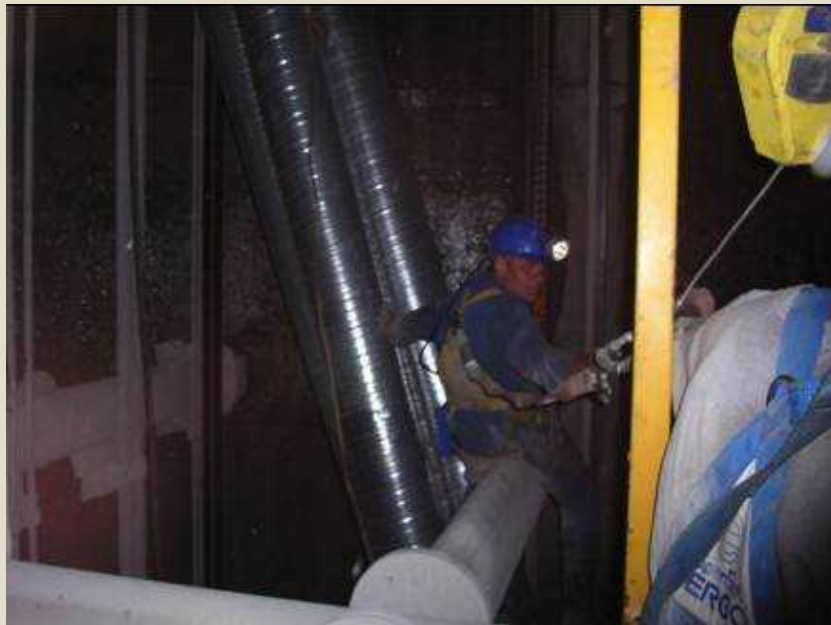
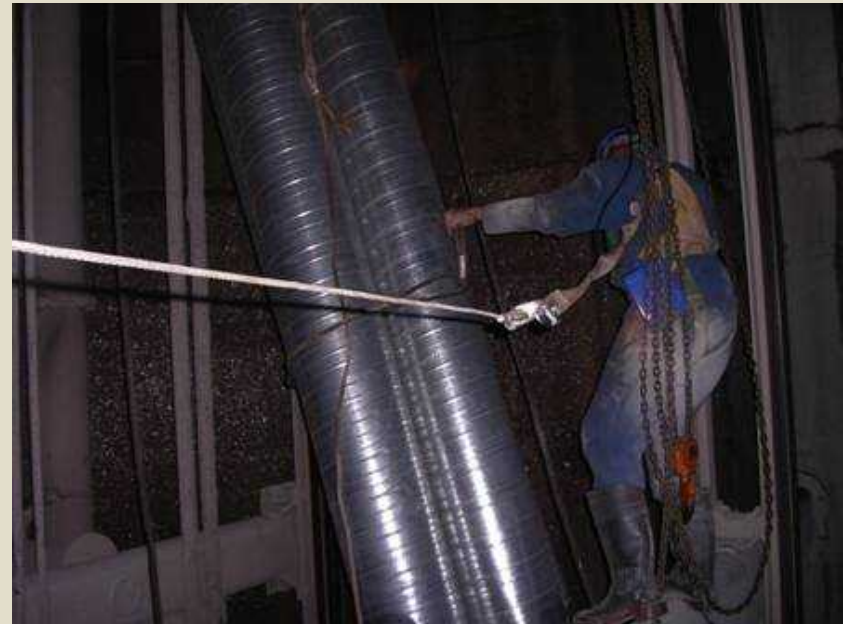
- The value of electronic slack rope device.
- With proper assessment and under controlled conditions, a kinked rope can be used to lift the conveyance.
