DRIEFONTEIN GOLD MINE

Safety Seminar

Pillar Steelwork – Ground Movement

YaRona Shaft (4#)

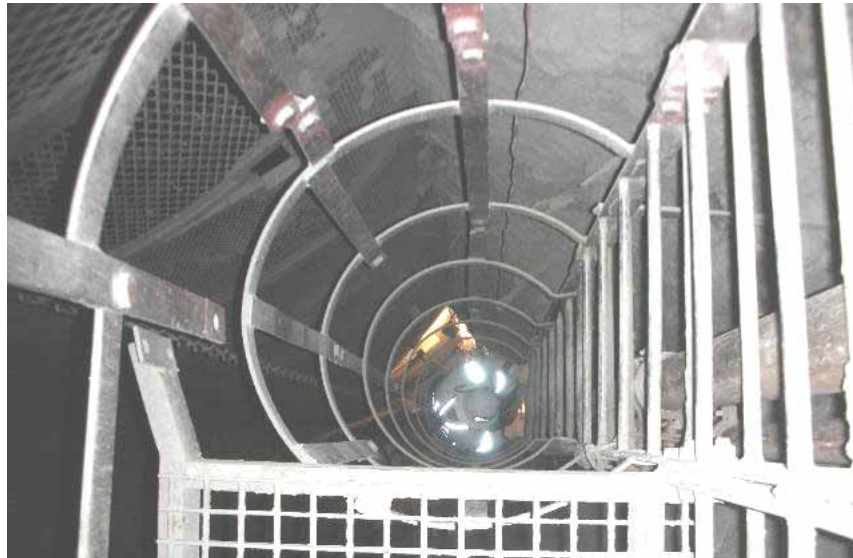
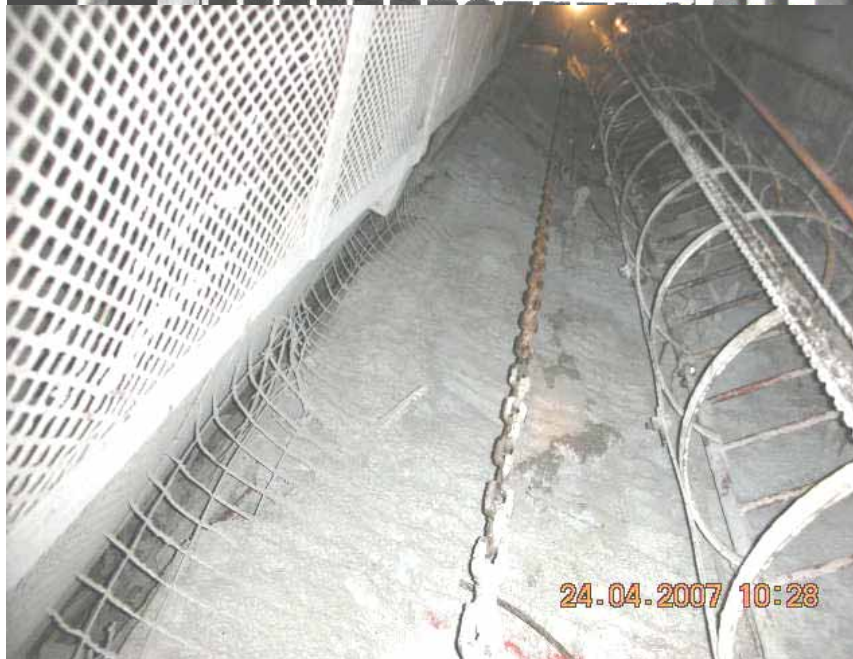
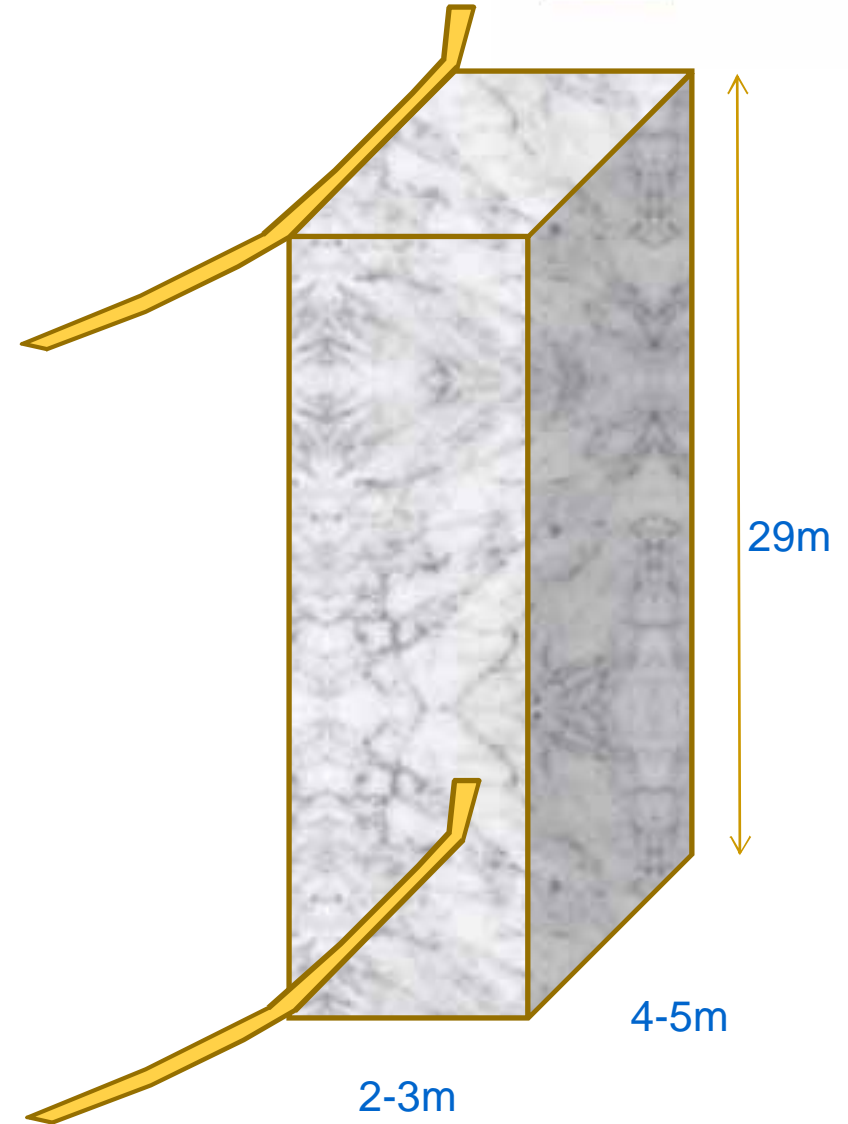
Background of the Pillar (chase)

Highest probability of failure lies in the hangingwall of the reef up to 18m from top reef contact on the chase side of the barrel

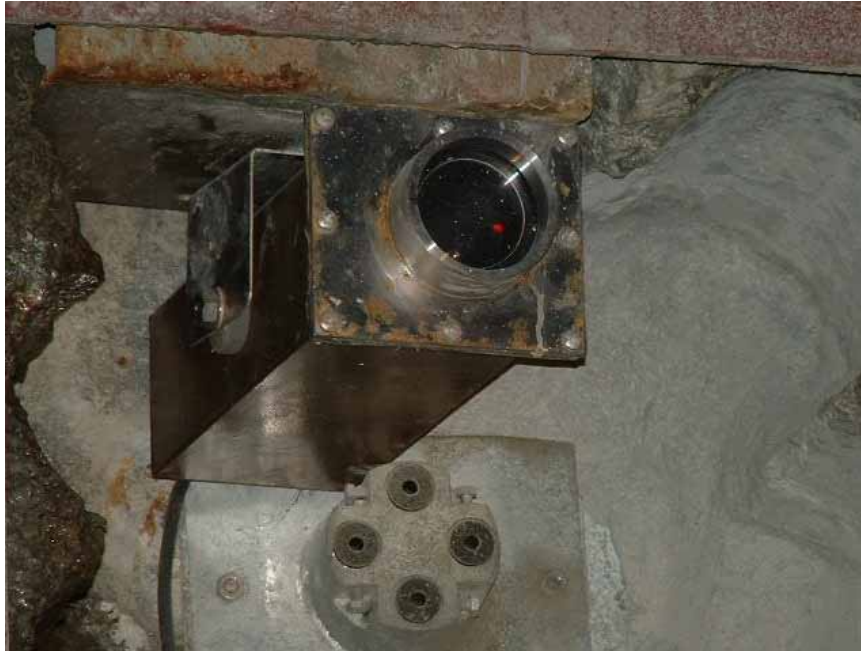
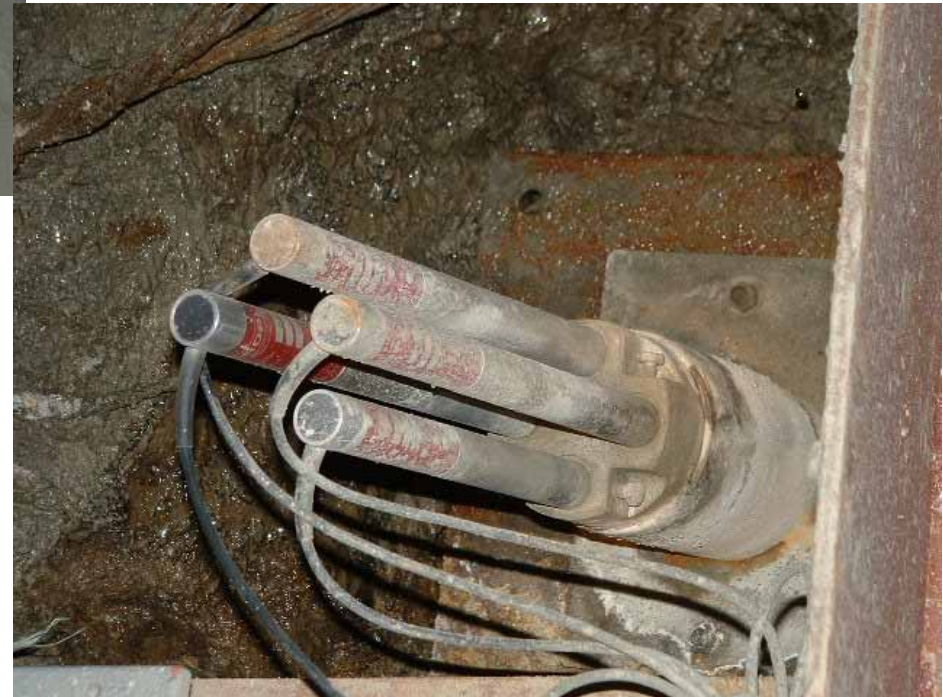
Existing controls

- ❑ Lasers, measuring across the shaft at 2 points
- ❑ LVDT ground movement measuring instruments, measuring the horizontal stresses
- ❑ Vertical pull wires measuring vertical movement in the shaft
- ❑ Guide gauge weekly, findings in shaft logbook
- ❑ Measuring the compensating guide distances
