Accident at 38 Level Waste Tip

J.L. de Beer

Main Shaft

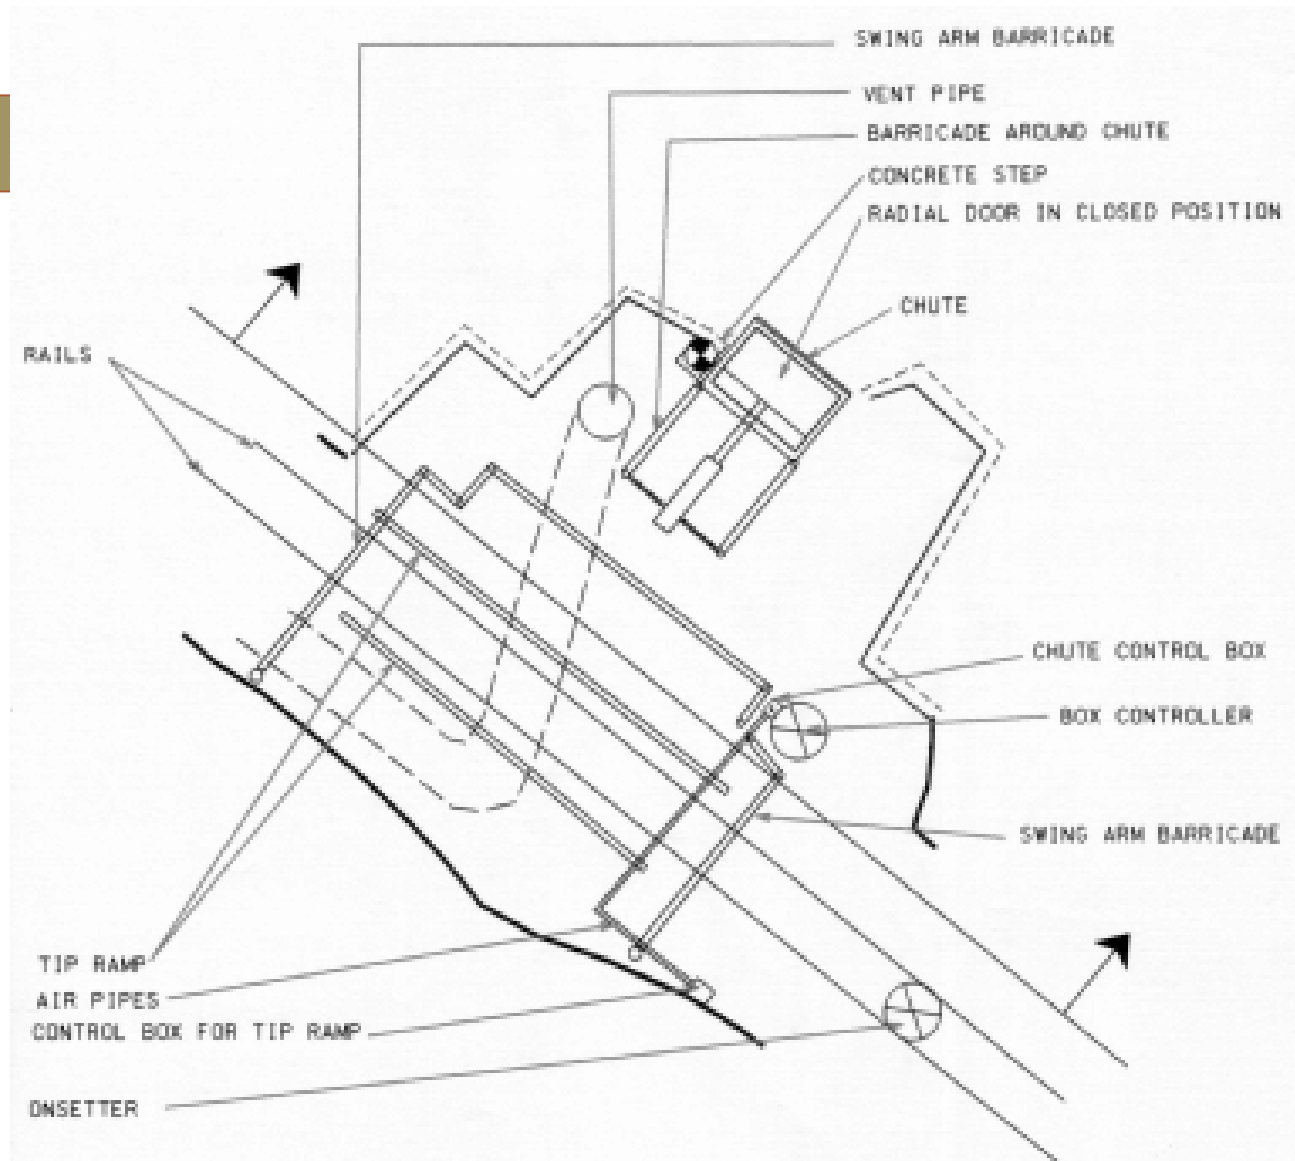
Accident Plan after Accident

- The now deceased said he was going to have a look why the rock has stopped running.
- At the same time it is alleged the Shaft Timber man proceeded to the controls and closed the door.
- It is also alleged that the now deceased went to the chute and it is assumed he looked up into the ore pass by positioning himself between the waste pass chute and the radial door, which was then closed, fatally injuring him.

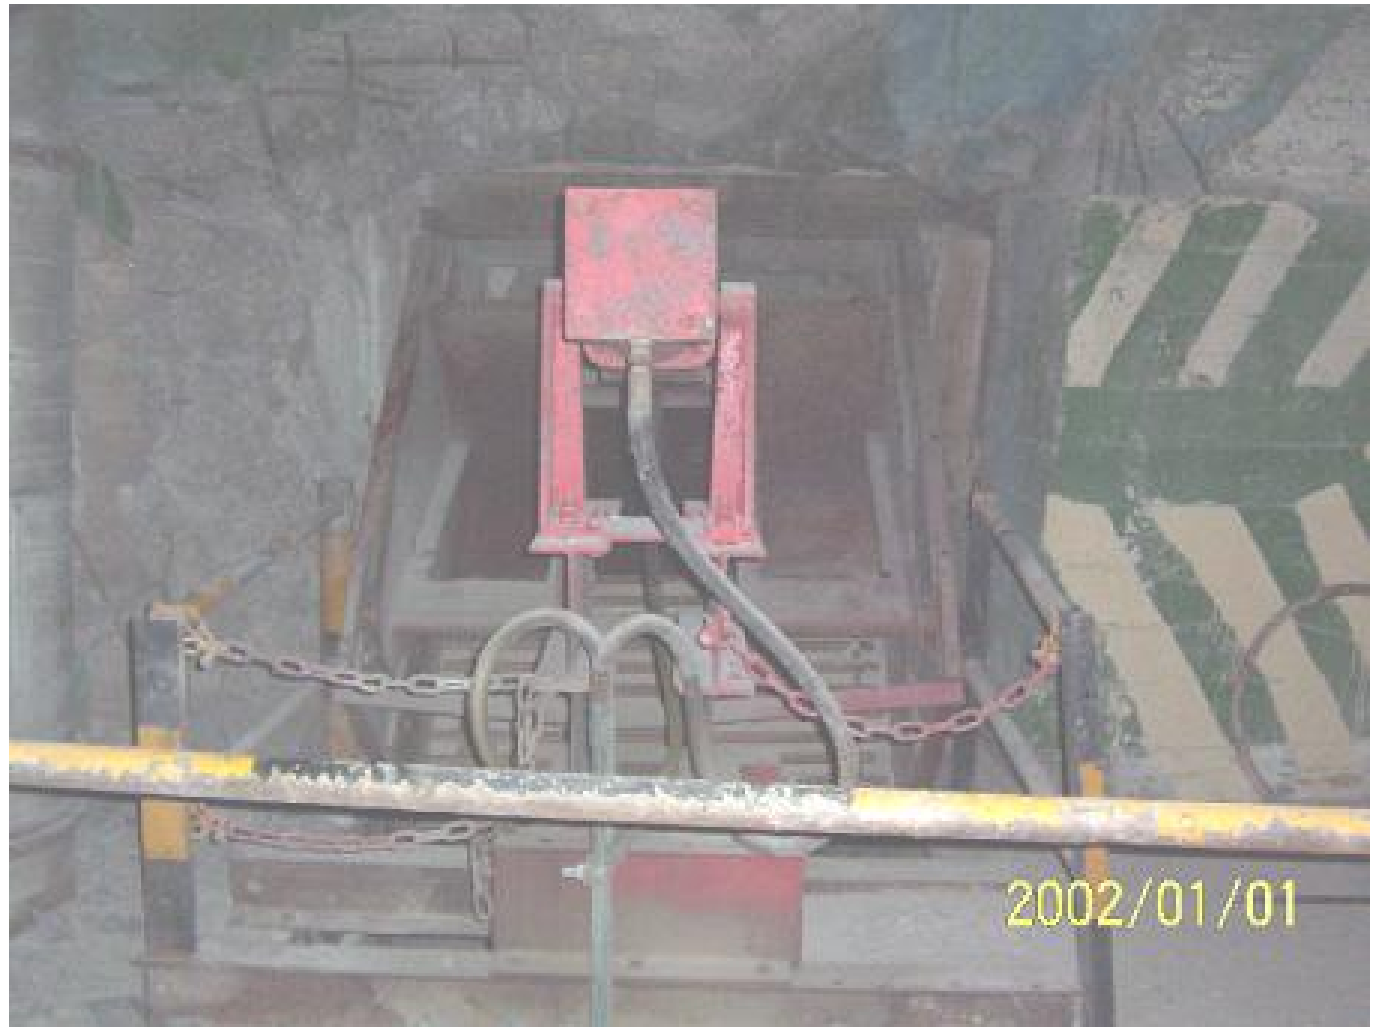
Photos of accident scene

Photo of defective control

- The Shaft Timber man failed to identify dangerous conditions and apply the 5 Steps to safety or the “Stop, Fix and Continue Working” safety program.
- The Shaft Timber man failed to ensure the area was clear of persons and safe before closing the radial door.
- The Radial door control valve was defective.
- The accident side of the chute could not be seen when the radial door was in the open position.
- Poor illumination in the area.

<u>ACTION</u>	<u>COMPLETION DATE</u>	<u>RESPONSIBLE PERSON</u>
The control valve was replaced	15/07/2004	Fitter
The illumination in the area was rectified.	15/07/2004	Electrician
Damaged grating on the walkway was replaced.	15/07/2004	Boilermaker
Monthly over inspections of the tip areas	Monthly	Foreman Fitter, Foreman Boilermaker, Shaft Foreman, Mine Overseer (3 Monthly)
Monthly inspections of all tipping arrangements as per Standard procedure	Monthly	Boilermaker
