Great Noligwa Mine Electrical Flash Accident

Mini Substation Details

Equipment N°:	M258
Switchgear:	Lucy (OCB)
Last overhaul:	1995
Manufacturer:	Steelcor
Installation date:	1996
Last serviced:	08-09-2004
Load:	Two mini-substation in parallel
Status:	Temporary installation, was due to be removed

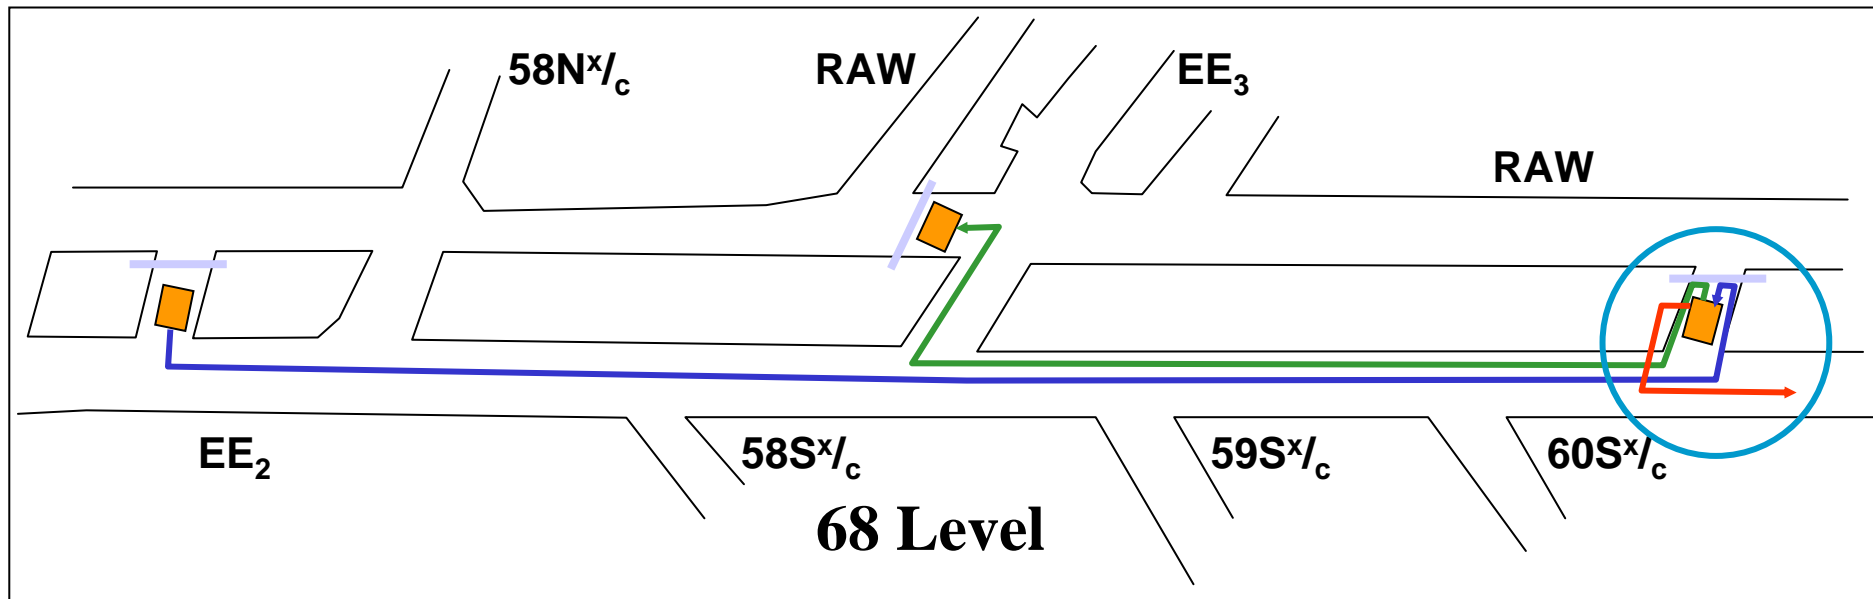
To be able to disconnect the mini substation which was feeding the raise bore machine, the electrician had to switch off the out going power on the unit in question.

In the processes of switching off the out going power, a flash occurred in the switchgear.

The electrician sustained 1st and 2nd degree burns to his face, lower neck, hands, both forearms and right thigh.
