In Memory of

Danizele Isaac Vula

7 February 1968 to 24 June 2005

Description of Accident

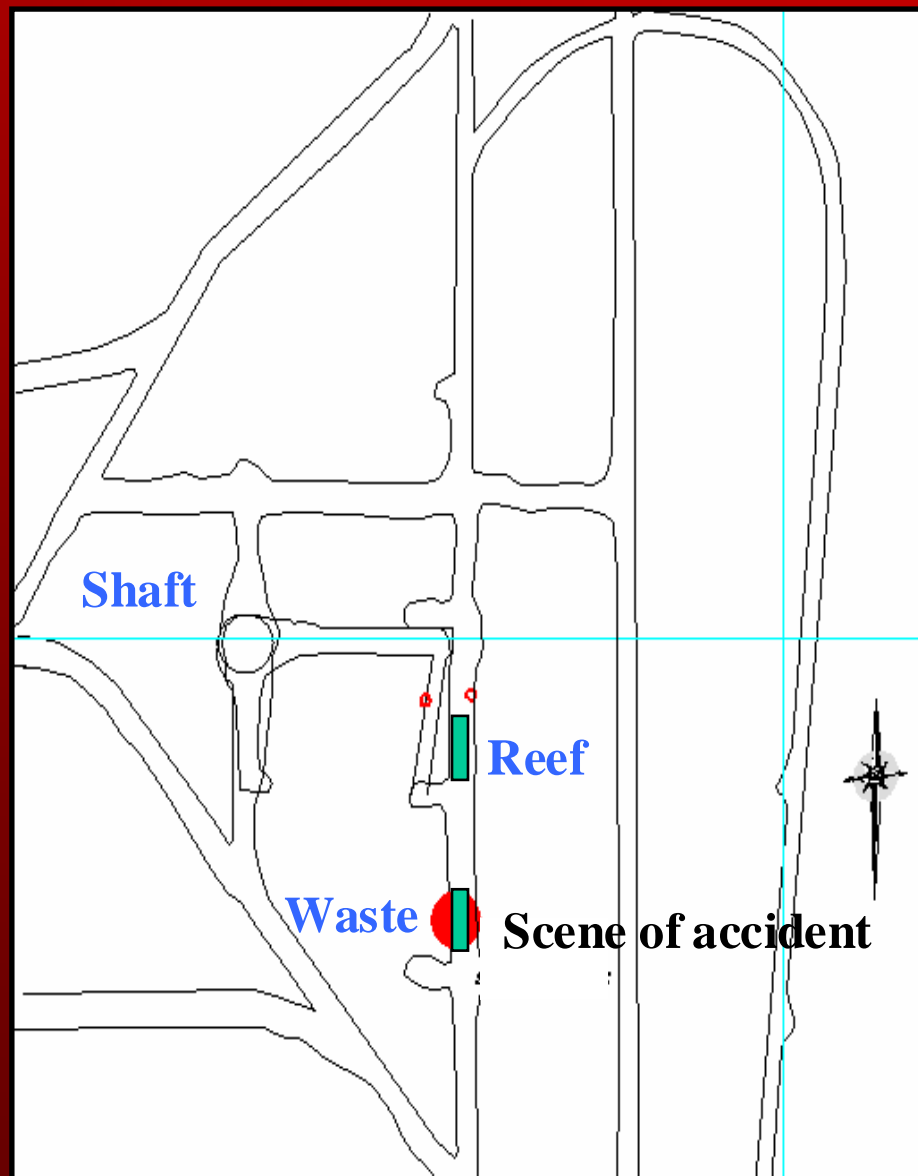
1350 LEVEL STATION AREA

Whilst crossing the tips with his locomotive on 1350 level at approximately 08h25, Danizele collided with a partially open farmgate barricade on the waste tip. The leading edge of the farmgate entered the locomotive cabin via a vacant light housing and penetrated Danizeles' pelvic area ejecting him from the cabin. Positioned on the footwall next to his locomotive, Danizele passed away as a result of his injuries at approximately 08h45.

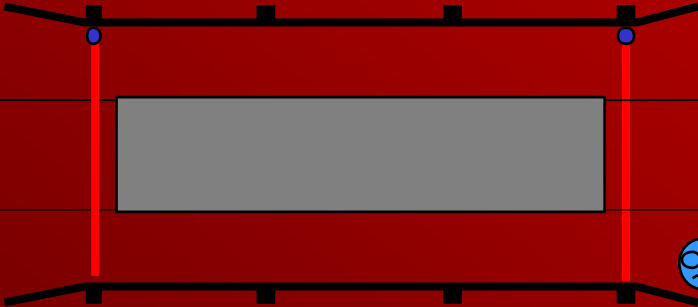
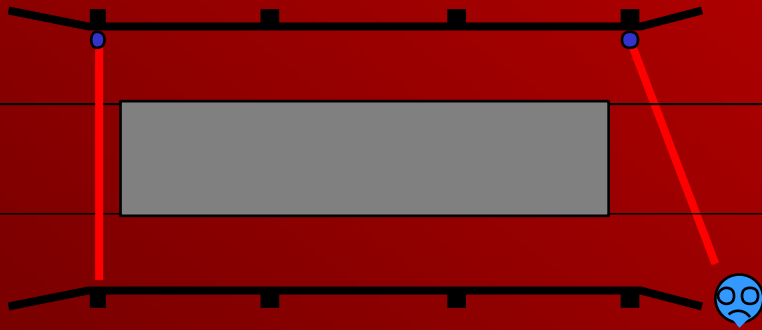
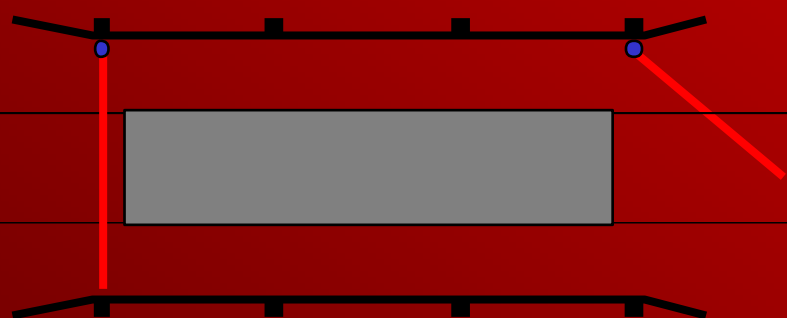
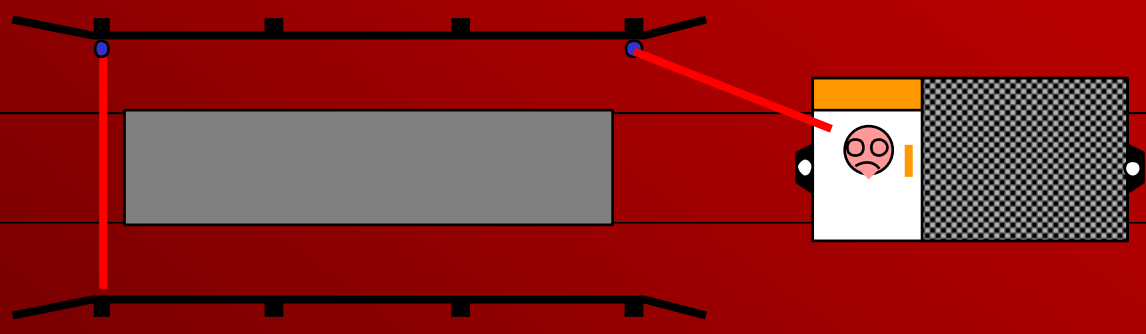
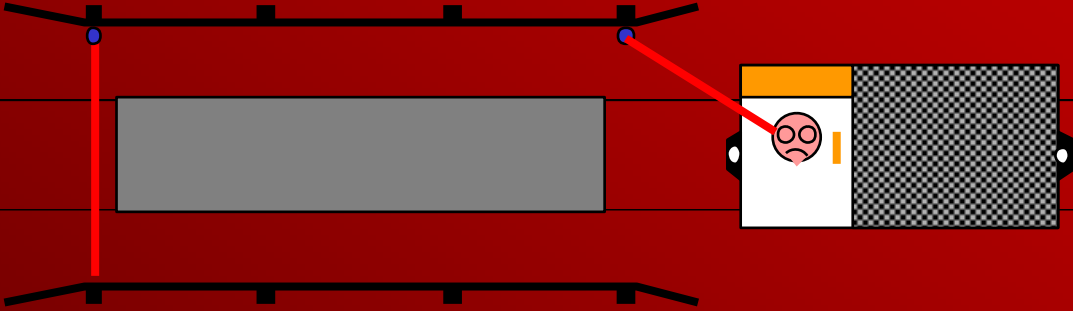
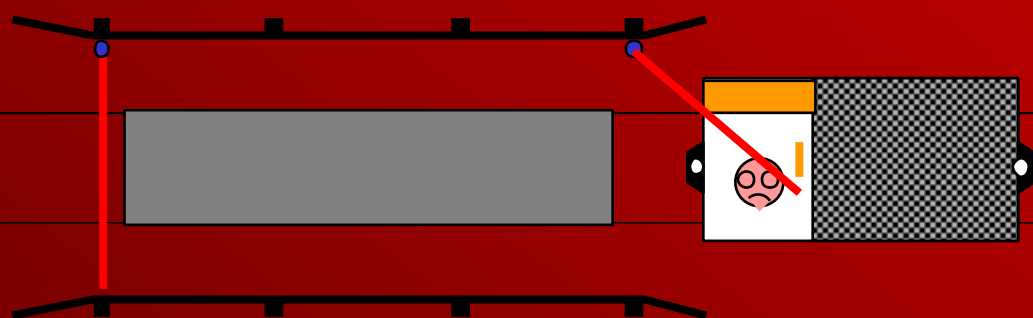
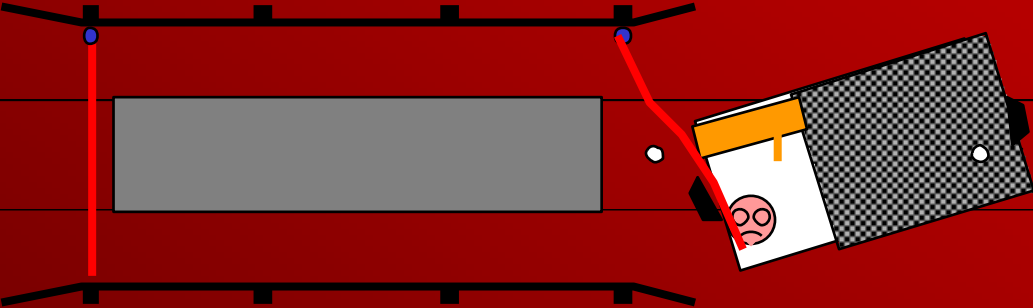
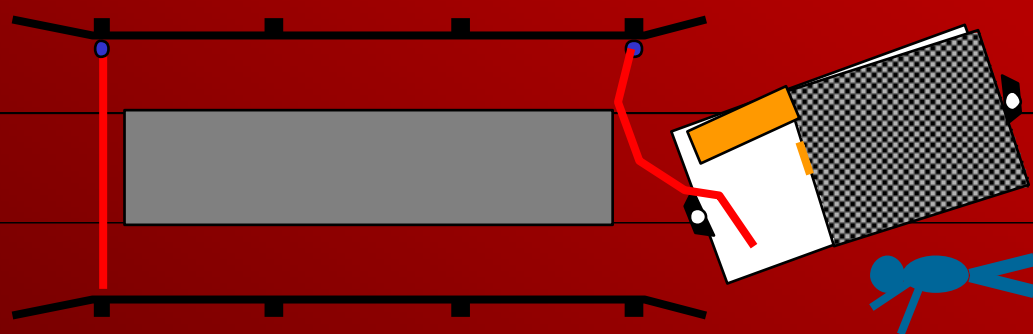
- After having collected his equipment, Danizele proceeded back in the direction of the shaft once again having to cross both tip arrangements.
- On reaching the reef tips, he disembarked his locomotive and opened and closed the tips' farmgate barricades himself in order to cross. The time was approximately 08h25. The tip attendant (Mothobi Phumo), was positioned at the waste tips some 25 meters away at this stage.
- Mothobi, who was also the only eye witness, noticed that Danizele was approaching the waste tip at what he recalls was at high speed and attempted to open the farmgate barricade from the latching point side but could not swing it into a fully open position before the locomotive had struck it.

- On impact, the leading edge of the barricade then entered into the drivers cabin of the locomotive via a vacant light housing and this penetrated Danizeles' pelvic area ejecting him from the cabin and bringing the locomotive to an abrupt halt. Danizele was laying on the footwall alongside the locomotive after having been ejected.
- Mothobi immediately ran to the tip telephone and informed the control room of the accident who immediately alerted the paramedics.
- On returning to the scene Mothobi summoned the help of a Miner and Shift Overseer that where close to the station. The paramedics arrived shortly afterwards but unfortunately, Danizele had already passed away. The time was approximately 08h45.

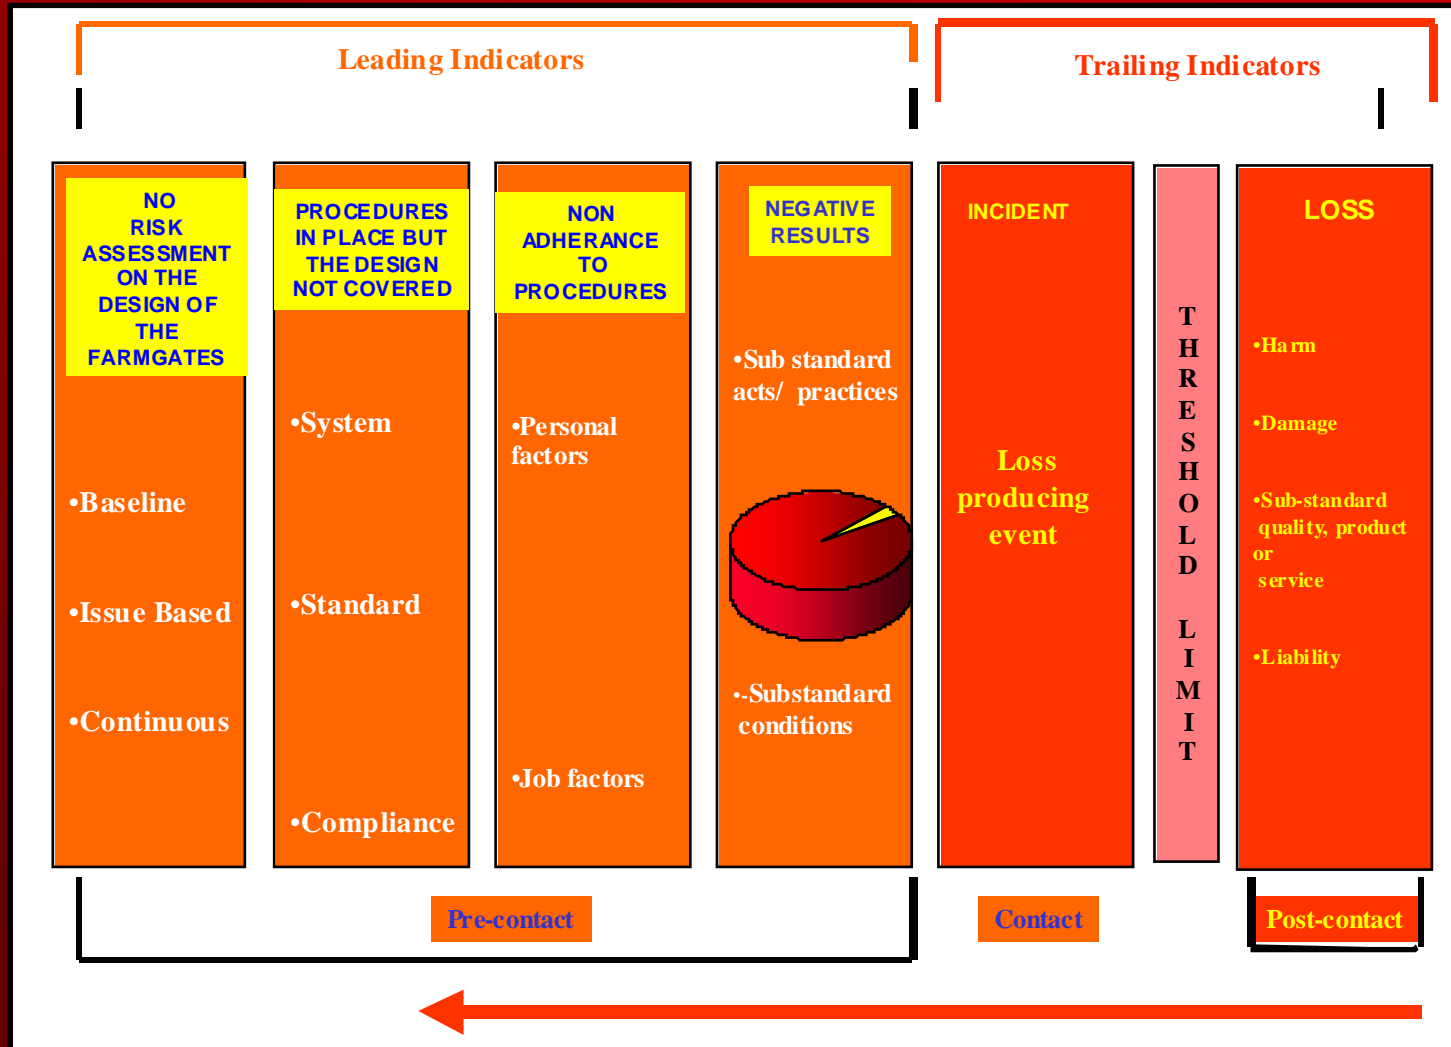
Causation Analysis

- *Failure to conduct an issue based risk assessment on the farmgate tip barricade installations.*
- *Failure in the continuous risk assessment process in that neither the vacant light housing nor the farmgate were identified as potential hazards.*

- *The gates were never intended for the purposes of stopping a locomotive but instead for preventing people from inadvertently walking over the tips.*
- *All tips are fitted with sliding tip covers that are kept closed at all times except when tipping takes place.*
