Electrical 6,6 kV Flash Incident

LONMIN

Date Of Incident : 10 March 2009
Actual Severity : Level 4

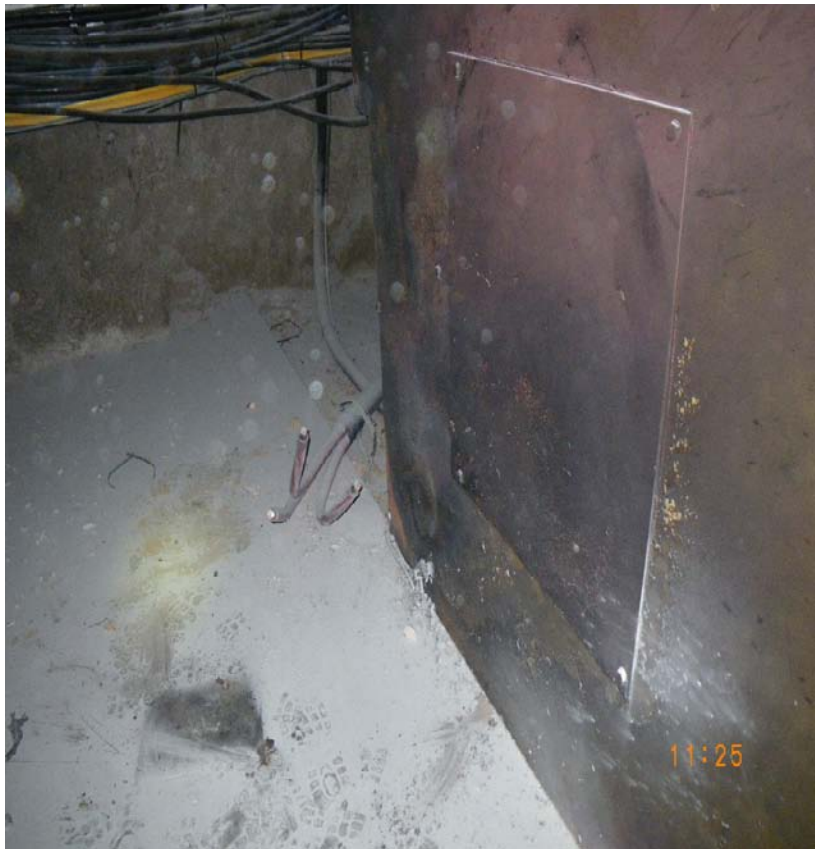
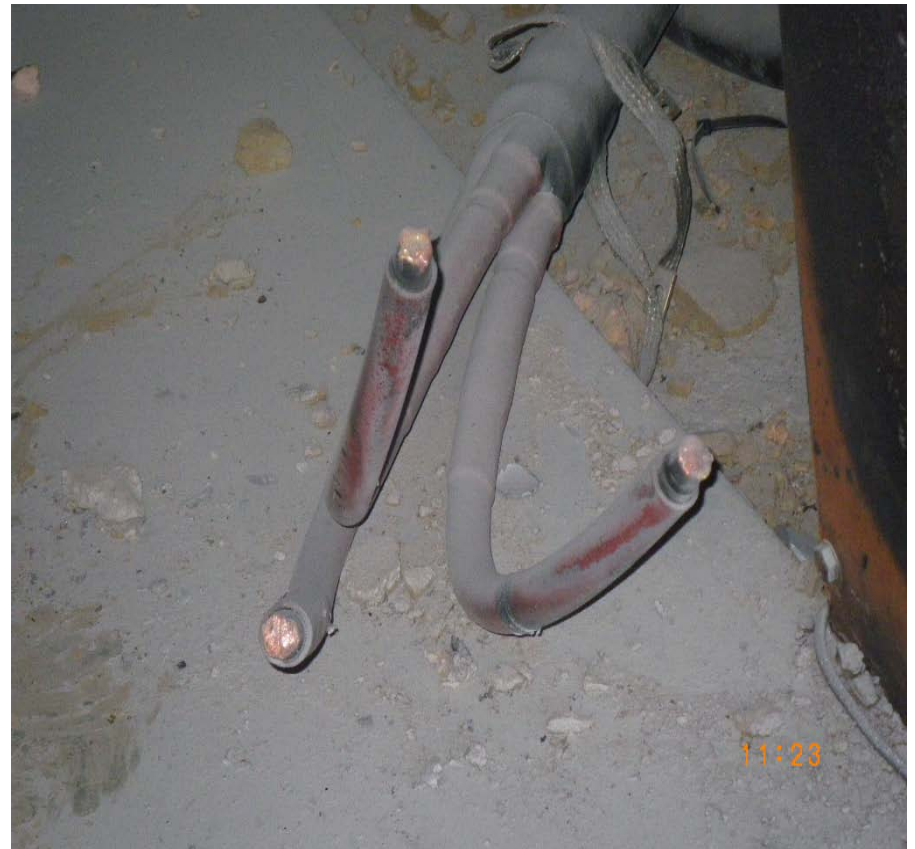
PHOTO'S

The following deviations were observed at 31 Level HT Sub Station:

- **Broken lock pin of entrance gate to HT Sub Station.**
- **Open/un-guarded 6.6kV Cable.**
- **Evidence of fire at scene of accident.**
- **Burned clothes, hard hat, SCSR & cap lamp on the station.**
- **Used fire extinguisher.**

1. Live open ended \ un-guarded 6,6kV electrical cable lying on footwall.
2. Live open ended \ un-guarded 6,6kV electrical cable not isolated on 30 level sub-station

- **Notified DME – Inspector of Machinery.**
- **The open/un-guarded 6.6kV feeder to 31 level was isolated on 30 level.**
- **All underground work stopped until the shaft electrical reticulation was declared safe by appointed Engineer.**
- **Immediate census and action of all open cables ends bolted together and taped closed.**
- **Communicated incident.**
- **Re-training of all Electrical employees (Foremen, Electricians and Electrical Aids) on:**
 - ❑ **HT Switchgear, Lockouts ,Isolation Procedure and Restricted Areas – HT Sub Stations & Switchgear**
